### CONDITION ASSESSMENT REPORT FOR THE KZN ~~ROWING~~ ASSOCIATION

Project Name : Condition Assessment (Ex-Hydro jetting &  
Industrial Services (PTY)LTD

Owner : Transnet National Ports Authority

Release Date: 02/06/2025

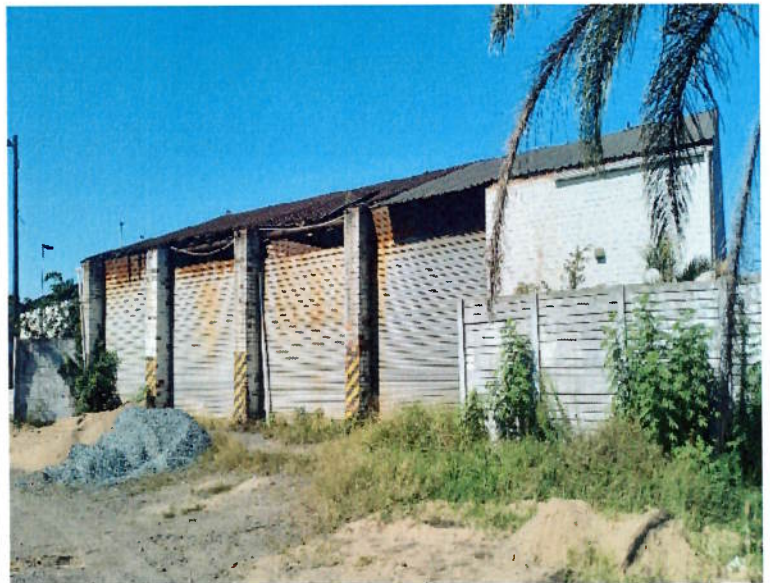
Figure 3: Building Exterior

- The area of land in this building is 1070 m<sup>2</sup>
- The exterior of this complex is in a very bad condition it has many things that have to be taken care of which can improve its appearance.
- The entire roof structure is covered by metal sheets of which now have corrosion in some parts and this affects the inside as the water coming from rain is entering the inside and causes damage to the floor.
- The roof has no drainage system, as well as the entire property. There's no evidence of a stormwater management system within the boundary of the property.
- The roof has asbestos.

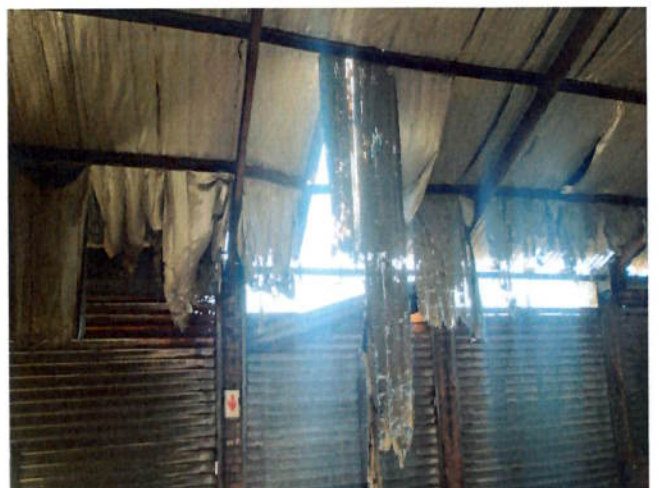
Figure 4: Roofing

- The roofing of this building is in a very bad condition and some of the metal sheets are missing, and they are causing the water from rain to get inside the building.
- The steel portal frames on this building are starting to get affected by corrosion and the membrane on the roof is starting to lose its properties as it has been ignored for a very long time.

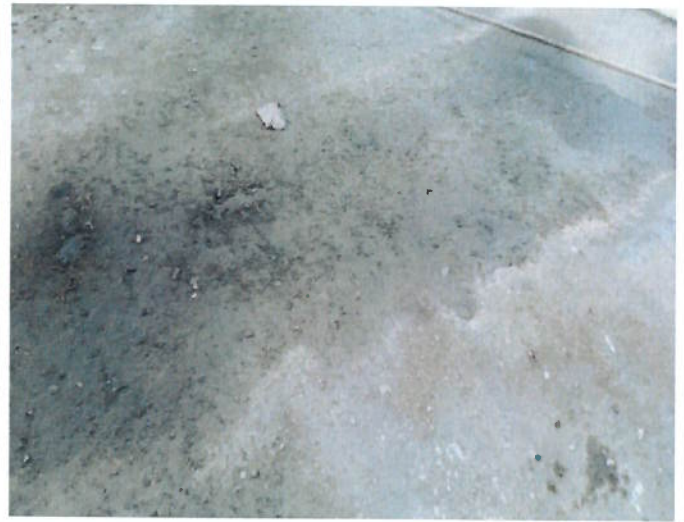
Figure 5:floor

- The floors are dirty. The cause of this is due to the bad roofing and there are water ponds on some of the areas.
- The finishing on this floor is not in good condition it requires attention so that it can get back to its condition.

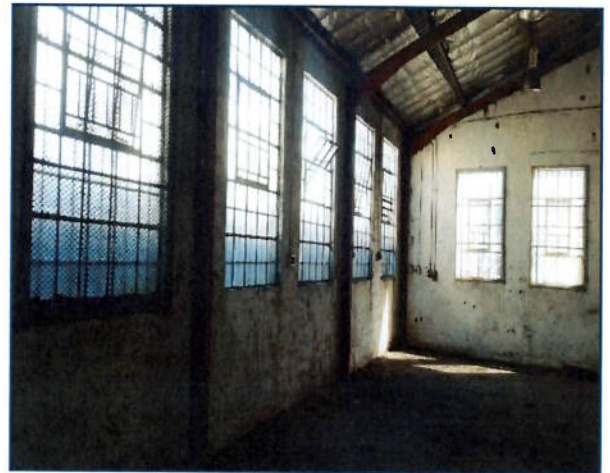
Figure 6:windows

- The windows in this building are not in bad condition, only a few windows are broken in this building.

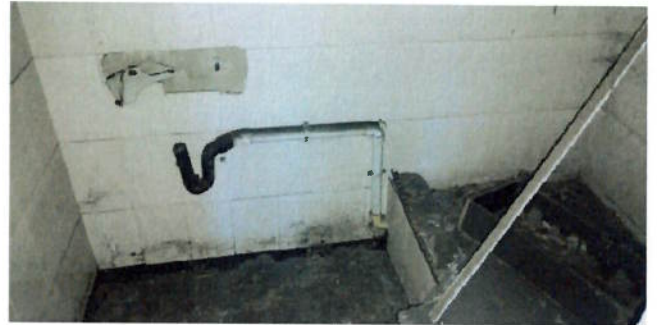
Figure 7:plumbing

- The water pipes in this building are damaged and there was flooding in this toilet area.
- The walls are not in good condition but can also be fixed by painting.

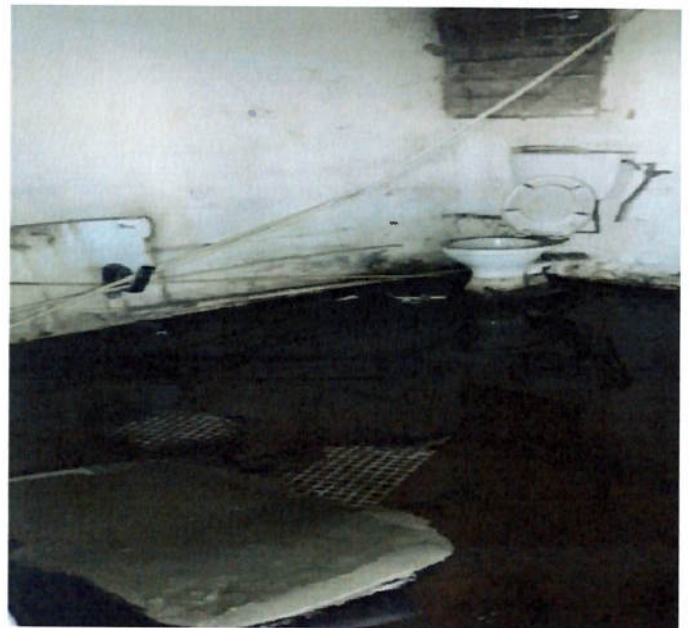
Figure 8:ablutions

- Ablution facility damaged and unusable.
- The floors are not completely damaged but are also in bad condition.
- The walls are dirty due to the dust that is coming inside the building.

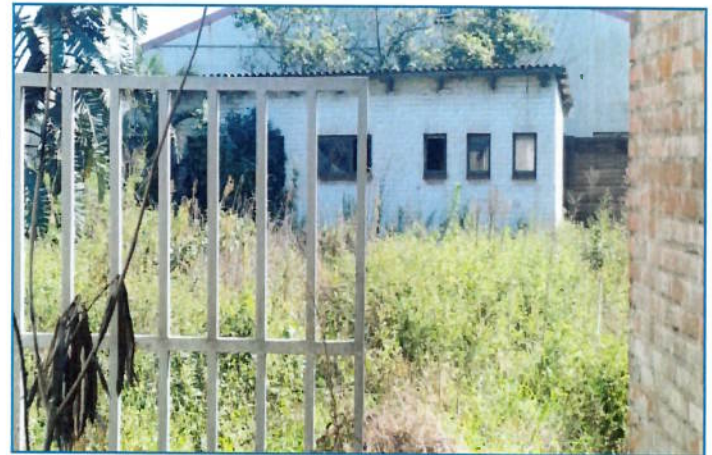
Figure 9:building 2 exteriors

- The walls of this building are not in a bad condition they only need to be painted because the walls are dirty.
- The windows of this building need to be changed as most of them are damaged.
- The roof of this building is not in a bad condition, but the only issue is that it has the asbestos roof.
- The building was not accessible due to the overgrown vegetation.

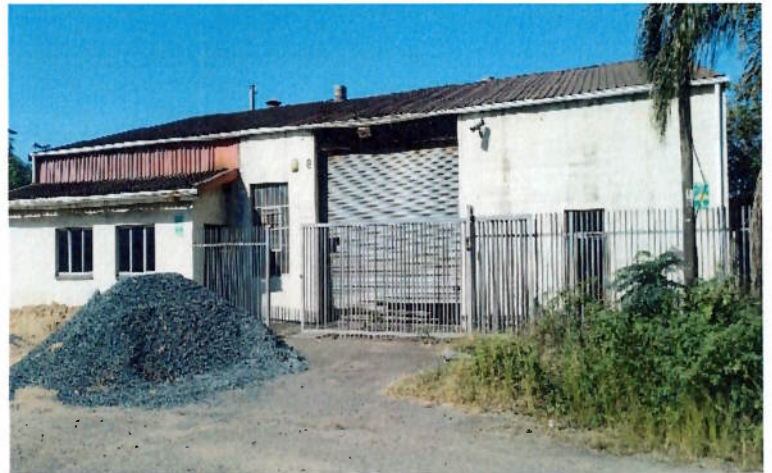
Figure 3: Building Exterior

- The area of land in this building is 447 m<sup>2</sup>
- The exterior of this complex is not in a very bad condition is has minor things that must be taken care of which can improve its appearance.
- The entire roof structure is covered by metal sheets of which some of them are starting to get corrosion.
- The roof has gutters, but they are starting to fall.

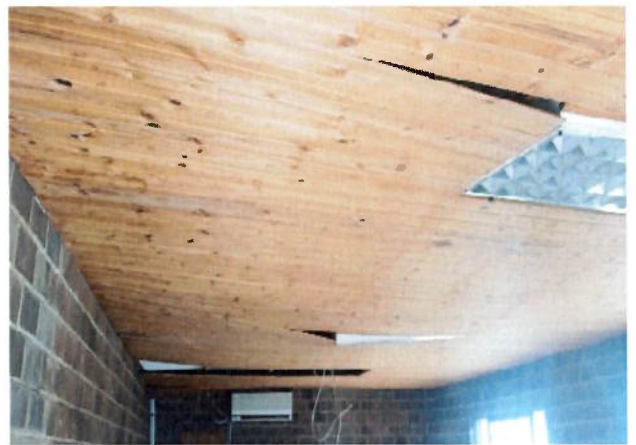
Figure 4: Ceiling Damages

- The ceiling of this building is not in a good condition it has leaks due to bad condition of the roof and it show that the water has affected it, water passes from roof to floor, and it is damaged
- Small panel gaps from the roofing were identified, which can cause water damage of the trusses.

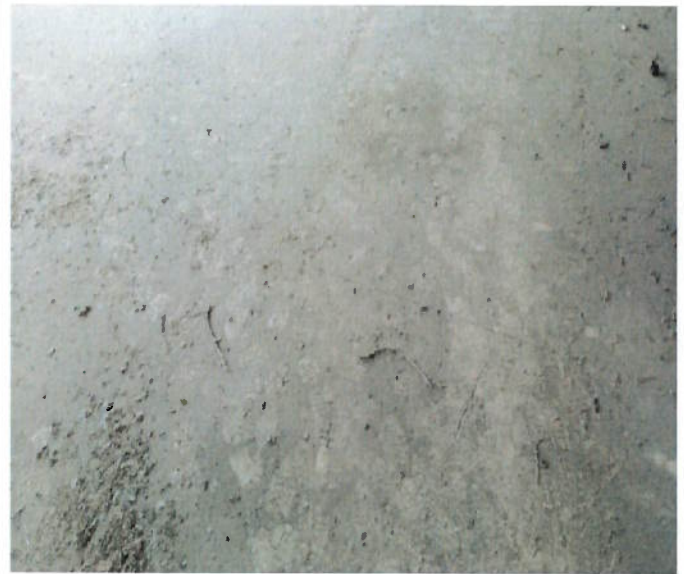
Figure 5:floor

The floor of this building is not in a bad condition they just need cleaning so that they can get back to the normal condition.

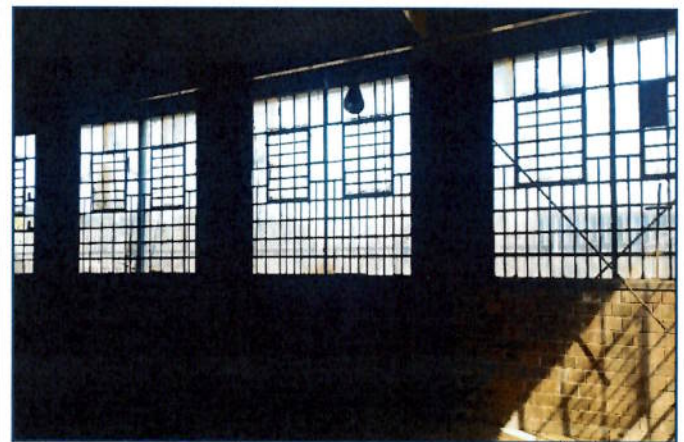
Figure 6:windows

- The windows are in good condition and only a few windows are broken.

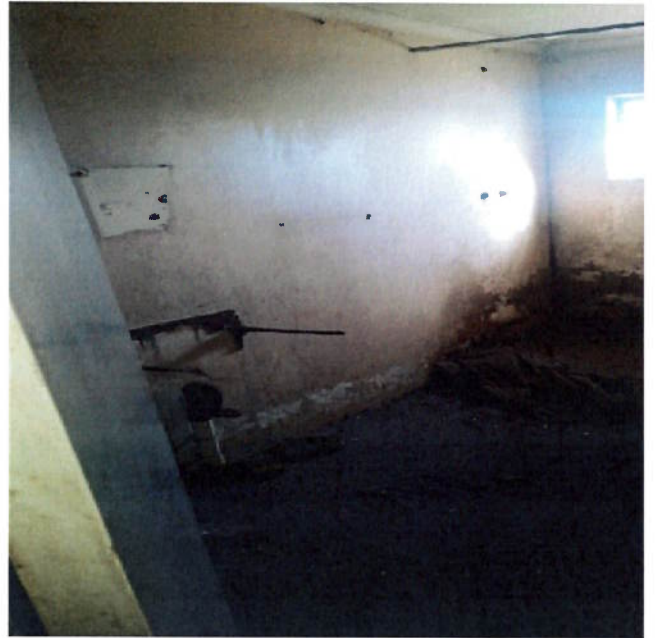
Figure 7:ablutions

- Ablution facility damaged and unusable.
- The floors are not completely damaged but are also in bad condition.
- The walls are dirty due to the dust that is coming inside the building.

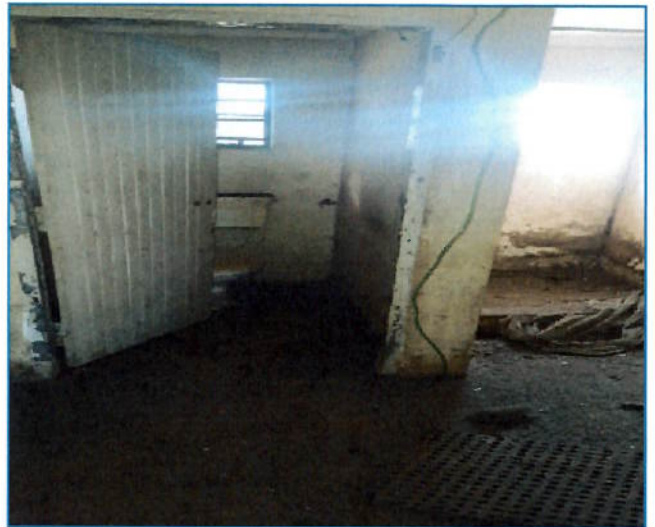
Figure 8:plumbing

- There's no evidence of water supply within the building.

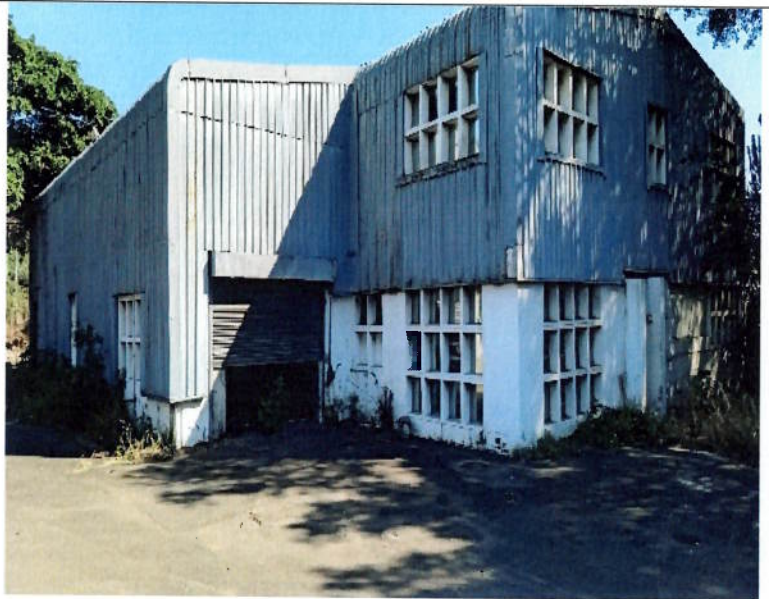
Figure 3: Building Exterior

The exterior of the complex is generally in fair condition, with minor maintenance issues that, if addressed, would enhance its overall appearance.

The entire roof structure is covered with metal sheets, some of which are corroded. This corrosion has led to rainwater infiltration, causing damage to interior mats and flooring.

The roof and the entire property lack a drainage system, with no evidence of a stormwater management system within the property boundaries.

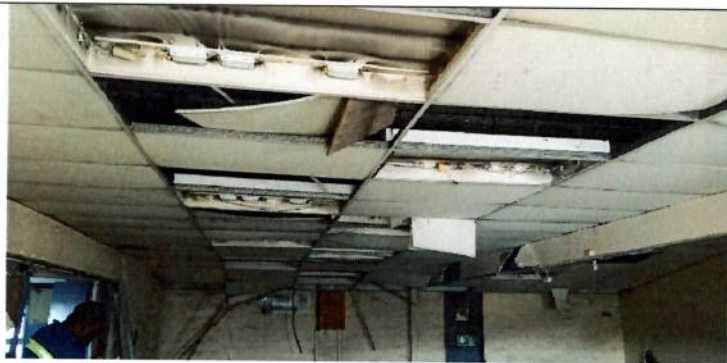
Figure 4: Ceiling Damages

The ceiling of the building is in poor condition, exhibiting leaks caused by the deteriorated roof. Water infiltration has damaged the ceiling, allowing water to pass through from the roof down to the floor.

Small gaps were identified between roofing panels, which pose a risk of water damage to the underlying roof truss

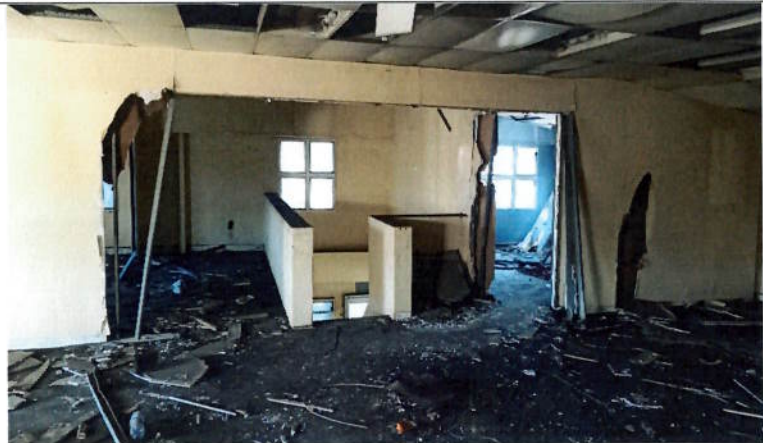
*Figure 5: walls*

The internal walls on the second floor are damaged and require replacement.

Several floor mats are beginning to peel and will need repair or replacement

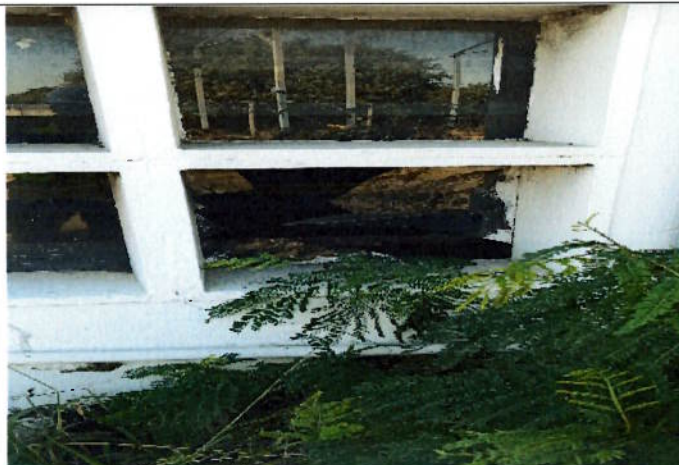
*Figure 6: windows*

Most windows are intact, with only a few showing signs of damage.

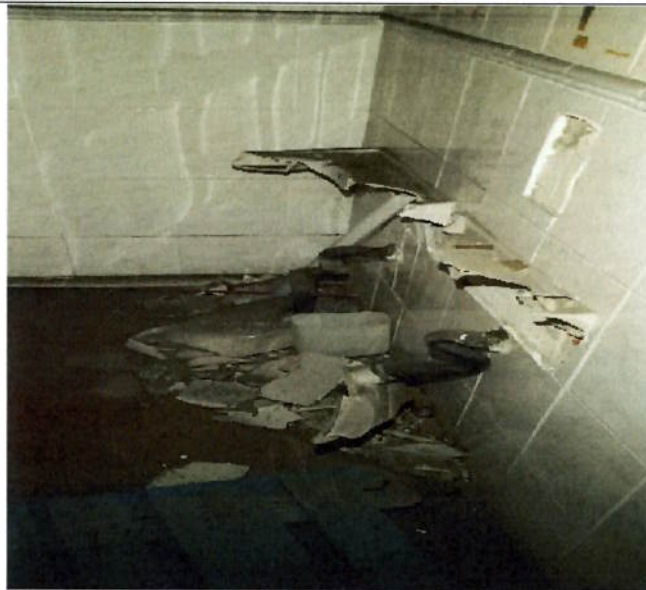
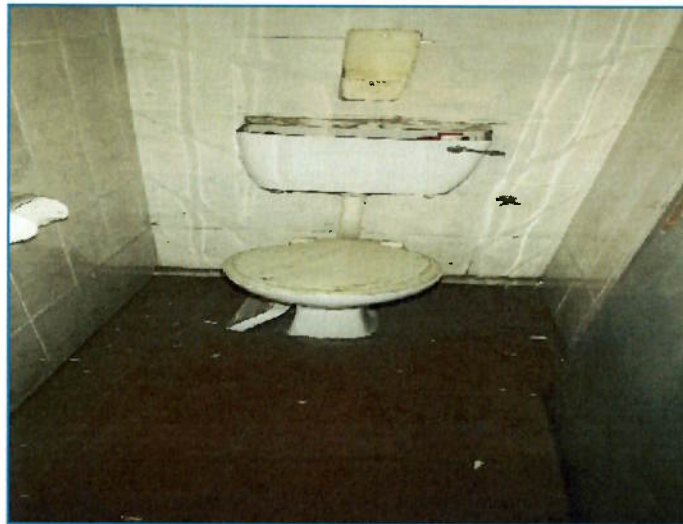
The ablution facility is damaged and currently unusable.

While the floors are not completely destroyed, they are still in poor condition.

The walls are dirty, stained by dust entering the building.

No signs of an internal water supply system are present within the building

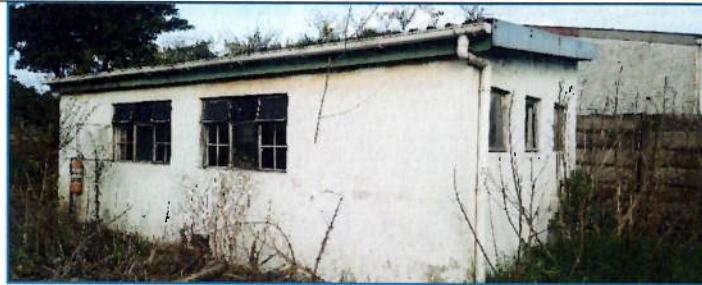
Figure 9: building 2 exteriors

The walls are dirty, and sections of the ceiling are deteriorating and falling apart.

The roof contains asbestos and requires immediate replacement.

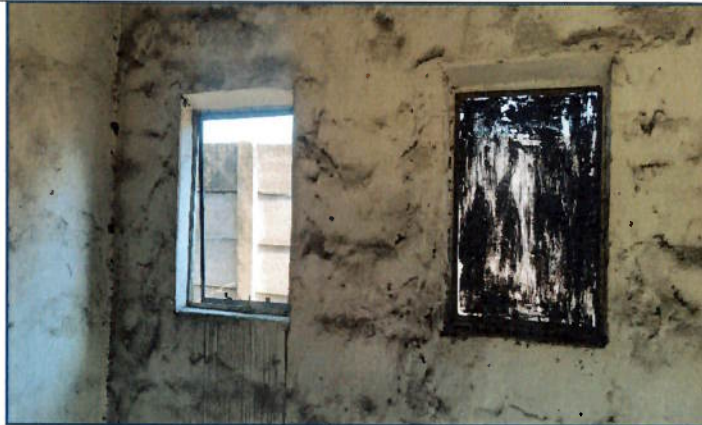
Figure 10: building 2 walls

The internal walls of the building are structurally sound but dirty, requiring cleaning before repainting

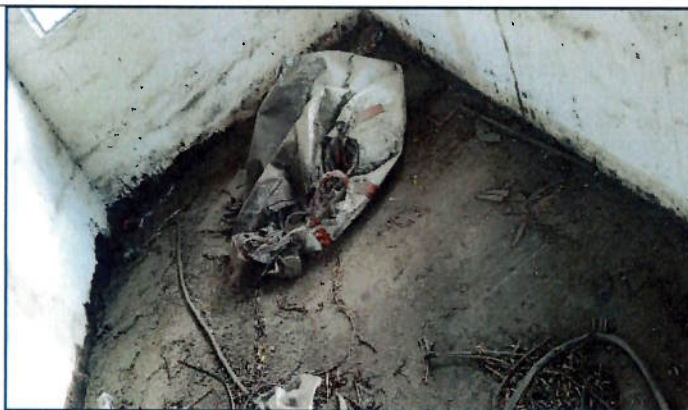
Figure 11: building 2 floor

The floors are in good condition but need thorough cleaning

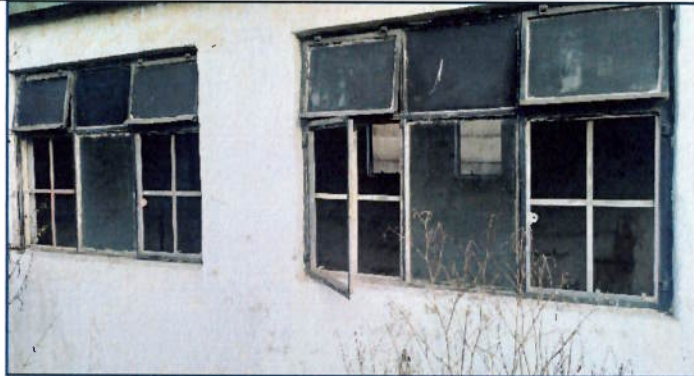
Figure 12:building 2 windows

The windows are damaged, with some missing entirely, and all need to be replaced.

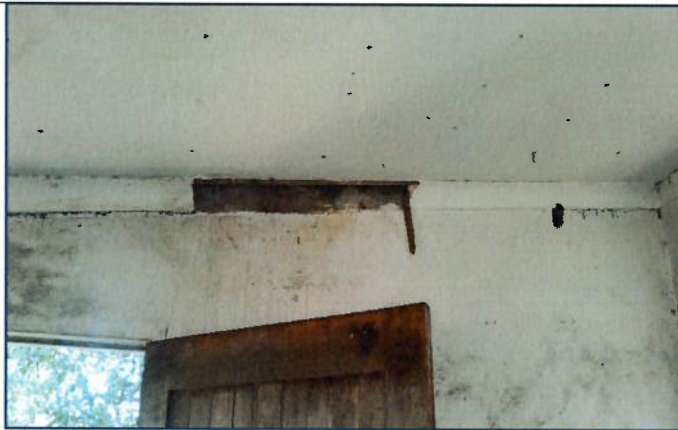
Figure 13:building 2 ceiling

The ceiling is structurally sound but dirty, stained by dust entering through broken windows and doors.
