CONDITION ASSESSMENT REPORT FOR THE KZN ROWING ASSOCIATION

Project Name : Condition Assessment (Ex-Port Services (Pty) Ltd

Owner : Transnet National Ports Authority

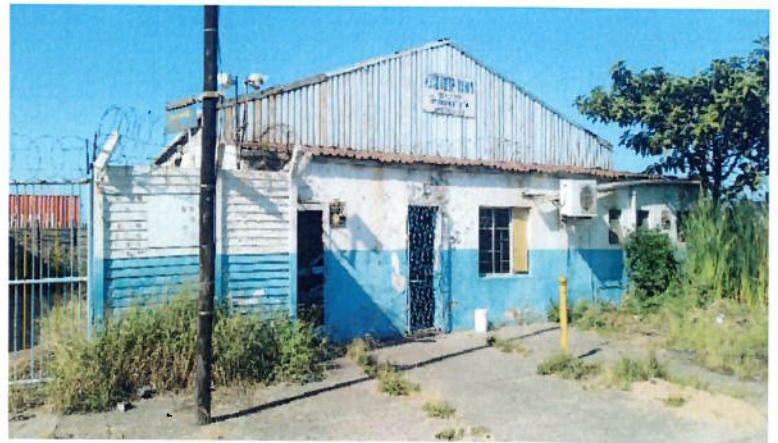
Figure 3: Building Exterior

- The area of land in this building is 1725 m²
- The exterior of this complex is in very bad condition it has many things that must be taken care of which can improve its appearance.
- The entire roof structure is covered by metal sheets of which now have corrosion in some parts, and this affects the inside as the water coming from rain is entering the inside and causes damage to the floor.
- The roof has no drainage system, as well as the entire property. There's no evidence of a stormwater management system within the boundary of the property.

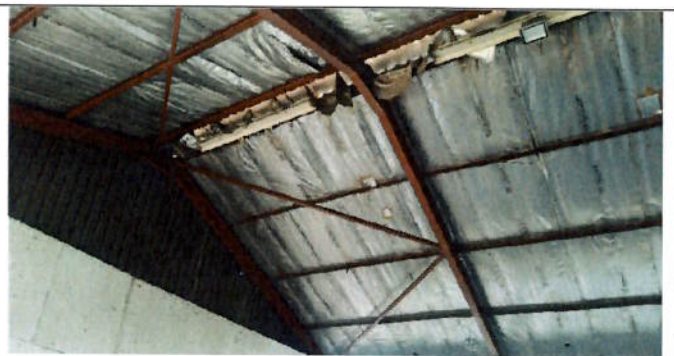
Figure 4: roof

- The roofing of this building is not in a bad condition.
- The steel portal frames on this building are in a good condition.

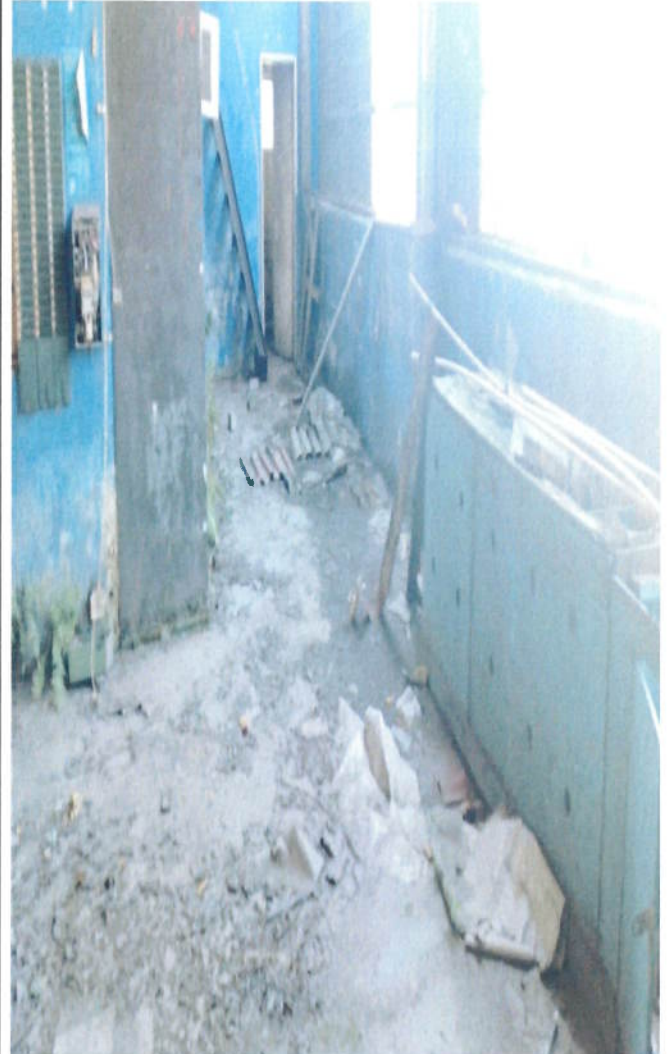
Figure 5: floor

- The floors are dirty and the cause of this is due to the bad roofing and there are dried water ponds on some of the floor areas.
- The finishing on this floor is not in good condition, it needs attention so that it can get back to its condition.

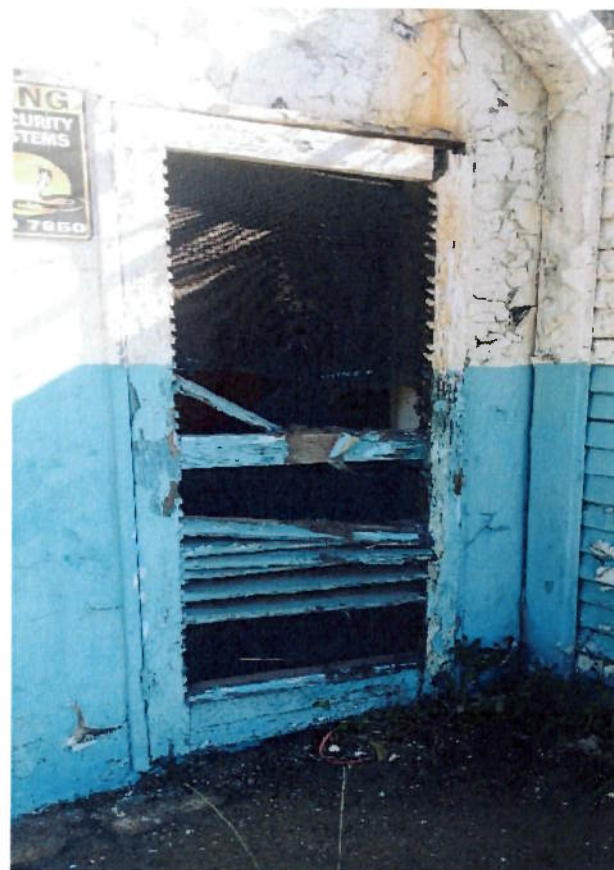
Figure 8:door

- The windows and doors are in bad condition and some of the windows need to be replaced and there are doors which are totally damaged and need to be changed.

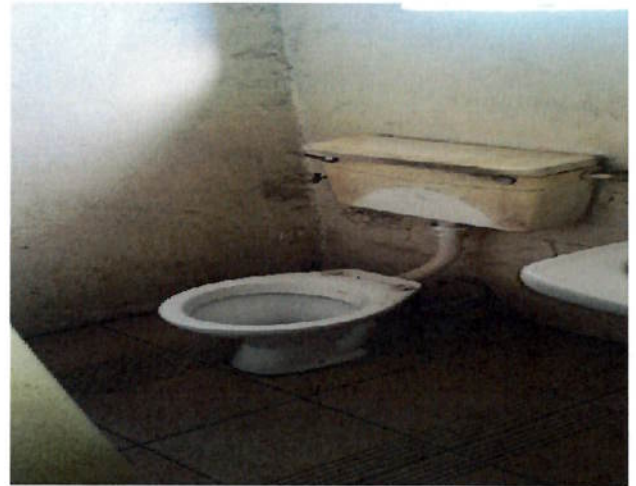
Figure 9:ablutions

- Ablution is not in a very bad condition it just needs some minor fixings.
- The floors are not in a bad condition but also need to be cleaned.
- The walls are dirty due to the dust that is coming inside the building.

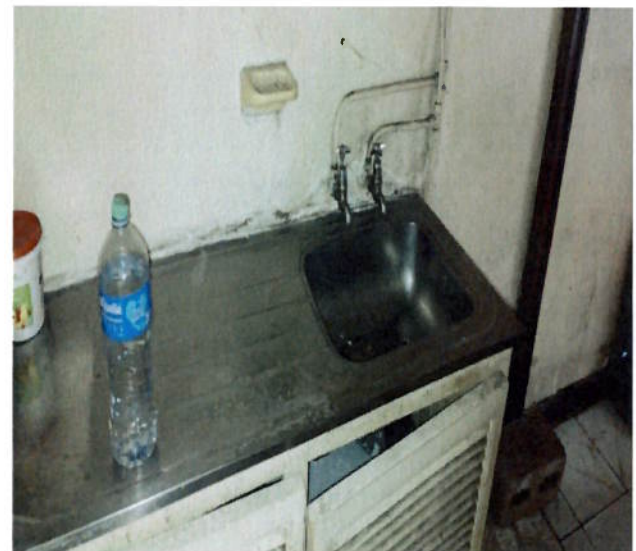
Figure 10:plumbing

- The water pipes in this building are not damaged but might need to be changed so improve its appearance.
- The wall is not in good condition but can also be fixed by painting.

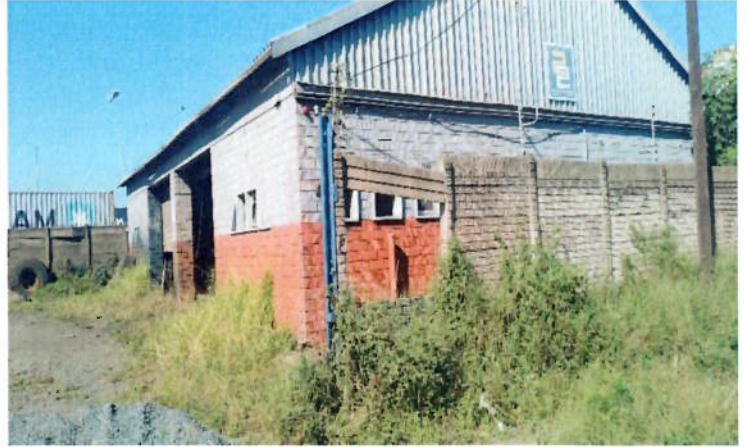
Figure 3: Building Exterior

- The area of land in this building is 1700 m²
- The exterior of this complex is in very bad condition; a lot of exterior works need to be undertaken to restore the aesthetics.
- The roof structure is covered by metal sheets of which are now corroded in some sections, and this allows water to enter which further cause damage to the floor.
- The roof has no drainage system, as well as the entire property. There's no evidence of a stormwater management system within the boundary of the property.

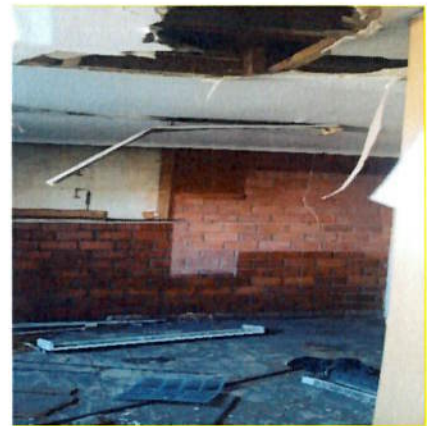
Figure 4: Ceiling

- The ceiling needs to be replaced in section where damaged.

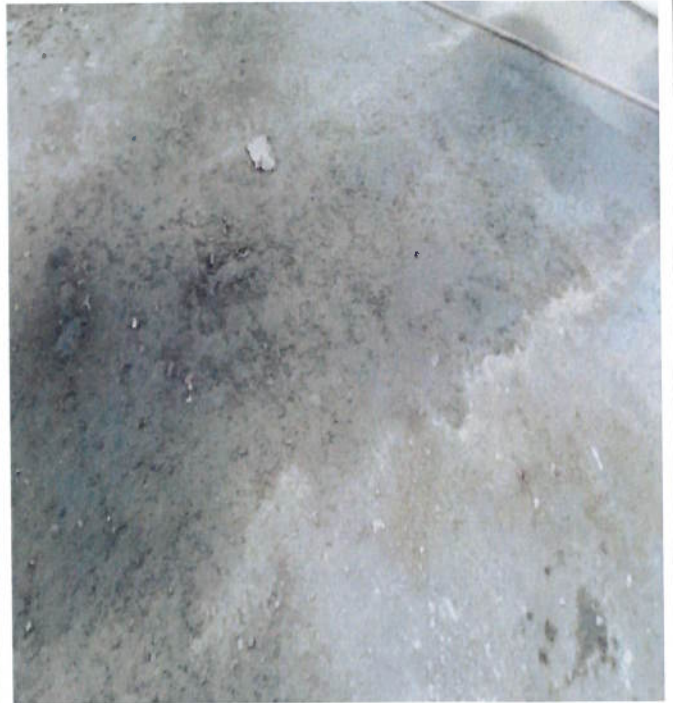
Figure 5:Floor

- The floors are dirty, primarily due to poor roofing, which has resulted in water ponds forming in some areas.
- The floor finish is in poor condition and requires attention to restore it to an acceptable state.

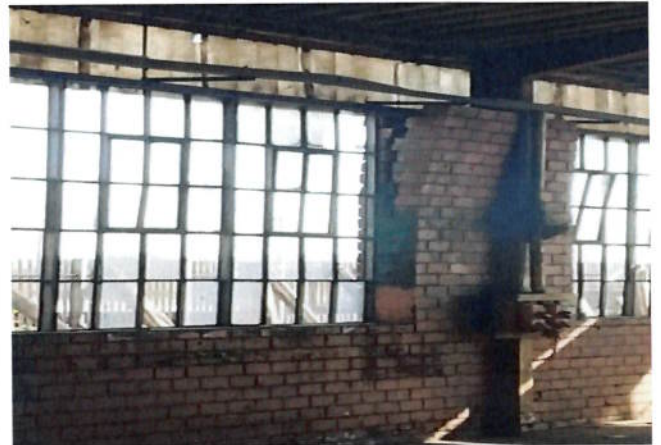
Figure 6:Windows

The windows in this building are generally in good condition, with only a few broken.

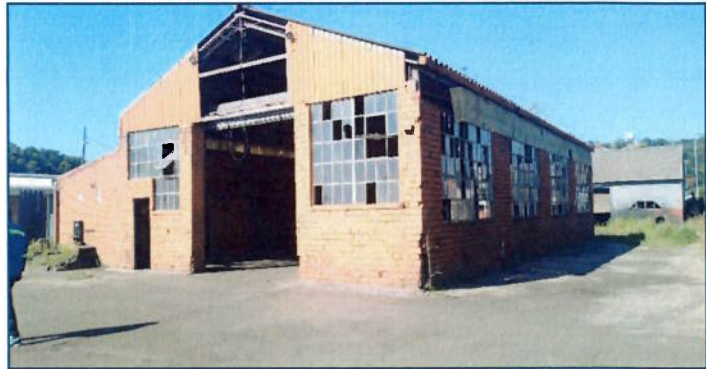
Figure 7: Building No. 2 Exteriors

- This is the exterior of the building, this building is in a very bad condition, most of the things are damaged.

In contrast, Building No. 2 is in very poor condition and should be demolished, as its walls are severely damaged and pose a safety risk if used in their current state.

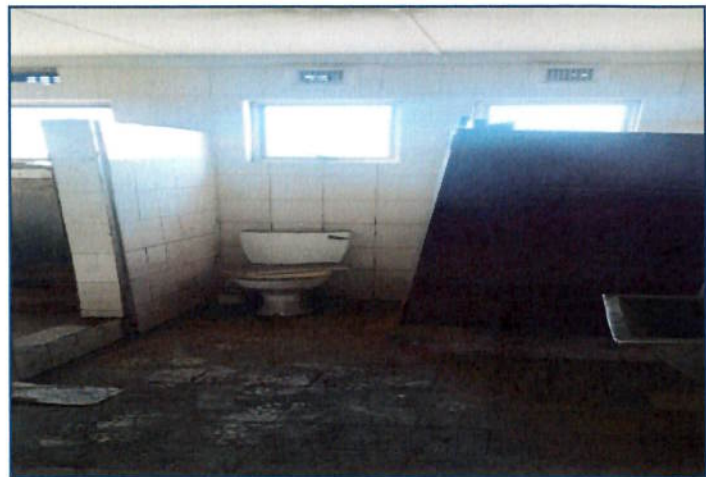
Figure 8: Building No. 2 ablutions

- The ablution facilities in this building are in very poor condition; the doors are missing, and the partition panels between the toilets are damaged.
- The toilet floor is generally in good condition, but it is extremely dirty and covered in dust. It can be cleaned and restored to its original state.

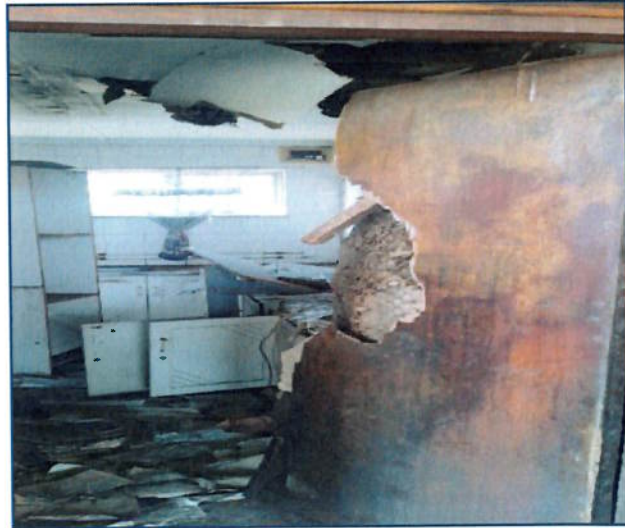
Figure 9: Building No. 2 Kitchen door

- Almost all doors in this building are damaged.

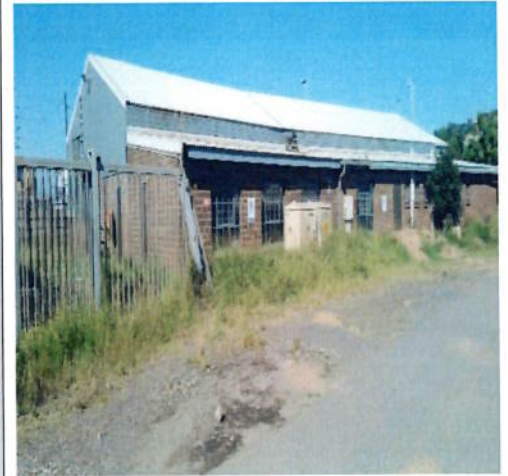
Figure 3: Building Exterior

- The area of land in this building is 1131 m²
- The exterior of this complex is in very bad condition; a lot of exterior works needs to be undertaken to restore the aesthetics.
- The roof structure is covered by metal sheets of which are now corroded in some sections, and this allows water ingress which further cause damage to the floor.
- The roof has no drainage system, as well as the entire property. There's no evidence of a stormwater management system within the boundary of the property.

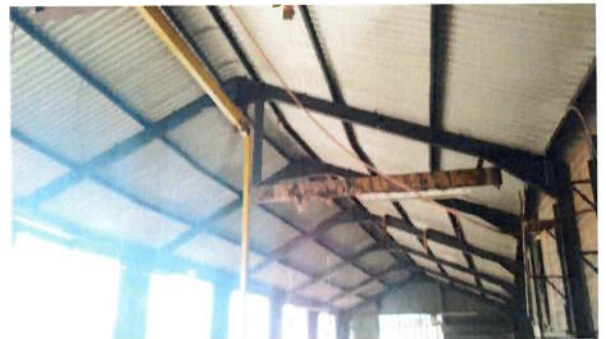
Figure 4: Roofing

- The roof sheets appears to be in good condition, no corrosion was noticed. However the steel purlins appears to have buckled;
- The steel portal frames on this building are in a good condition.

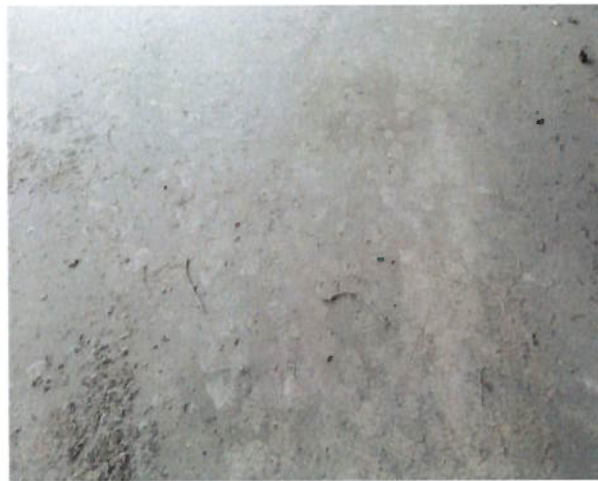
Figure 5:floor

- The floors are dirty with them and the cause of this is due to the bad roofing and there are water ponds in some of the areas.
- The finishing on this floor is not in good condition, it needs attention so that it can get back to its condition.

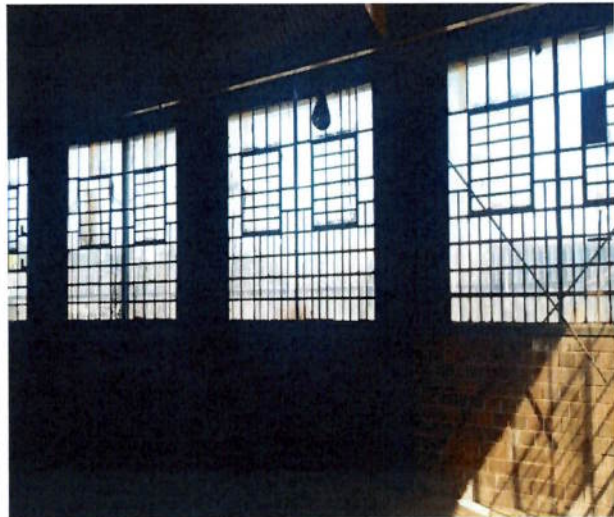
Figure 6:windows

The windows in this building are not in a bad condition, only a few windows are broken in this building.

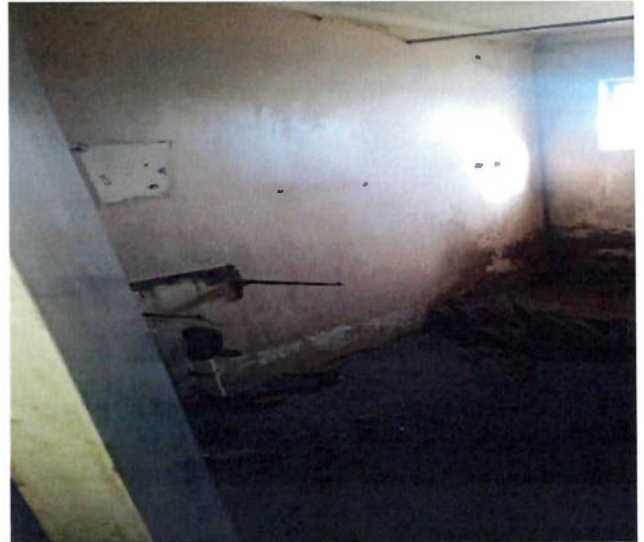
Figure 7:ablution walls and floor

- Ablution facility damaged and unusable.
- The floors are not completely damaged but are also in bad condition.
- The walls are dirty due to the dust that is coming inside the building.

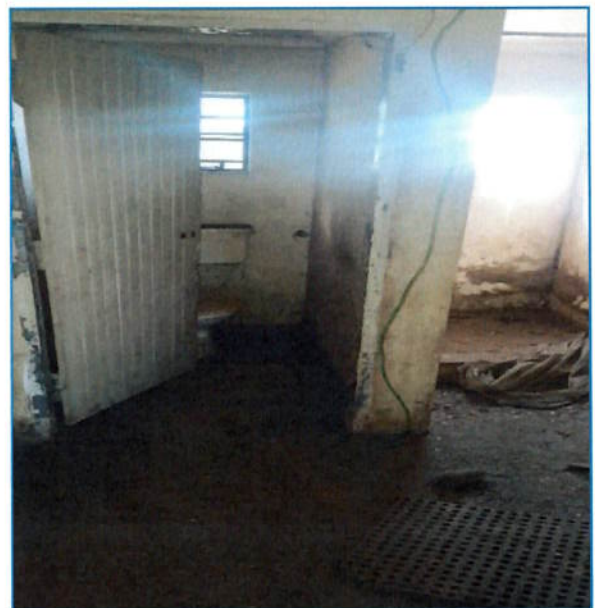
Figure 8:ablution water closet and floor

- The water pipes in this building are damaged and there was flooding in this toilet area.
- The wall is not in good condition but can also be fixed by painting.
