### CONDITION ASSESSMENT REPORT FOR THE ~~KZN~~ ~~ROWING~~ ~~ASSOCIATION~~

Project Name : Condition Assessment (Ex-Del Shipping and Trading (PTY)Ltd)

Owner : Transnet National Ports Authority

Project Name : Condition Assessment (Ex-BBBEE Tyre Holdings  
(PTY)LTD)

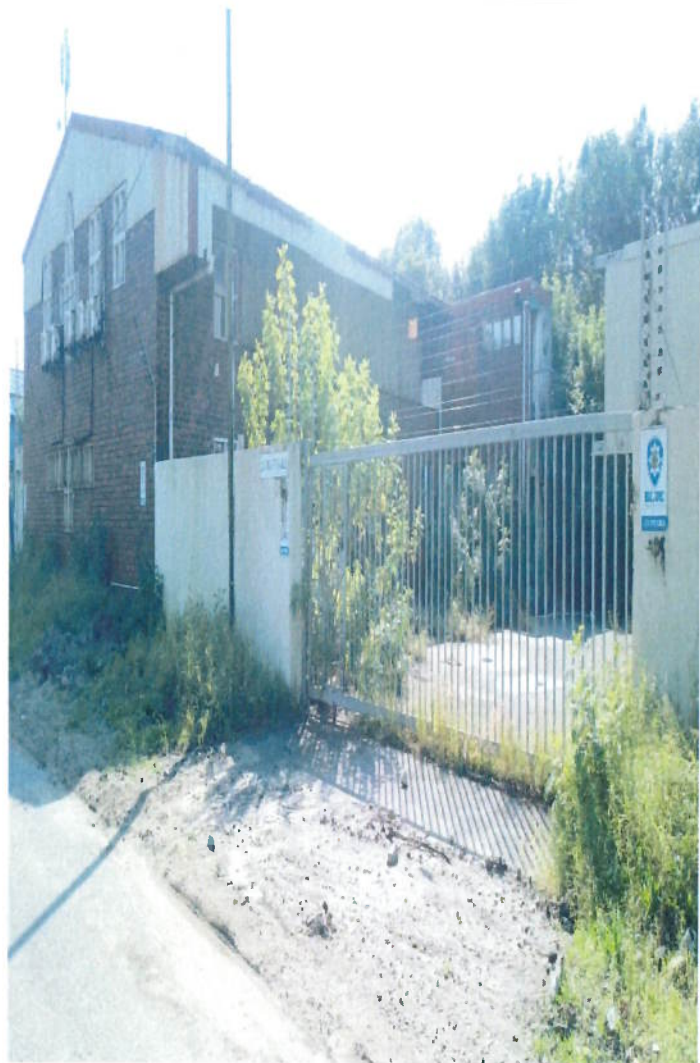
*Figure 3: Building Exterior*

The exterior of the complex is generally in fair condition, with minor issues that should be addressed to improve its appearance.

The entire roof structure is covered with metal sheets, some of which show signs of corrosion. This has resulted in water ingress during rainfall.

The roof lacks a drainage system, and there is no evidence of any stormwater management system within the property boundaries

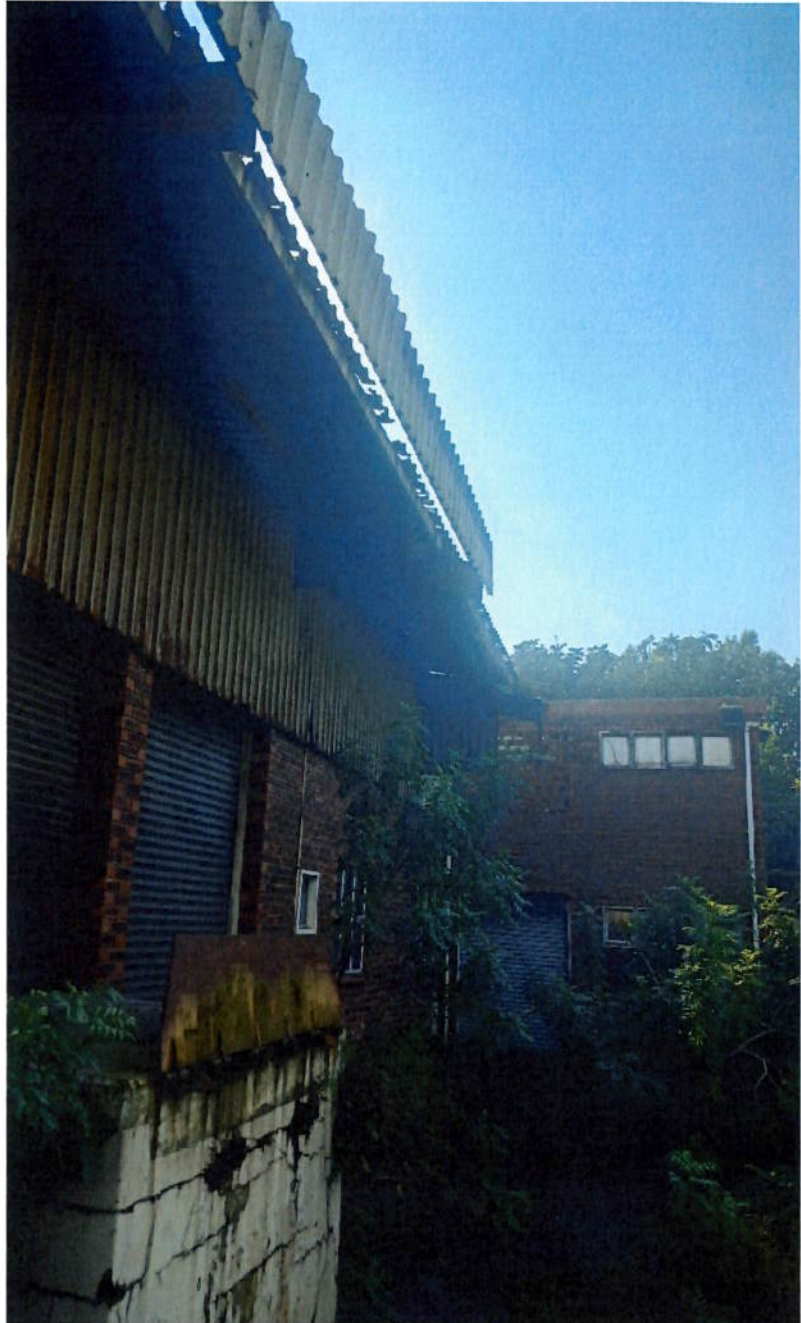
Figure 4: building 1 exterior

The roof of this building is in very poor condition, with leaks allowing water to pass through to the floor, causing water pooling.

Small gaps between roofing panels were identified, which could lead to water damage of the trusses

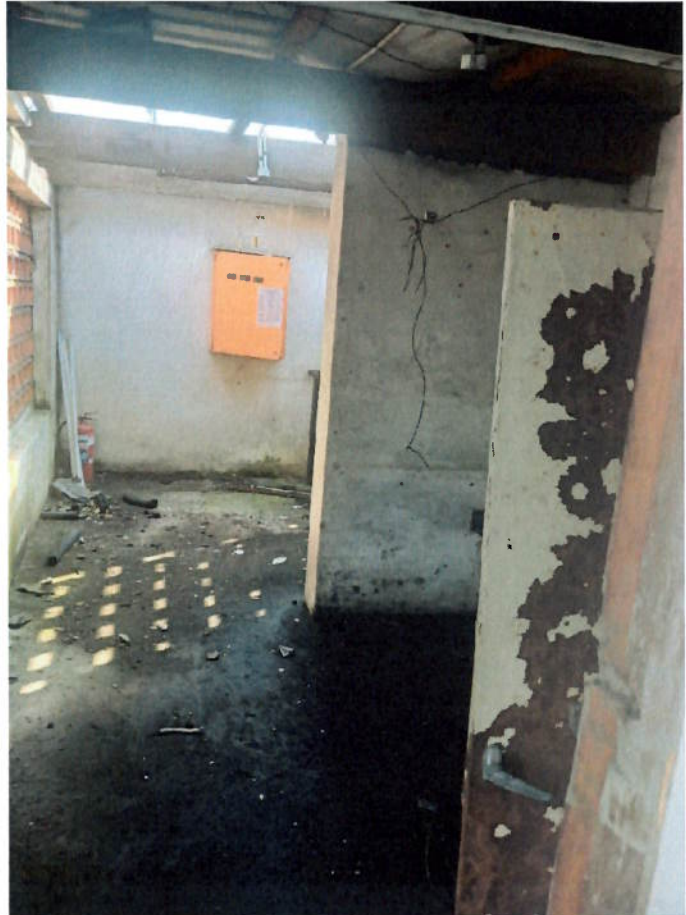
*Figure 6: building 2 interior walls*

Some roof sheets are missing, allowing rain and stormwater to damage the interior walls and floors.

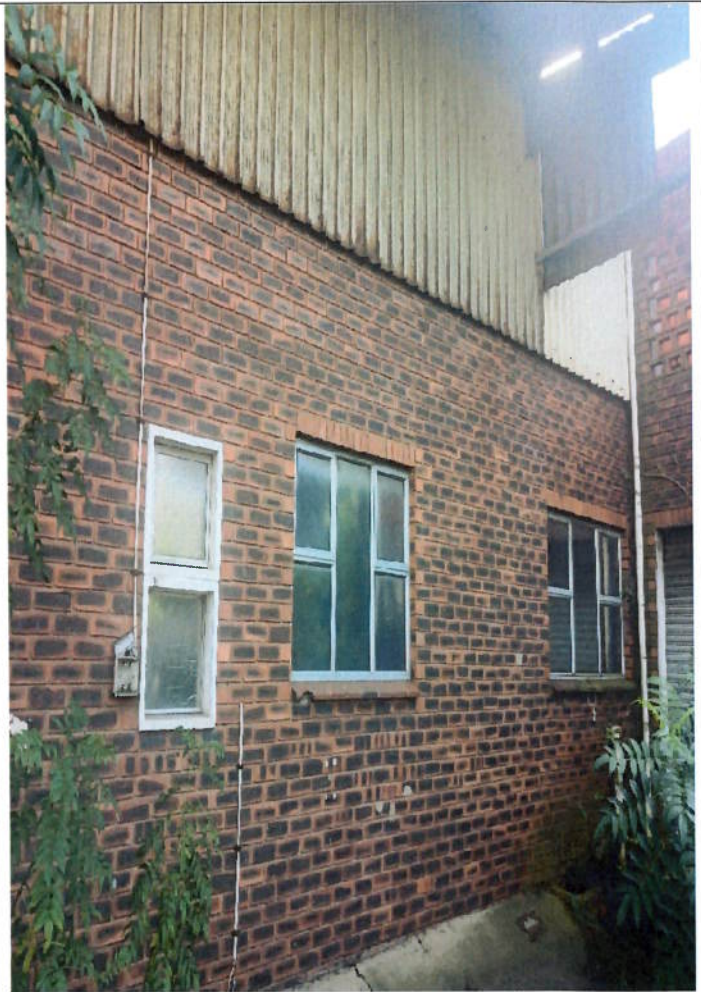
*Figure 7: building 1 window*

- The external walls are in good condition.

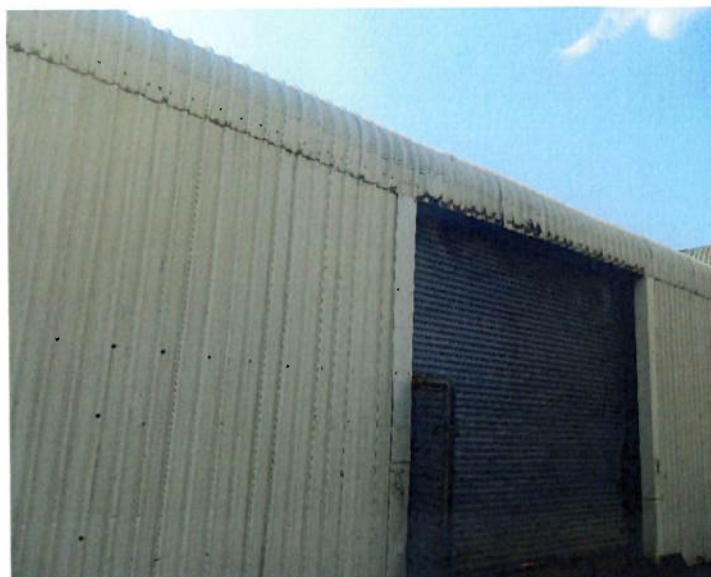
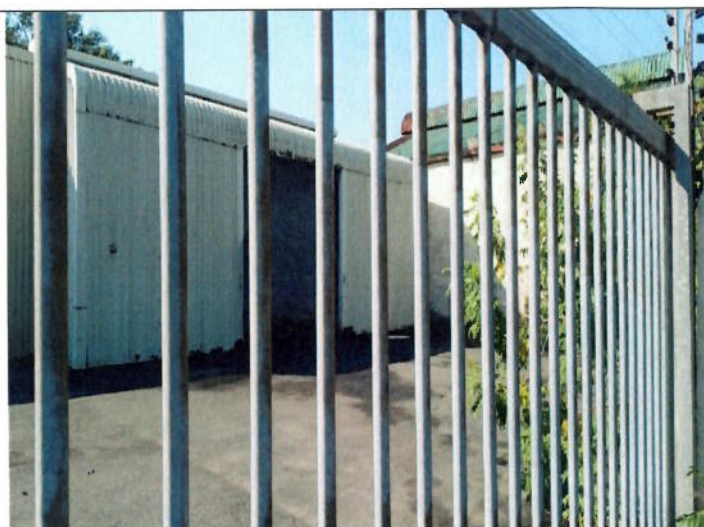
The entire roof structure is covered with metal sheets that have developed corrosion.

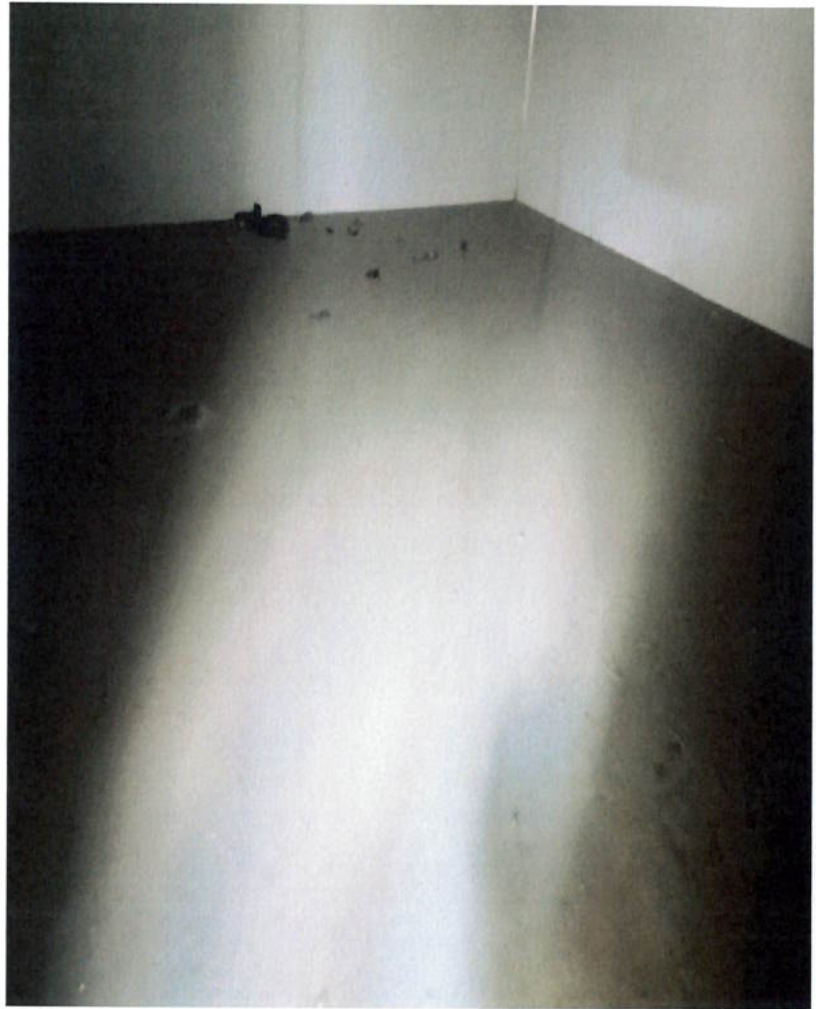
*Figure 9: building 3 floor*

The floor is in good condition but requires cleaning.

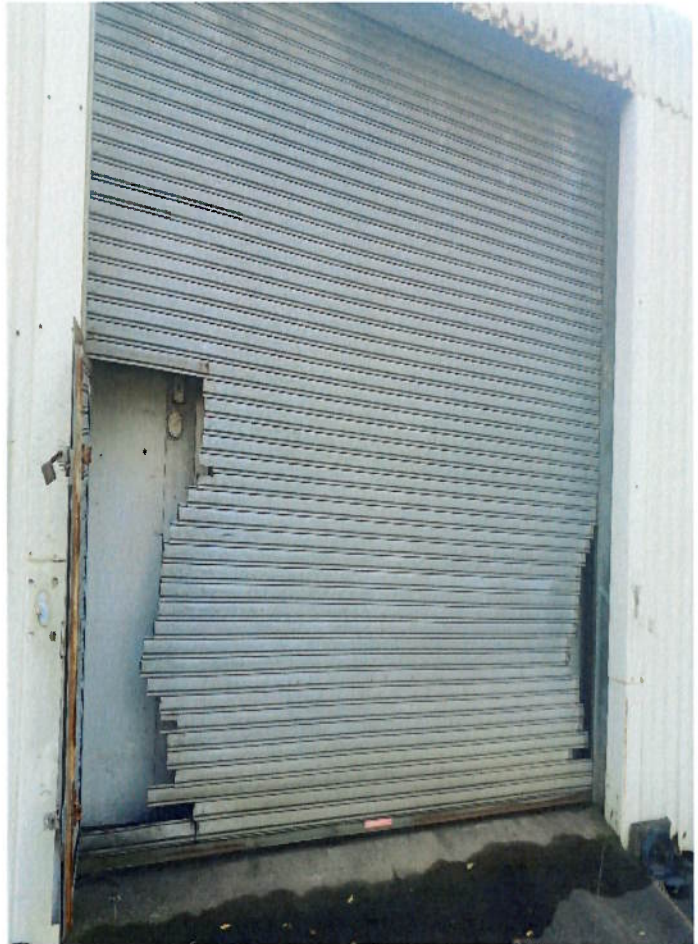
*Figure 10: building 3 front door*

The sliding door has been vandalized.

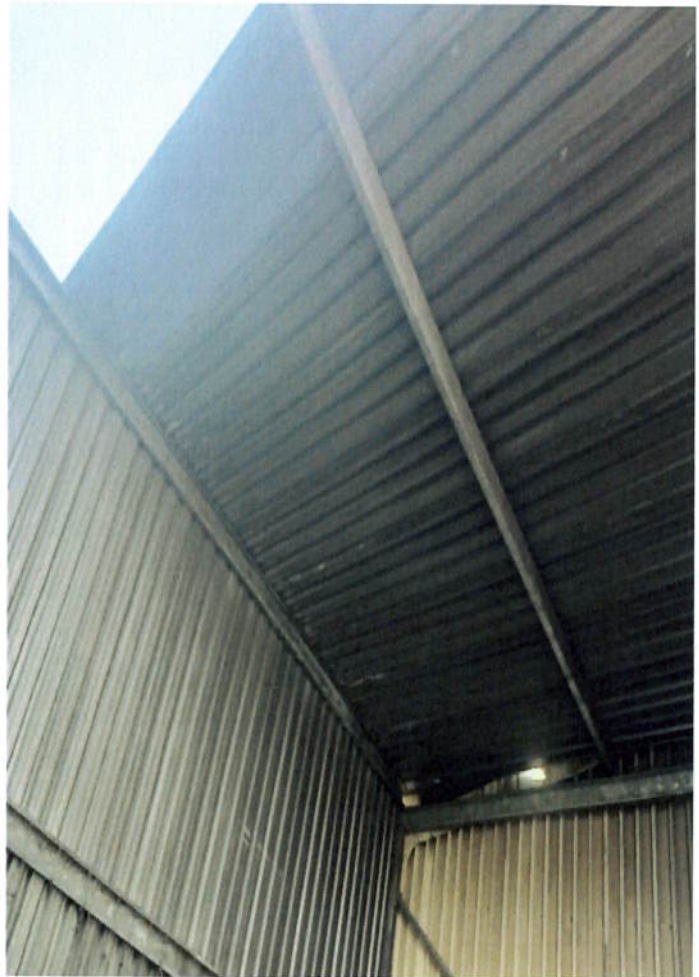
*Figure 11: building 4 roof*

Although a roof sheet is missing, the overall structure remains in good condition.

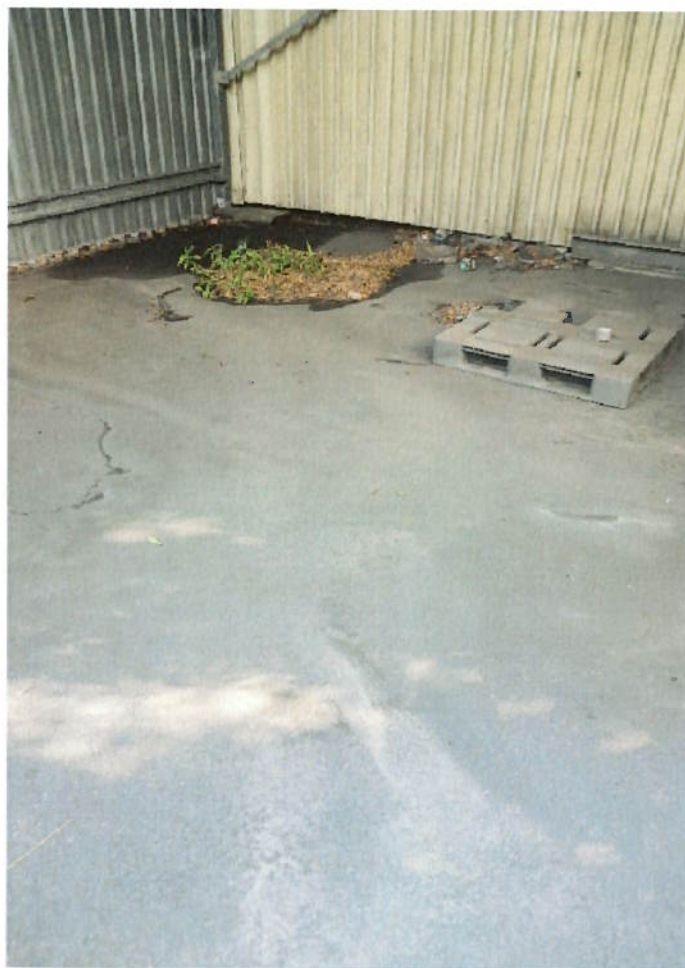
*Figure 14: building/shelter 4 floor*

The floor is in good condition but requires cleaning.

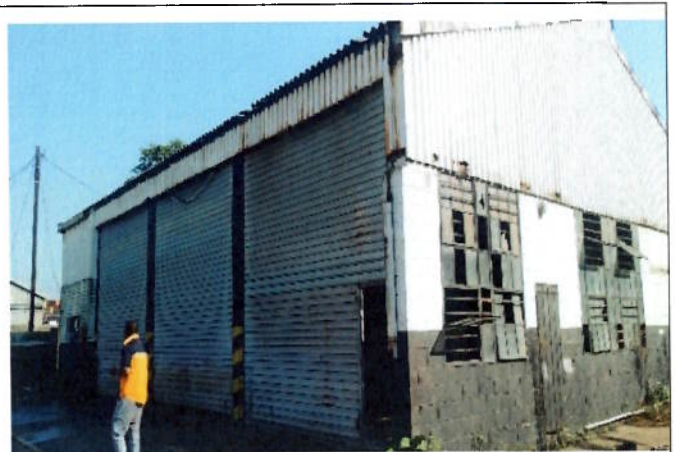
Figure 3: Building Exterior warehouse 1"

- The combined floor area of Warehouse 1 and Warehouse 2 is approximately 354 m<sup>2</sup>.
- The exterior condition of the warehouses is deteriorated, with several broken windows; the walls are primarily clad in galvanized steel sheeting, with some sections made of masonry.
- The entire structure requires repairs and scheduled maintenance, including repainting

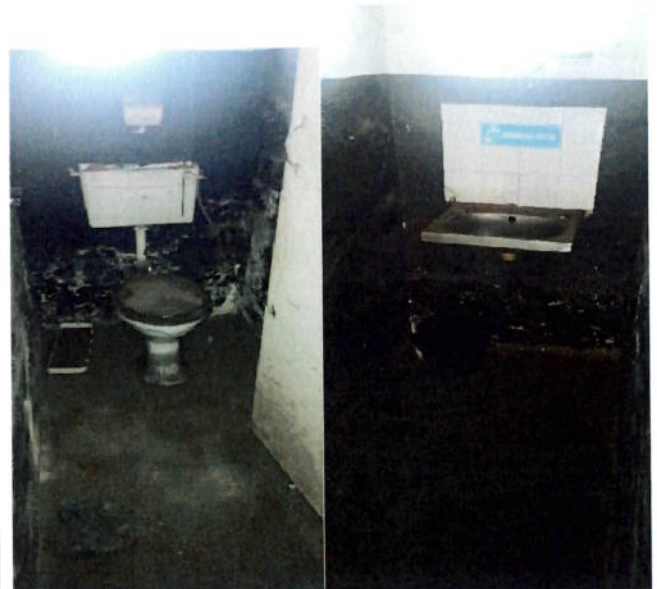
Figure 4:Figure 4: bathroom warehouse 1

- The bathroom is in poor condition, with damaged toilet lids and sinks missing taps

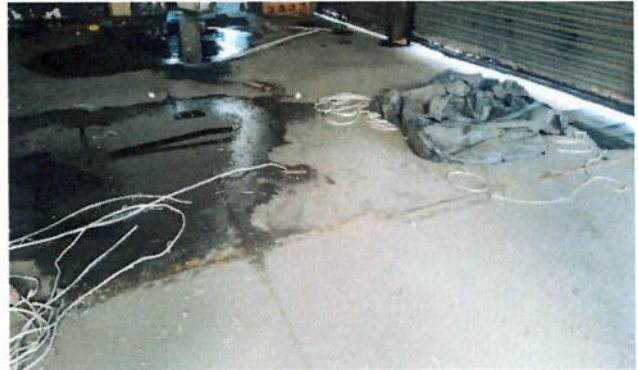
*Figure 5: floor "warehouse 1"*

The floor is not significantly damaged but requires thorough cleaning to restore it to its original condition.

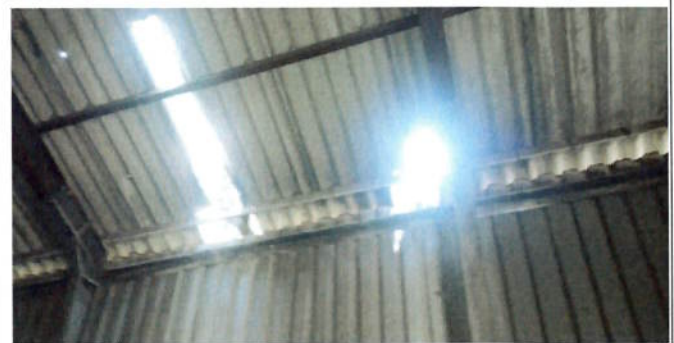
*Figure 6: Roof*

The steel roof trusses over the warehouse are in good condition

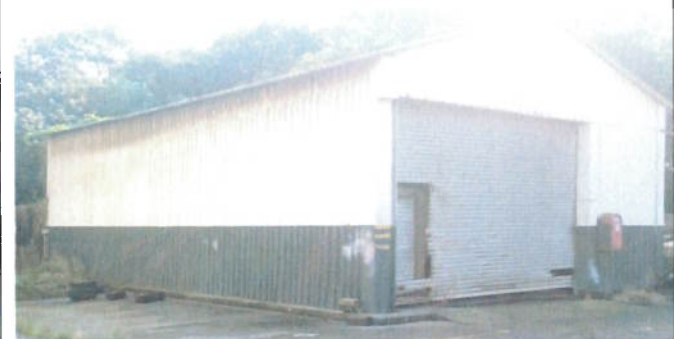
*Figure 7: exterior*

Warehouse 2 is in fair condition but requires general maintenance. The door exhibits signs of rust, and although the floor is not significantly damaged, it needs cleaning to restore it to an acceptable condition.

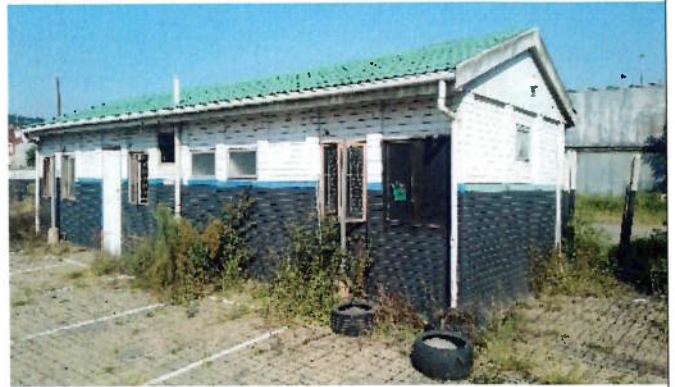
*Figure 8: exterior*

- The office building has an approximate floor area of 59 m<sup>2</sup>.
- The interior is in good condition.
- The tiled roof is also well maintained and in good condition

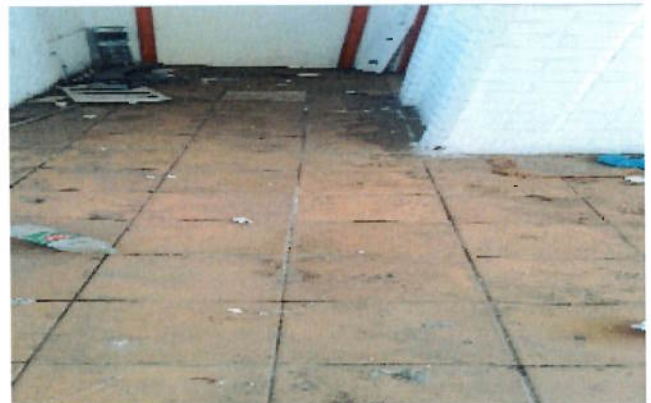
*Figure9: office floor*

The floor is in fair condition but requires thorough cleaning to restore it to its original state.

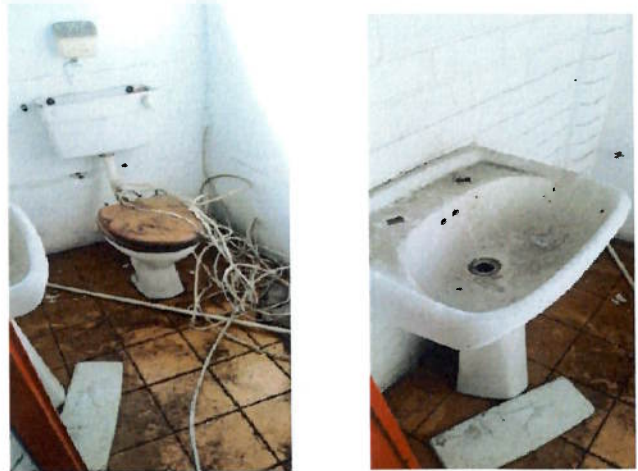
Figure10: office ablution

The bathroom is in poor condition, with damaged toilet lids and sinks missing taps.

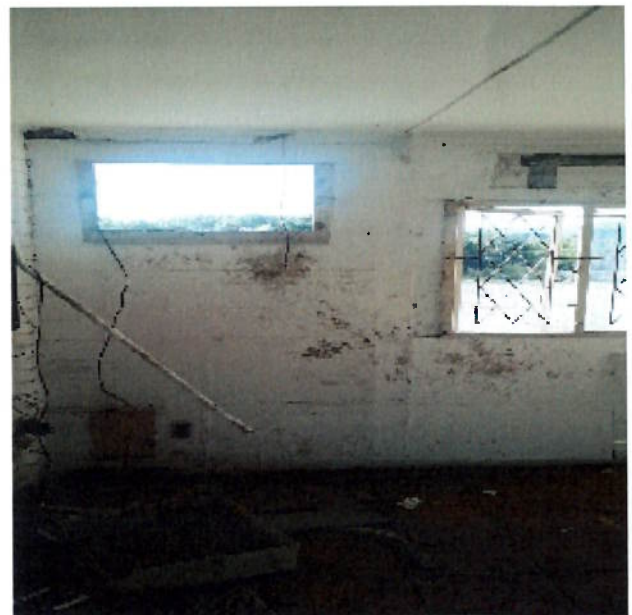
Figure 9:interior wall of office

The office building's walls are structurally sound but dirty, requiring cleaning and repainting.

The ceiling is in poor condition and needs repair or replacement

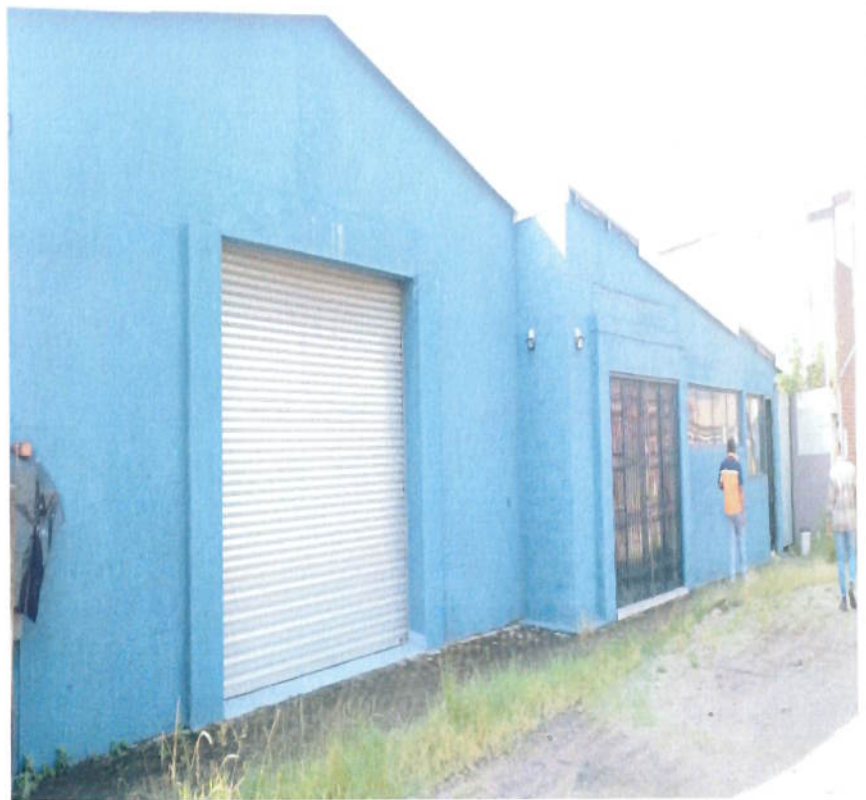
*Figure 3: Building Exterior*

- The area of land in this building is 785m<sup>2</sup>
- The exterior of this building is in perfect condition
- The entire roof structure is covered by new IBR of which needs to be changed.
- The roof has a drainage system.

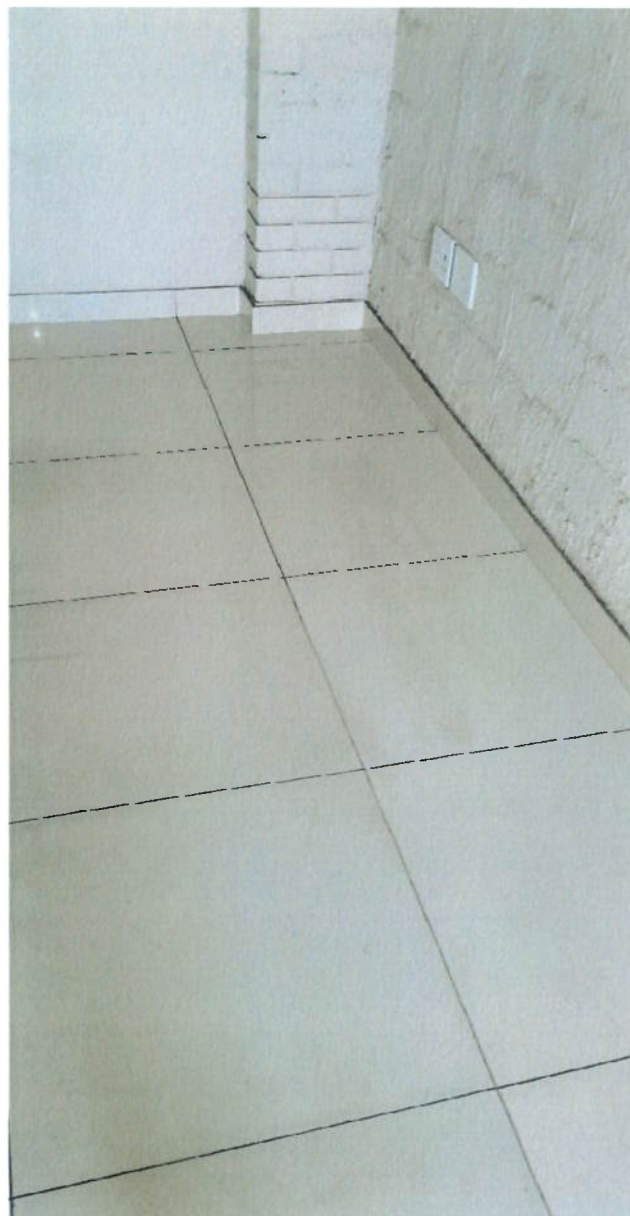
*Figure 4: interior of building*

- The condition of the floor in this building is perfect condition.

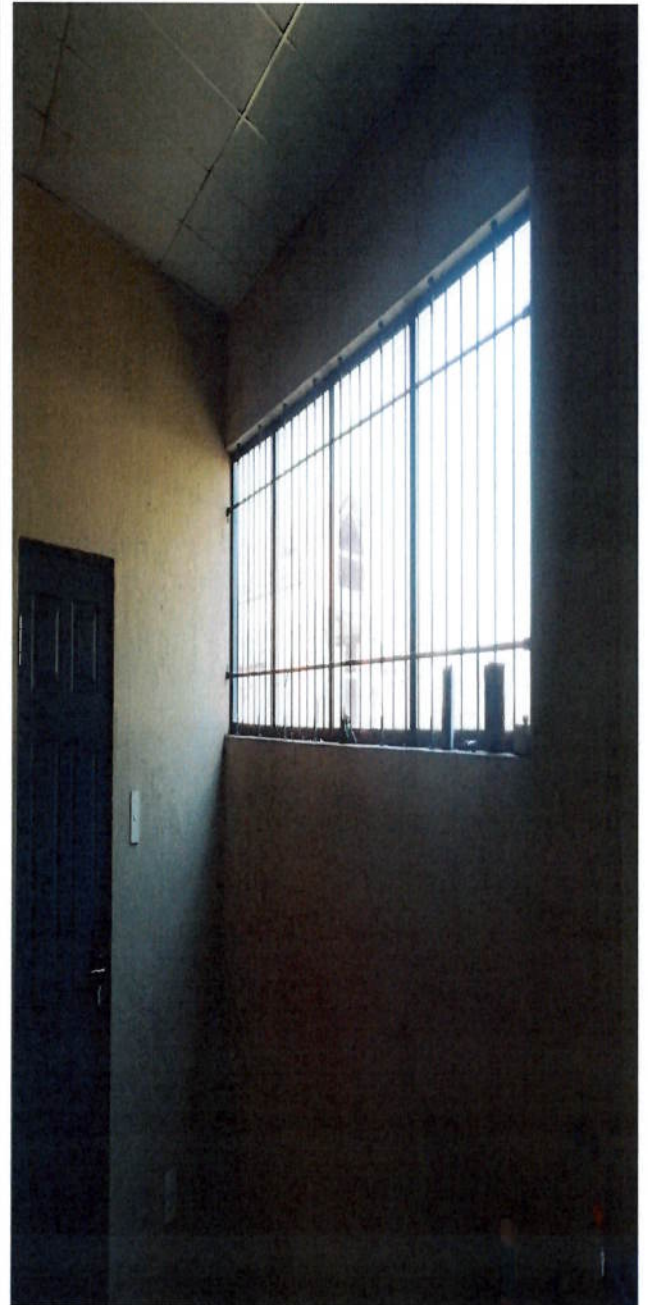
*Figure 5:windows*

- The condition of the windows in this building is in perfect condition.

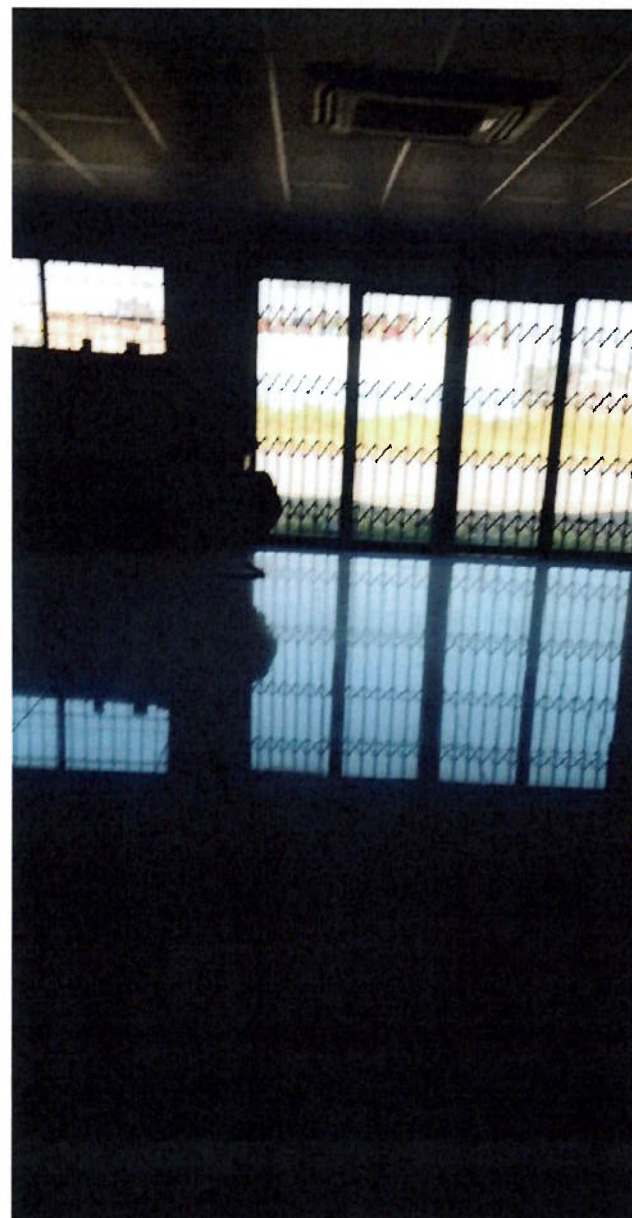
*Figure 6: floor and doors*

- The condition of the windows and doors in this building are in perfect condition. Main doors have a crack that require attention soon.

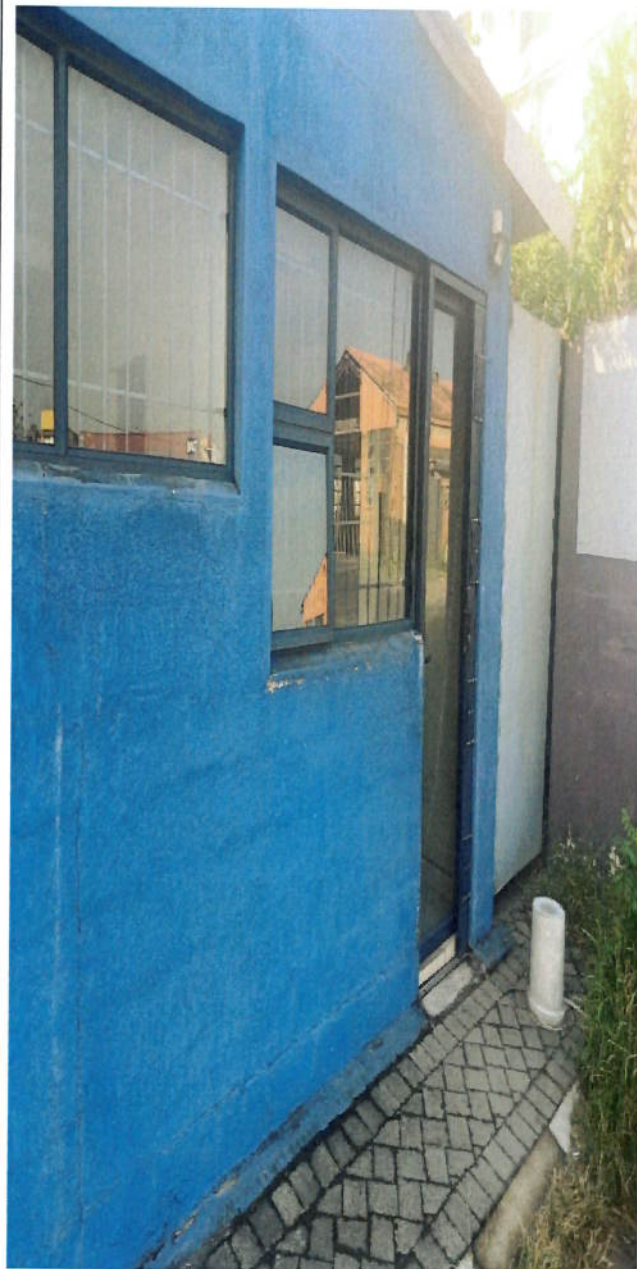
*Figure 7: walls and windows*

There is a minor crack on the wall that requires attention before it expand.

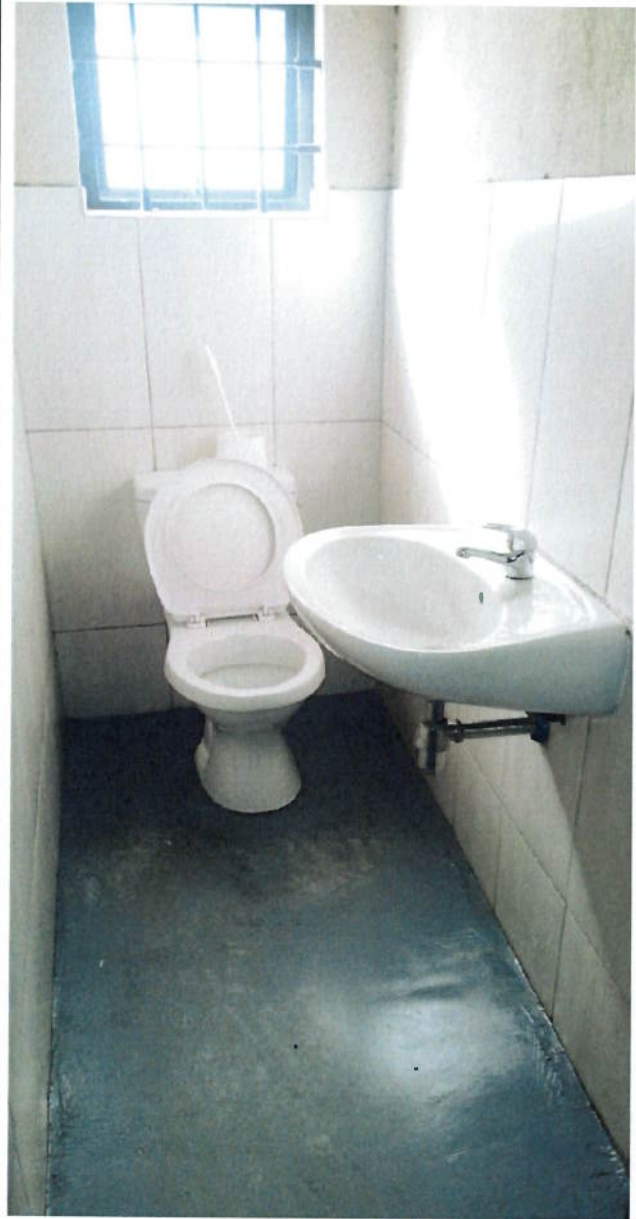
*Figure 9: ablutions*

- The condition of the ablution is in very good condition, no leaks spotted.

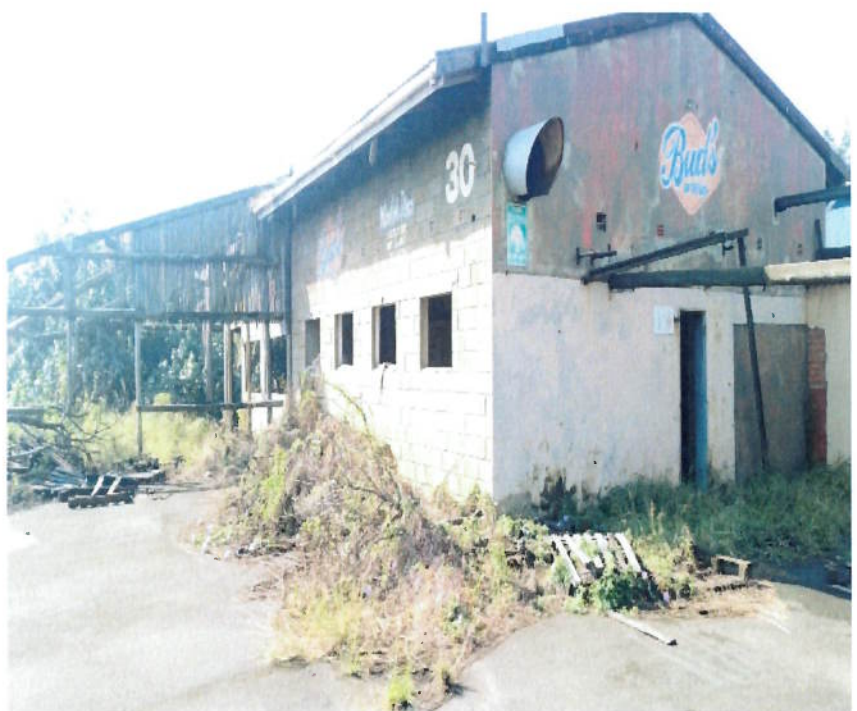
Figure 3: Building 1 exterior

- The area of land in this building is 780 m<sup>2</sup>
- The exterior of this building is not in bad condition
- The entire roof structure is covered by asbestosis of which needs to be changed.
- The roof has drainage system, but it is starting to fall apart some parts have no gutters now.

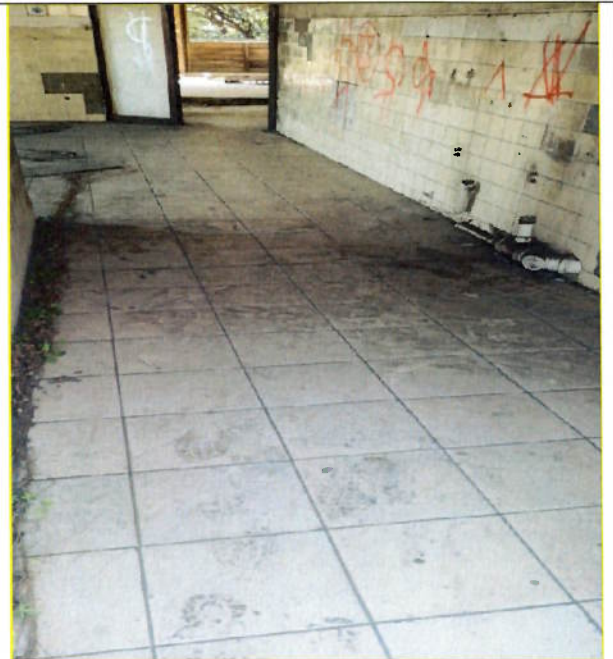
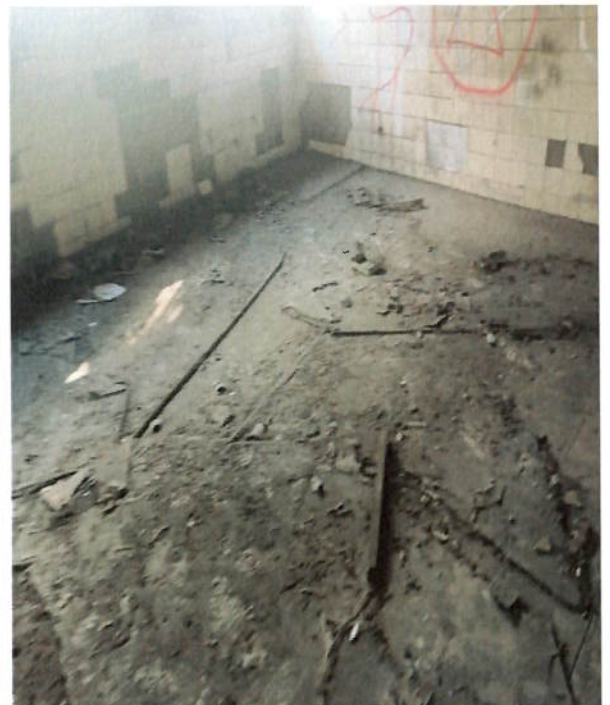
- The condition of the floor in this building is not in bad condition, it needs deep cleaning

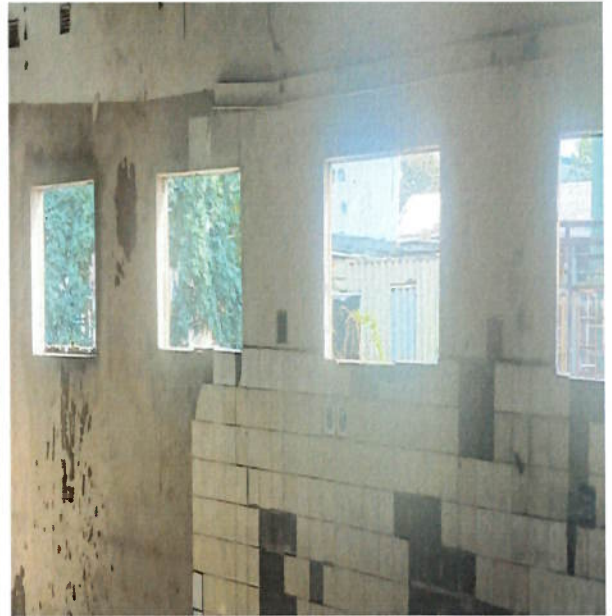
*Figure 7: interior walls and windows*

- Windows have been vandalized and some have been stolen.

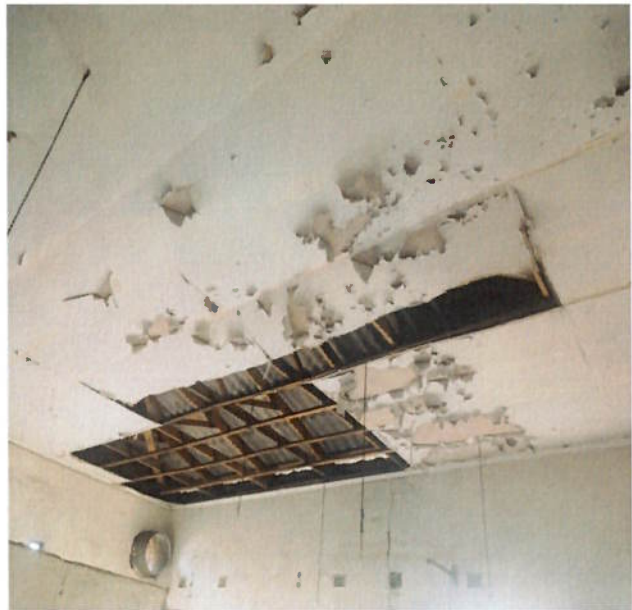
Figure 9:ceiling

- The ceiling in this building is not in good condition, it needs to be rehabilitated because some of the panels from it are missing and other parts of the ceiling are damaged.

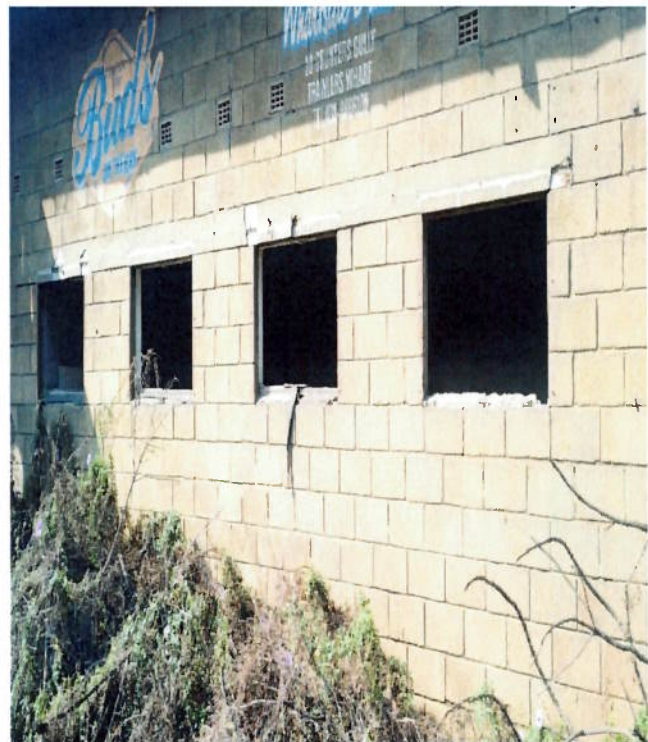
Figure 10:windows

- The external wall is in good condition. The windows have been stolen.

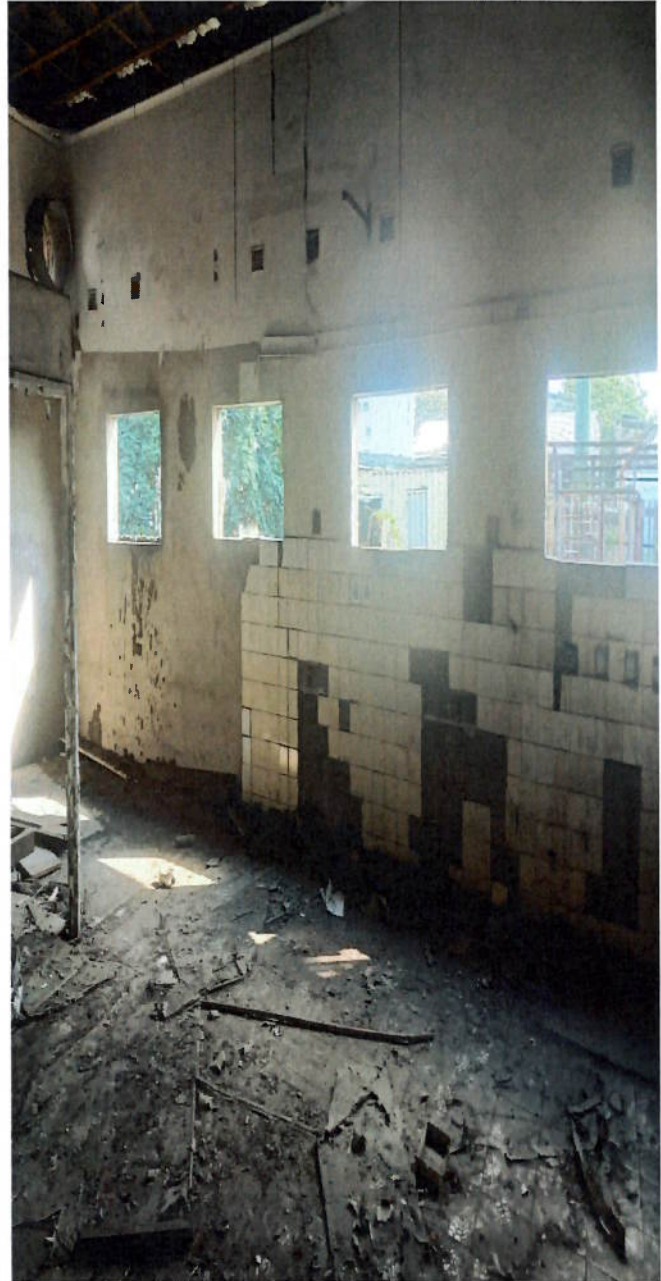
*Figure 11: walls and windows*

- The external wall is in good condition. The windows have been stolen.
- The internal wall is in bad condition, require renovations.

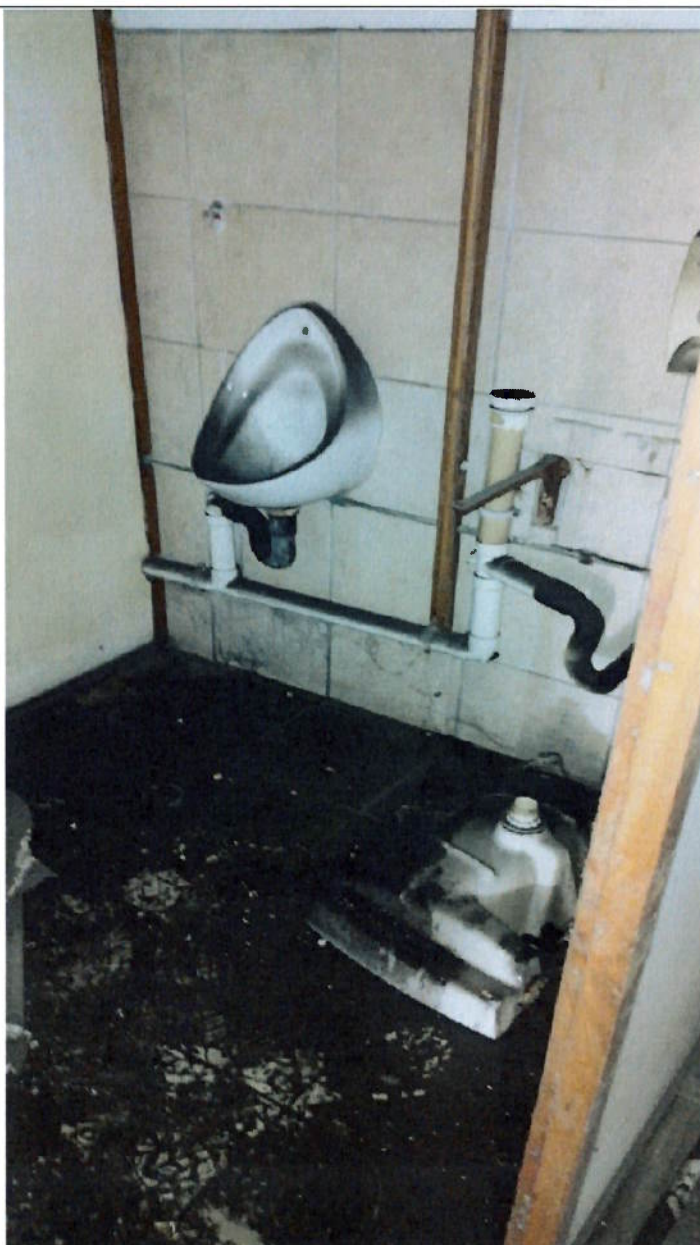
*Figure 12:ablutions*

- The bathroom in this building is not in a good condition the toilet is damaged and there is no sign of water pipe inlet.

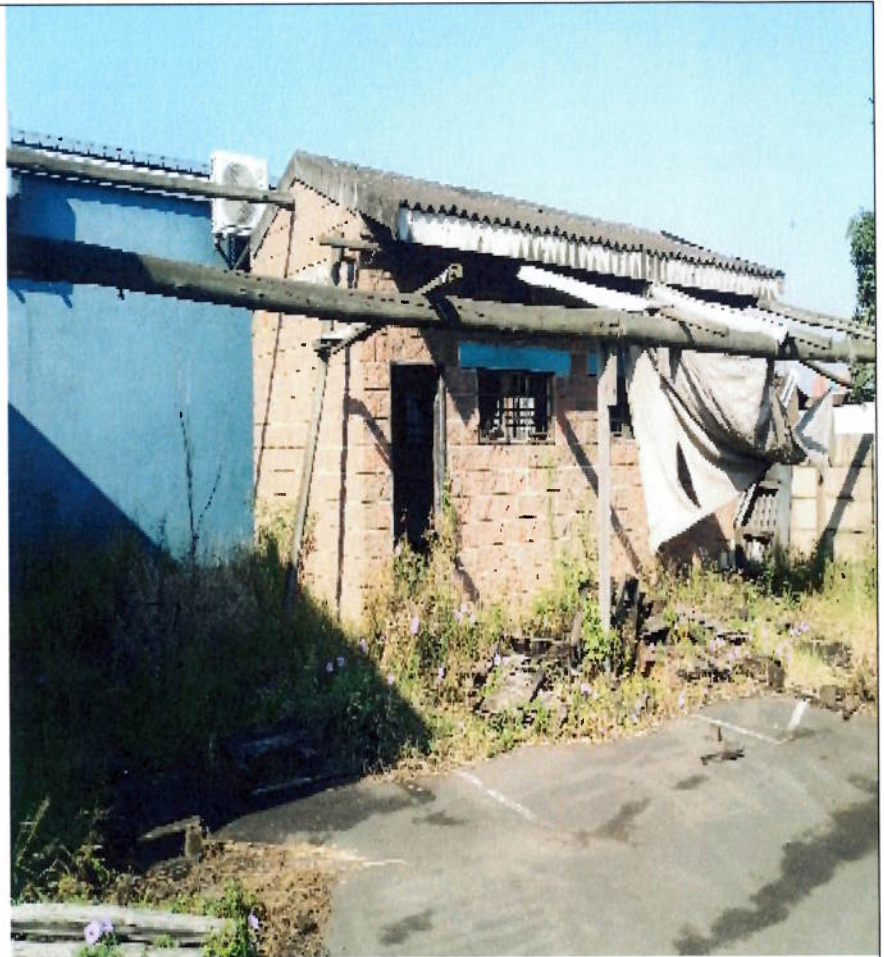
Figure 13: Building 2 exterior

- The exterior of this building is not in bad condition
- The entire roof structure is covered by asbestosis of which needs to be changed.

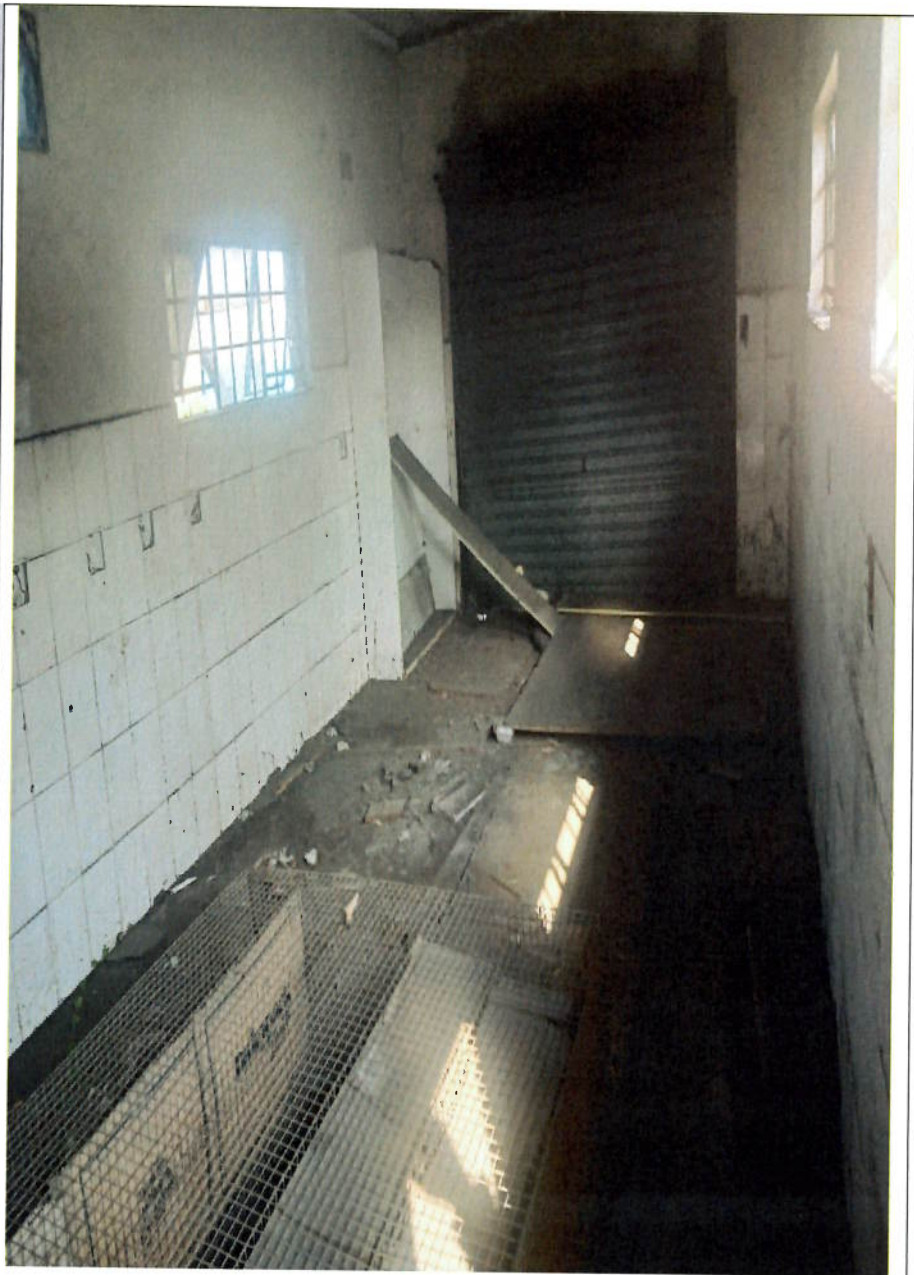
Figure 14: building 2 floor

- The condition of the floor in this building is not in bad condition, it needs to be cleaned so it can get back to its former condition.

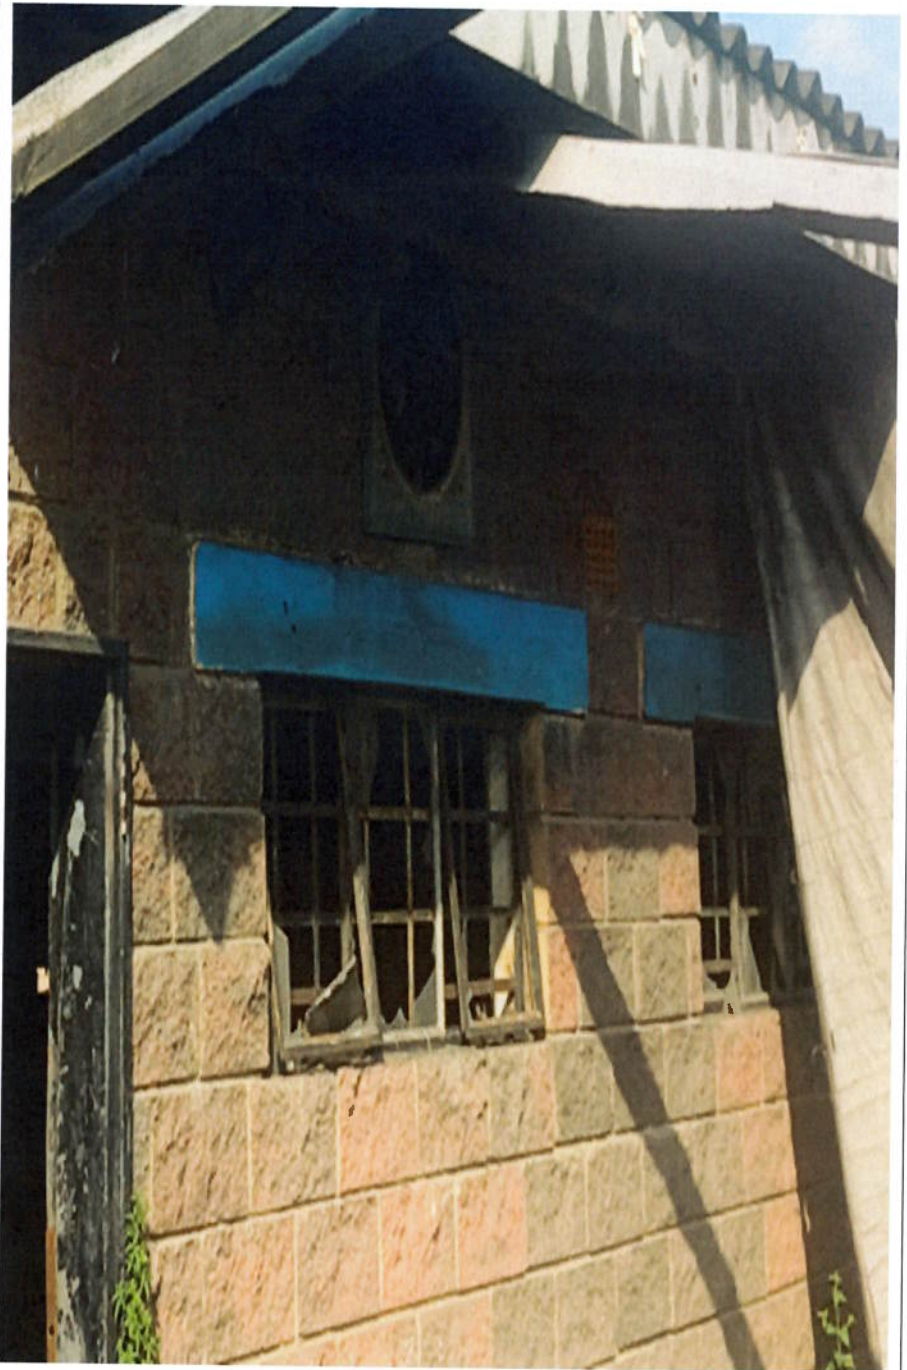
*Figure 15: building 2 doors and windows*

- The condition of the windows and doors are in bad condition; they must be replaced.
