### CONDITION ASSESSMENT REPORT FOR THE ~~KZN~~ ~~ROWING~~ ~~ASSOCIATION~~

Project Name : Condition Assessment (Ex-Del Shipping and Trading (PTY)Ltd)

Owner : Transnet National Ports Authority

Project Name : Condition Assessment (Ex-BBBEE Tyre Holdings  
(PTY)LTD)

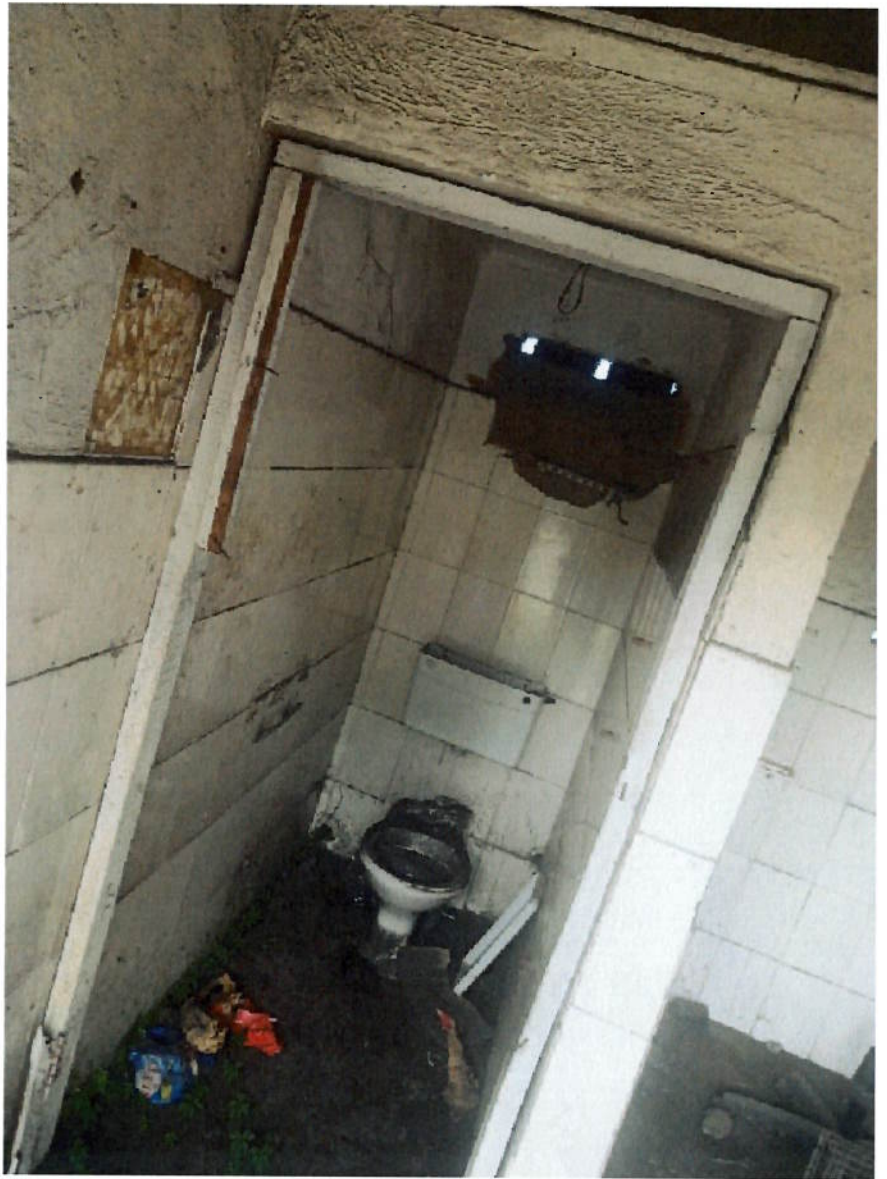
Figure 18: building 2 ablutions

- The condition of the ablution is bad, it requires renovation.
