TRANSNET NATIONAL PORTS AUTHORITY
TERMINAL OVERSIGHT AUDIT
INSPECTION REPORT

SITE: 10 BREMEN RD, BAYHEAD, DURBAN

LESSEE: ZUNGU- ELGIN ENGINEERING

COMPILED: TNPA PORT ENGINEERING
DEPARTMENT

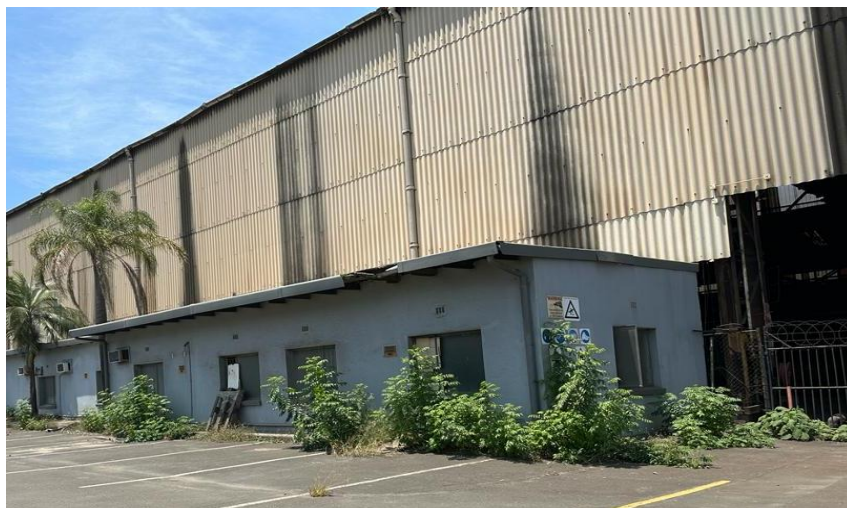
Figure 2: Warehouse

The structural integrity of the warehouse is overall in a good condition, however, there are certain elements in the warehouse that requires refurbishment such as the flooring, walls, roof sheeting. The structural beams and columns in the warehouse is in a good condition. The attached offices in the warehouse require a complete refurbishment in terms of flooring, walls, ceilings. Exterior paving is in a good condition.

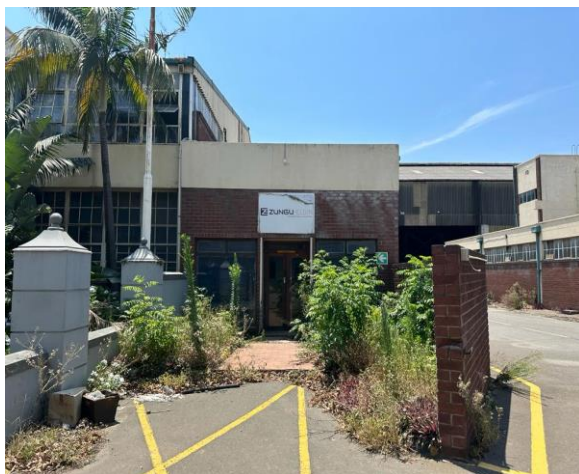
Figure 3: Admin Building

The concrete elements in the admin and staff building are in a poor condition, concrete spalling and corrosion of the rebar is visible, which requires further detail assessments. Water damage is visible, internal doors, ceilings and partitioning are damaged, requiring replacement.

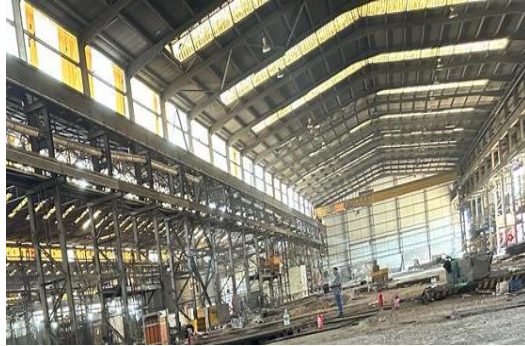
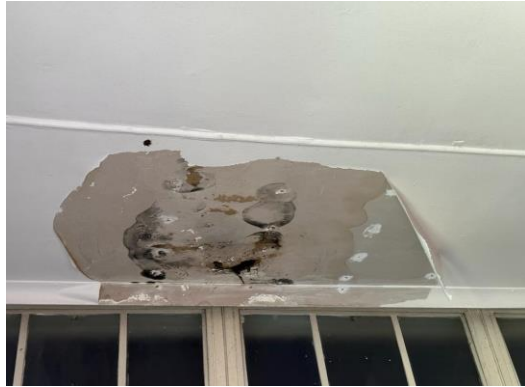
Elements	Condition	Images
Roof	<p>Warehouses:</p> <p>Both warehouses consist of asbestos roof sheeting. The roof sheeting is cracked & damaged in certain sections of the warehouse.</p> <p>Admin building & Staff Building:</p> <p>Both in the office & staff building some sections of the concrete slabs require waterproofing as there are signs of water ingress. Ceiling boards are damaged in the admin and staff building. Concrete spalling and reinforcement corrosion was noted. Some sections of the ceiling are damaged by water and is vandalised, which requires replacement.</p>

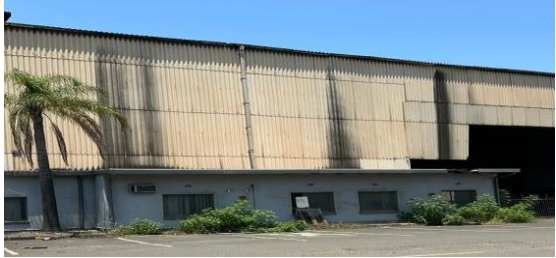
<p>Gutters & downpipes</p>	<p>Some gutters and downpipes are damaged and some are missing which needs to be replaced in the buildings and the warehouses.</p>

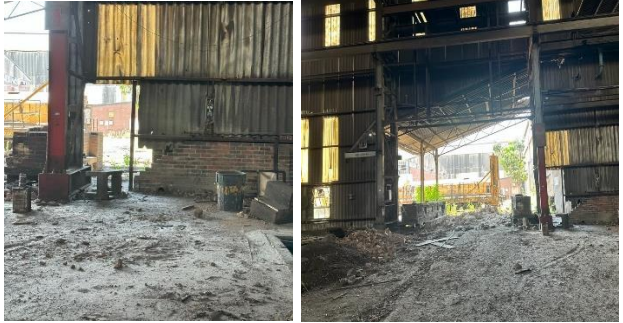
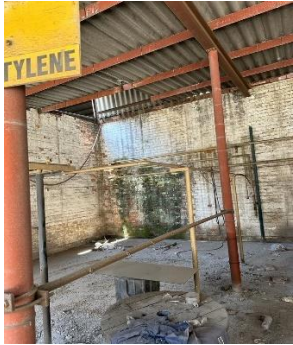
<p>Walls & beams</p>	<p>The warehouse consists of asbestos cladding, which is damaged, broken, cracked and removed in certain places.</p> <p>Brickwork is cracked on the joint connecting to the concrete section in the warehouse and the buildings.</p> <p>Concrete spalling and reinforcement corrosion on beams was noted in the staff building.</p> <p>Paint is peeling off on several sections of the walls in all buildings.</p> <p>Gas station bricks are broken, moulded and paint wash is peeling off.</p> <p>There are numerous cracks in all buildings.</p>

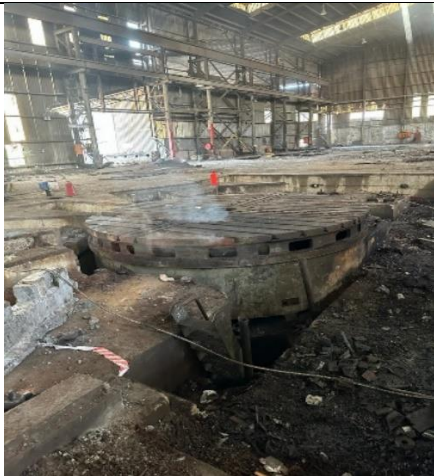
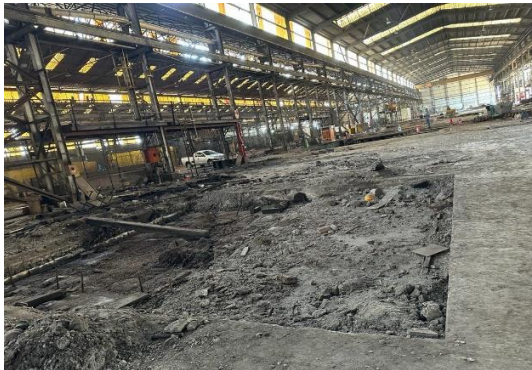
Flooring	<p>The concrete flooring in the warehouse is broken in certain places and consists of various trenches and deep openings which are filled with contaminated water.</p>

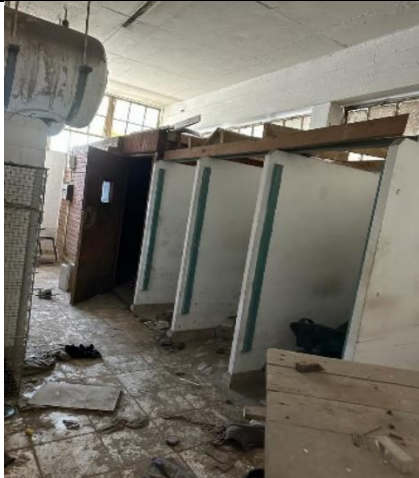
Ablution	<p>Pipes are broken, and sinks are also damaged. Shower rose and taps are removed from the showers. Toilet cisterns are damaged and non-functional.</p>

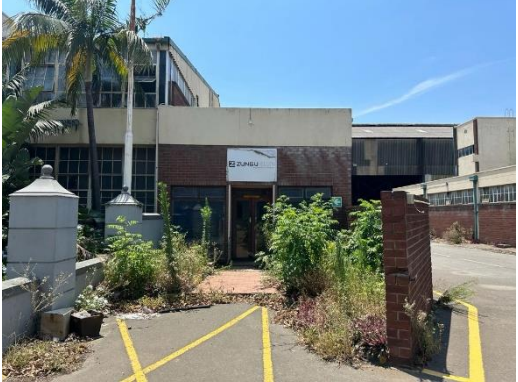
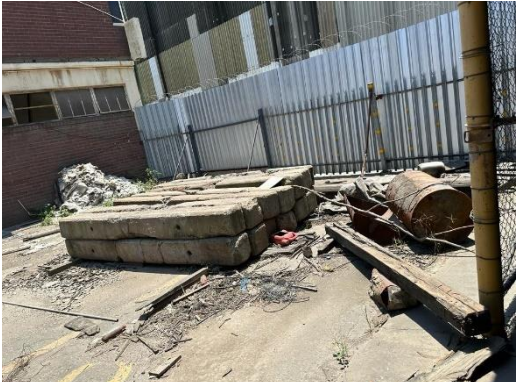
<p>House Keeping & other</p>	<p>There is evidence of overgrown vegetation in some areas. Waste material has not been collected from site. There are a lot of waste inside the building comprising of old furniture, paper files, damaged ceiling panels, fuel containers, stripped cabling, gym equipment etc. Fire hose reels and hoses are not in an acceptable housekeeping condition.</p> <p>It should be noted, fire emergency stairway was not visible in the admin building.</p>

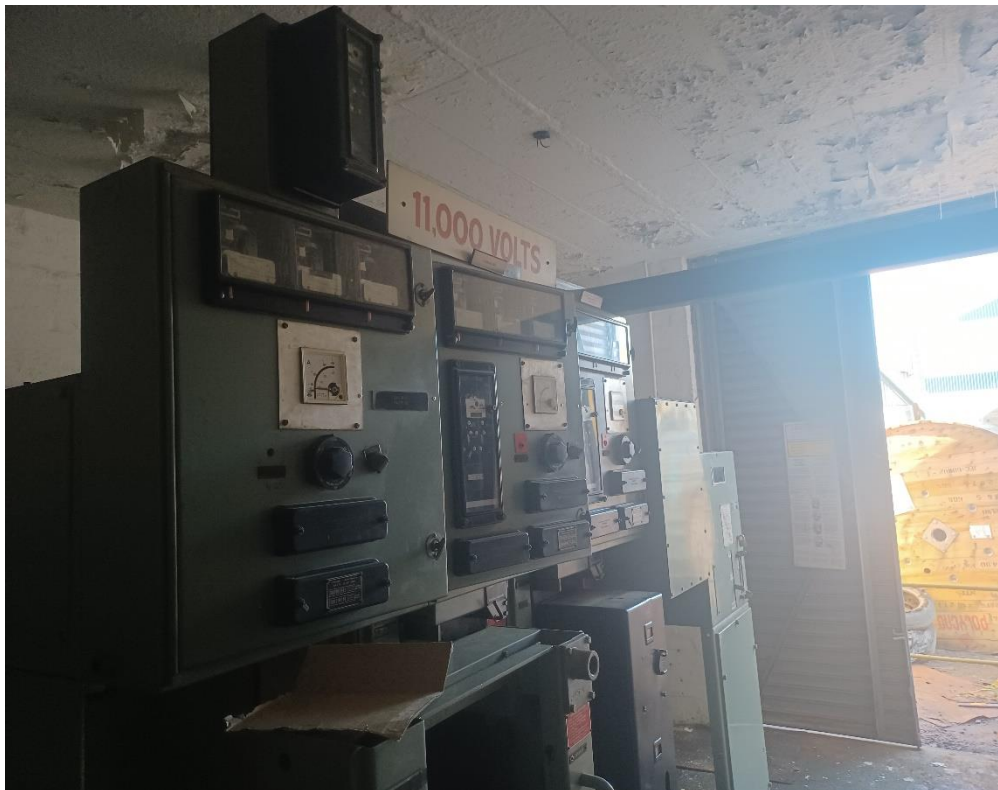
The facility receives 11 kV bulk electricity supply from eThekweni Municipality via the substation located just next to the gate of the site, this substation is currently de-energized due to damages during the KZN floods that took place in April 2022. The main substation is divided in to two rooms housing eThekweni and customer electrical switchgears that supply power to various substations in the facility, these substations consist of electromechanical equipment such as switchgears, transformers and standby generator.

Findings	Resolutions:
<ul style="list-style-type: none"> The entire substation was submerged with water during the floods and is currently de-energized. Customer side 11 kV medium voltage switchgear removed from site. Medium voltage cables still lying in the trench. TNPA has inherited the customer side asset and there is a project in place to replace the affected electrical equipment. 	<ul style="list-style-type: none"> Reported to eThekweni Municipality to test and undertake any possible repairs on the 11 kV medium voltage switchgear. Treat supply cables in the trench as "live". Apply for reconnection of electrical power supply to eThekweni Municipality.

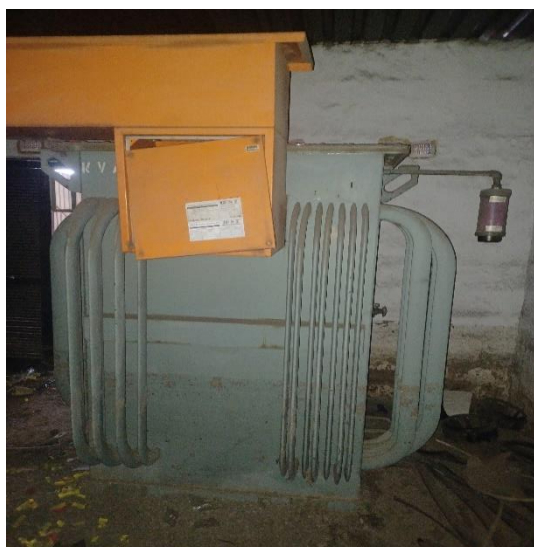
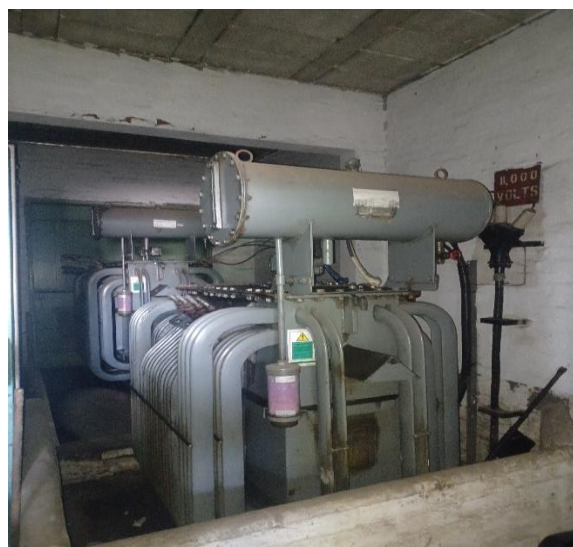
The electrical supply arrangement consists of seven (7) transformers that are used to step down the operating voltage from 11 kV to 400 V to supply electrical lights and power EL&P) to the facility, this includes the warehouse and administration building

Findings	Resolutions:
<ul style="list-style-type: none"> No maintenance records were available. Transformers are in a bad condition as they have not been operating for more than a year and has collected a lot of dust. Steel casing is corroded in all transformers. 	<ul style="list-style-type: none"> Transformers and associated components need be tested. Should the test results recommend replacement, new transformers sizes will depend on the new electrical distribution design as per the new tenant's operations electrical requirements.

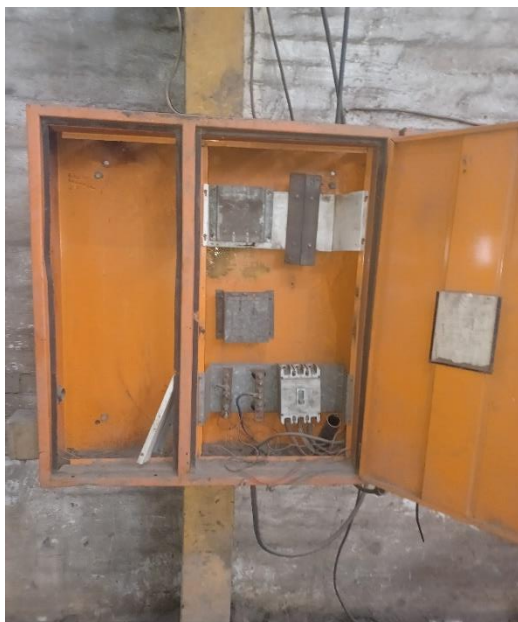
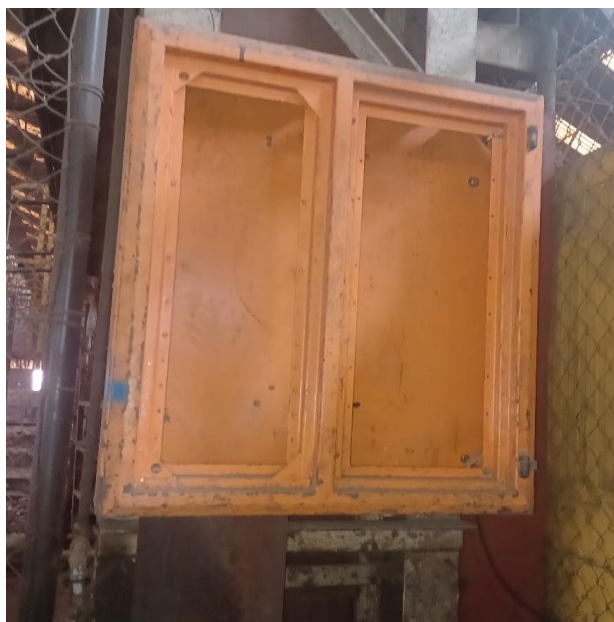
Findings	Resolutions:
<ul style="list-style-type: none"> All low voltage distribution boards have accumulated dust and are in a bad condition. Some low voltage supply cables to distribution boards have been cut. Some distribution boards circuit breakers have been removed or stolen. 	<ul style="list-style-type: none"> Some distribution boards require full replacement. New distribution boards with circuit breakers and supply cables required. Main distribution panel to be designed and rated according to the new tenant's operations electrical requirements.

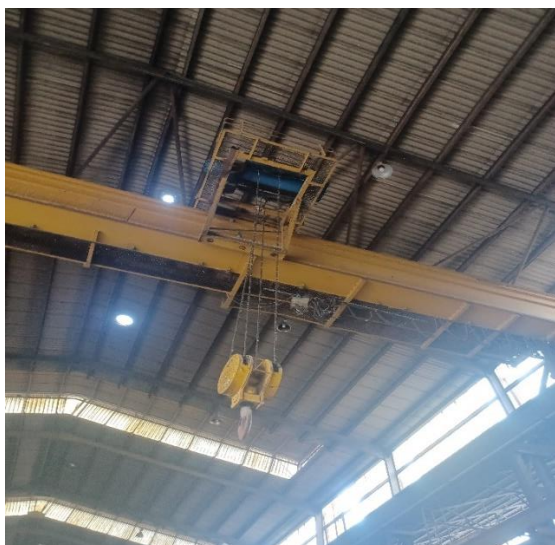
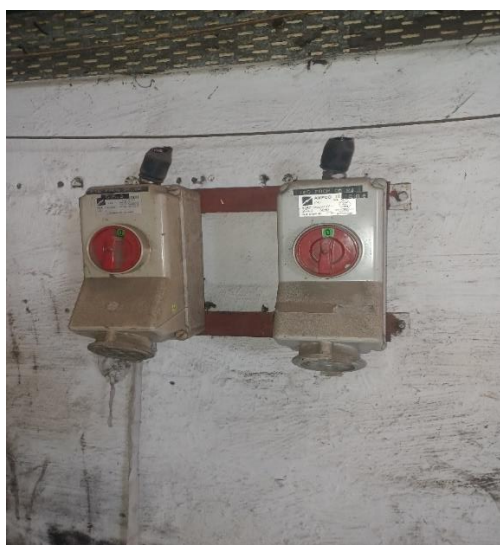
Findings	Resolutions:
<ul style="list-style-type: none"> • There are 2 x overhead cranes that were used hoist heavy loads, the rating of these cranes could not be identified. They both have accumulated dust as they have not been operated for a long period. • There are 24 high-bay lights that were used for lighting the warehouse, these have also accumulated dust as no maintained have been done on them in the last 18 months. • Industrial plugs supply cables have been cut and they are currently in a bad condition. 	<ul style="list-style-type: none"> • Overhead cranes to be inspected by the Heavy machinery Inspector ascertain their condition provide the recommendation. • Industrial plugs require full replacement • High-bay lights could not be switched on as the site has no power, they can be removed an used elsewhere.

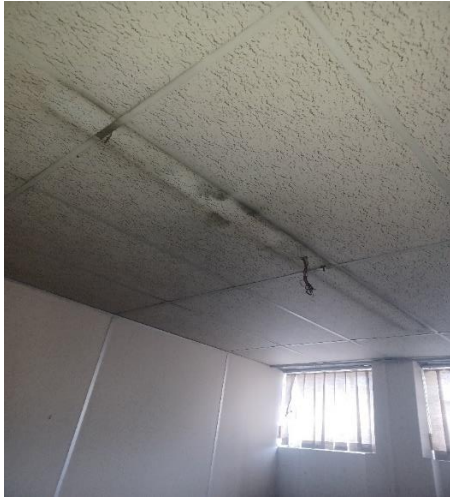
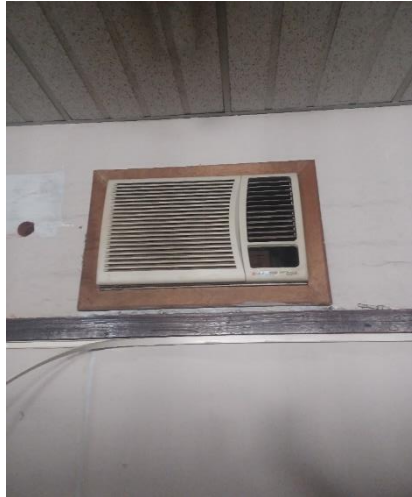
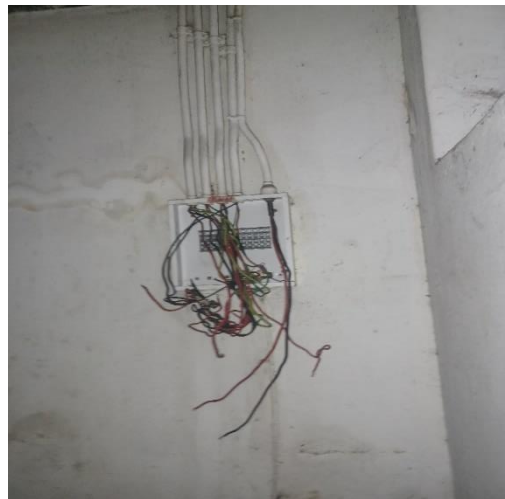
Findings	Resolutions:
<ul style="list-style-type: none"> The building consists of very old split units air-conditioning system, most of the aircon unit have been stripped and even the ones that still existing are badly corroded. The main building 3 phase distribution boards has been stripped out. 80% of interior light fittings (fluorescent) have been stripped out and the ceiling is vandalized. Exterior lights are all still intact but not operational. Power skirting in some offices is removed 	<ul style="list-style-type: none"> All electromechanical in the admin building require full replacement. New electrical lights and power design to be done as per the new tenant operational requirements.
