CONDITION ASSESSMENT REPORT FOR THE KZN ~~ROWING~~ ASSOCIATION

Project Name : Condition Assessment (Ex-Manila Ship Chandlers)

Owner : Transnet National Ports Authority

Print Date: 02/06/2025

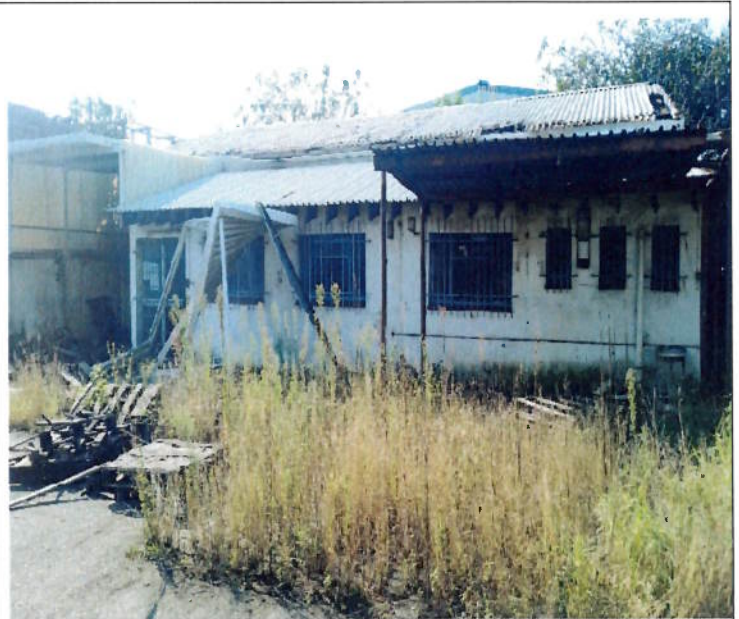
Figure 3: Building Exterior

- The area of land in this building is 687 m²
- The exterior of this complex is not in a very bad condition is has minor things that must be taken care of which can improve its appearance.
- The entire roof structure is covered by metal sheets of which now have corrosion in some parts, and this affects the inside as the water coming from rain is entering the inside.
- The roof has no drainage system, as well as the entire property. There's no evidence of a stormwater management system within the boundary of the property.

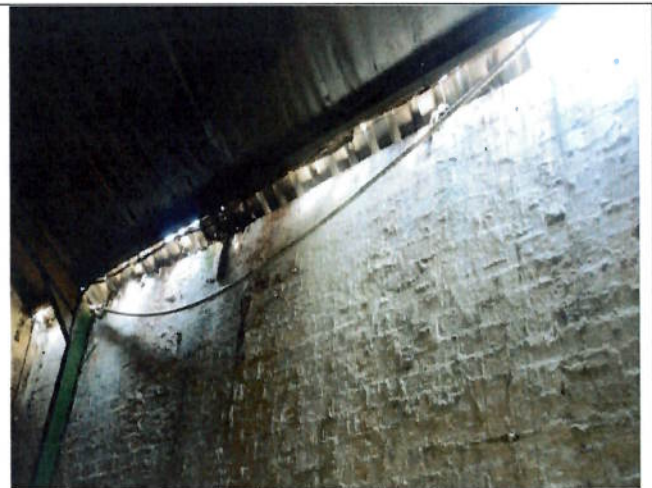
Figure 4:roof

- The roof of this building is in a good condition it has leaks, water passes from roof to floor, and it creates water ponds on the floor.
- Small panel gaps from the roofing were identified, which can cause water damage of the trusses.

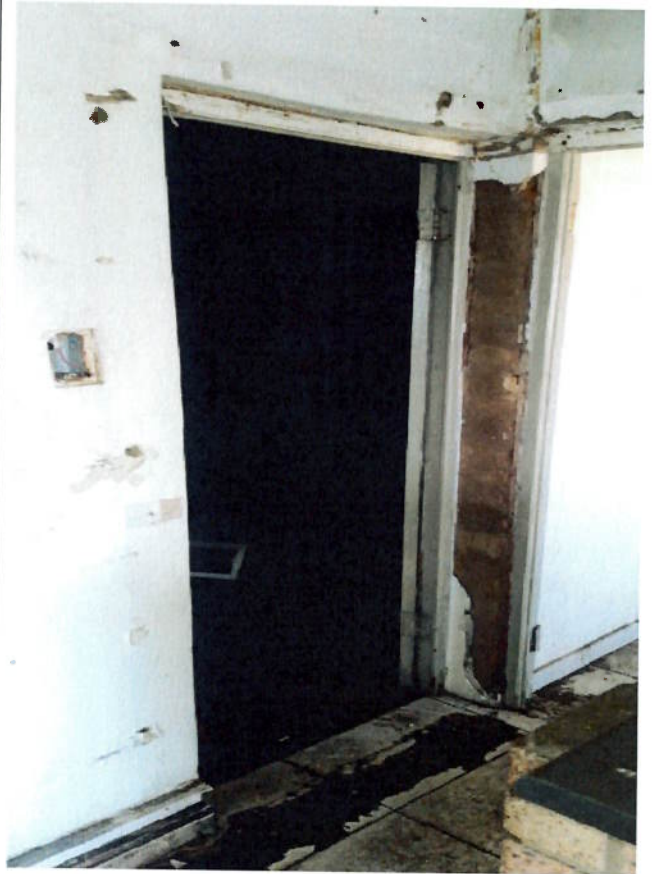
Figure 5:door

- The internal walls are damaged, and they need to be plastered, and other parts be painted.
- Some of the floor mats are starting to peel off.

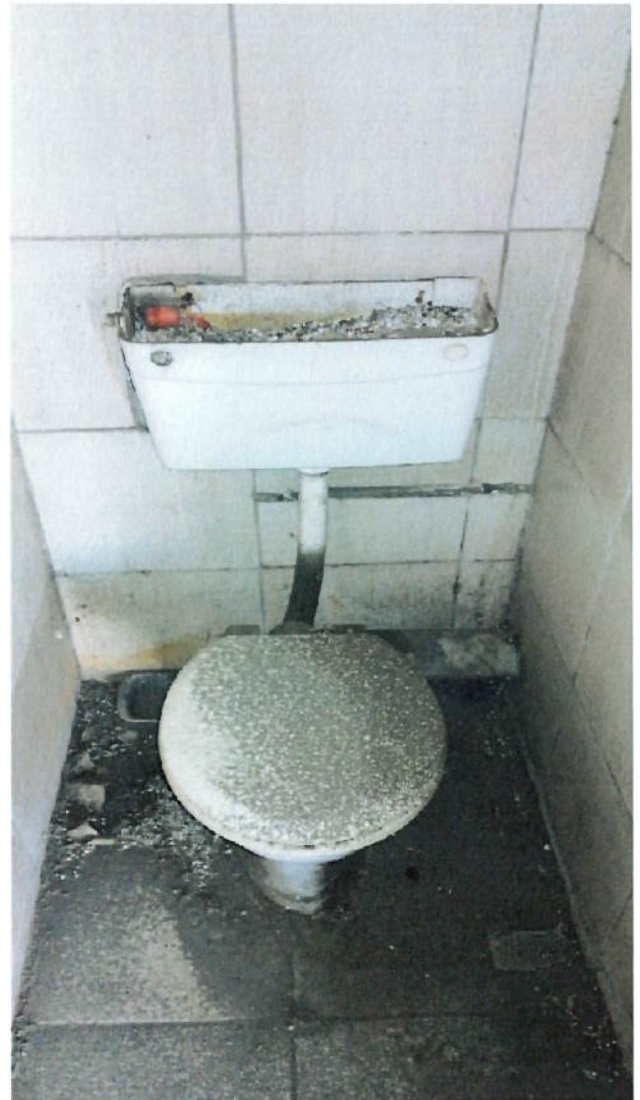
Figure 6:ablutions

- Ablution facility damaged and unusable.
- The floors are not completely damaged but in bad condition
- The walls are dirty due to the dust that is coming inside the building but can be cleaned since it is tiled.

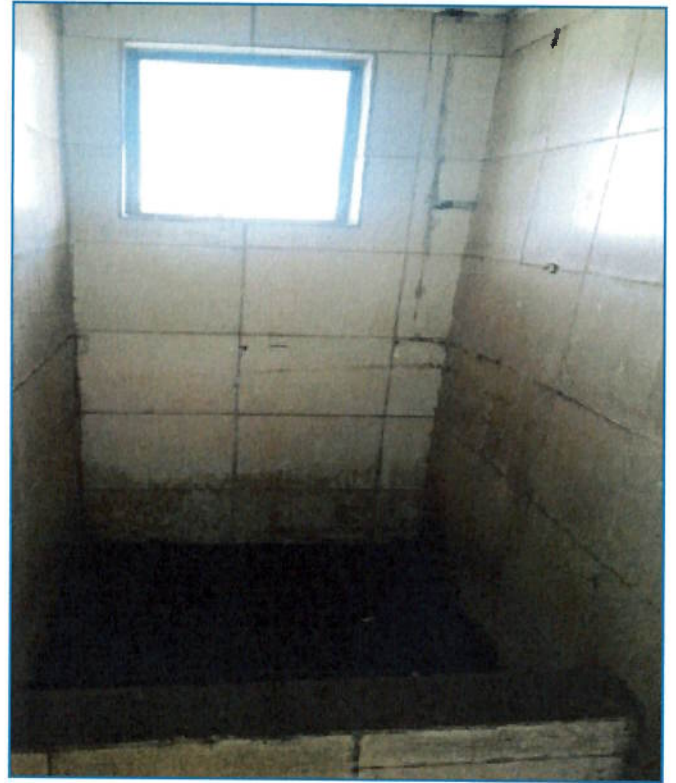
- There's no evidence of water supply within the building.
