| INSPECTION DATE: 23 SEPTEMBER 2025<br>ASSET NO:<br>TENAT NAME: OLD TANKER BERTH | FACILITIES MANAGEMENT-ANNUAL INSPECTION REPORT | |
| | PORT OF PORT ELIZABETH | |

### TENANT MANAGEMENT REPORT

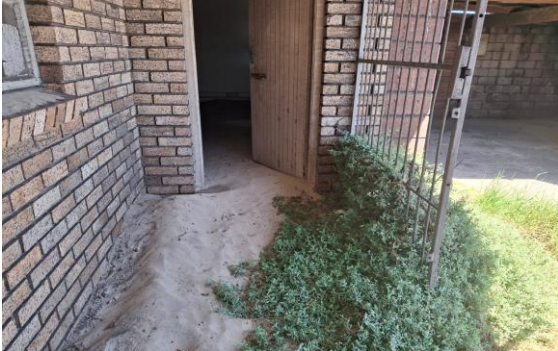
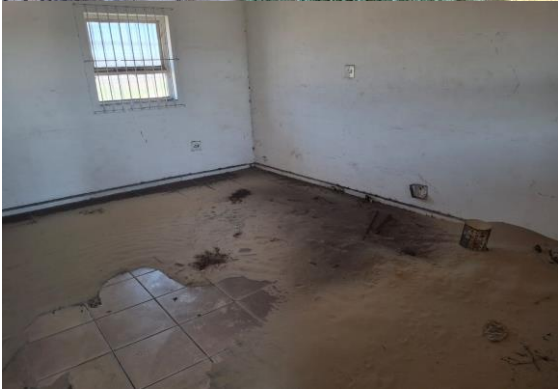
| AREA | FINDING | PICTURE/ EVIDENCE | RECOMMENDED ACTION FOR IMPROVEMENT | RESPONSIBLE PERSON | |
|---|---|---|---|---|--|
| Exterior | Continuation of sand build up around the building internally and externally | | Remove the sand build up and the debris from interior and exterior of the premises. | TNPA | |

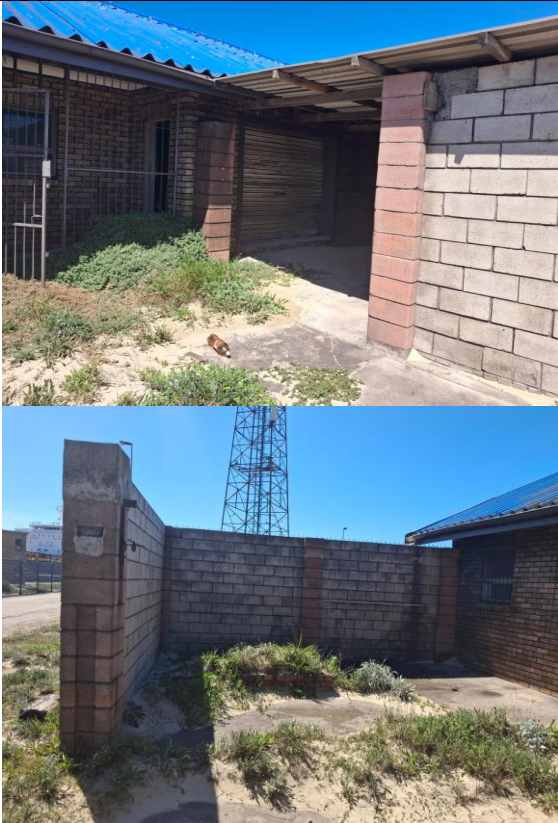
| <b>Exterior</b> | Overgrown vegetation all around the premises. | | Conduct cleaning and remove all vegetation as part of maintenance regime | TNPA | |

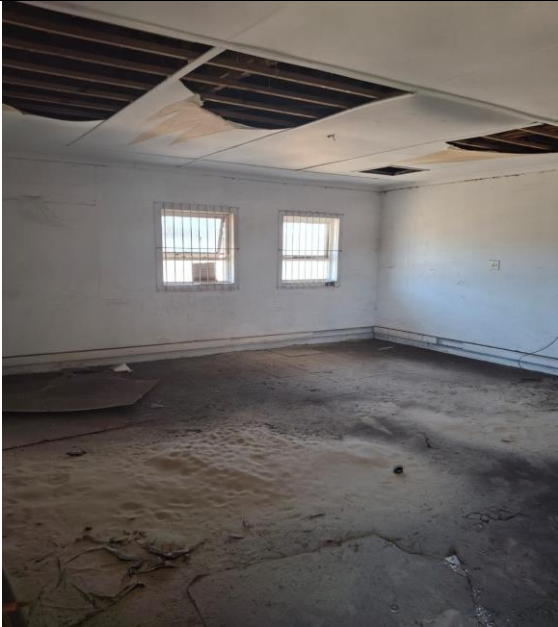
| <b>Interior</b> | Broken ceiling | | Repair of broken ceiling and the ceiling needs to be painted. | TNPA | |

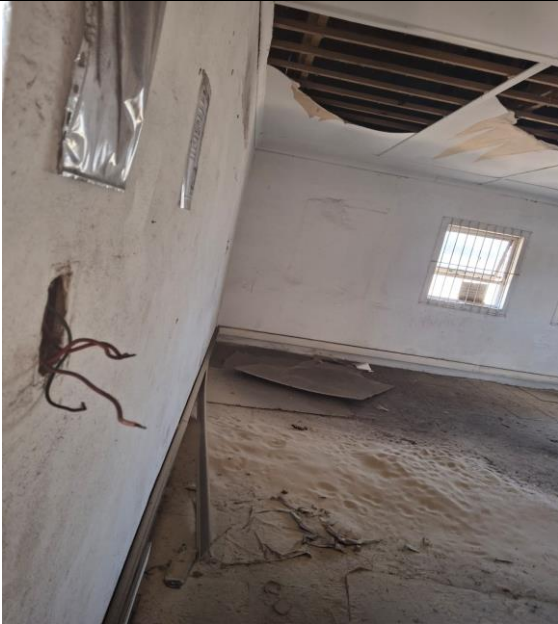
| <b>Interior</b> | No wall switch plates and light bulbs. All have been vandalised | | Overall requirement for new installation of all electrical equipment for the building. | TNPA | |

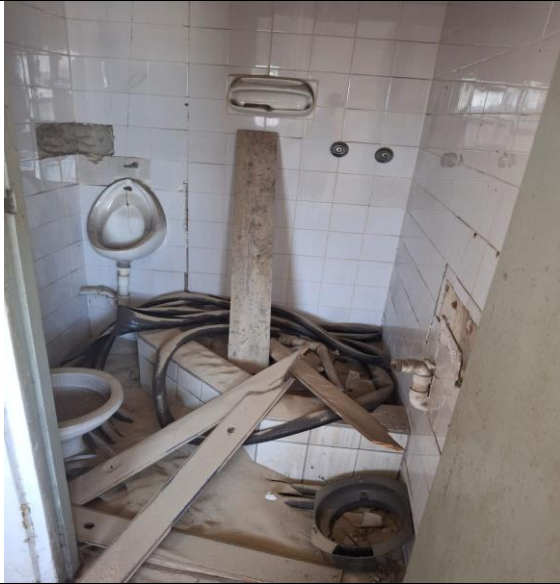
| <b>Interior</b> | <p>Build up sand on the bathroom, old wooden material and pipes.</p> <p>Visible vandalism of the plumbing material</p> <p>Broken wall tile.</p> | | <p>Overall cleaning and general housekeeping of the premises. Removal of the sand, wooden material and the pipes in the bathroom.</p> <p>Full refurbishment required for the premises.</p> | TNPA | |

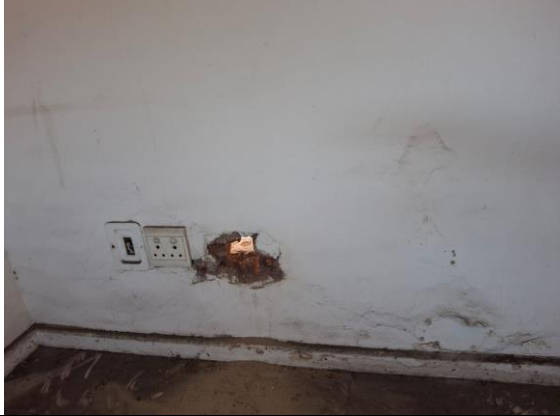
| <b>Interior</b> | <p>Wall has holes.</p> | | <p>Full refurbishment of the premises</p> | TNPA | |

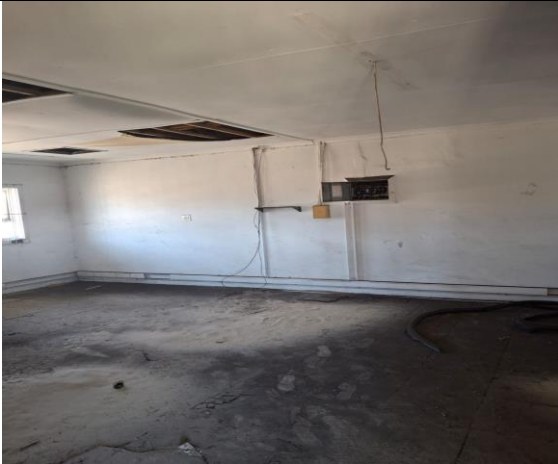
| <b>Interior</b> | Electrical DB is damaged | | Fix the electrical DB and install the cover to protect electrical components from dust, moisture and potential accidental contact. | TNPA | |

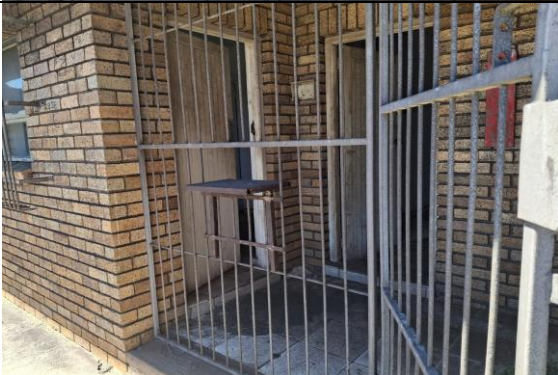
| <b>Exterior</b> | Corroded and rusty burglars. | | Repair the burglars and repaint them. | TNPA | |

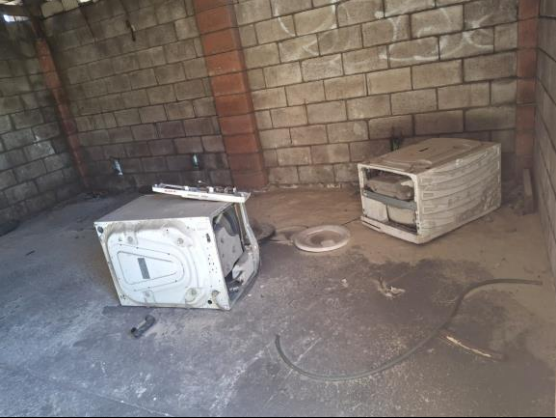
| <b>Interior</b> | Damage old equipment for aircon | | Remove the old damaged equipment. | TNPA | |

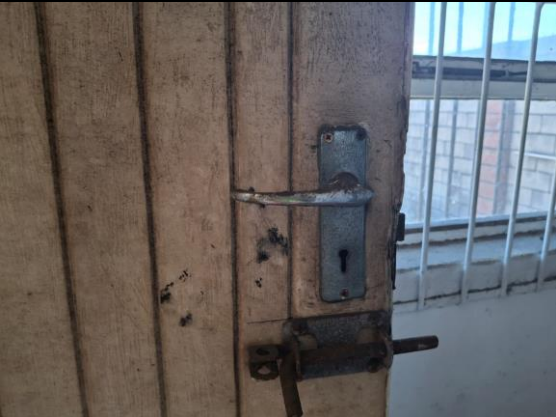
| <b>Interior</b> | <p>All the door locks are old and have rust.</p> <p>Doors are dirty due to manganese dust</p> | | <p>Remove the damaged door locks and install new door locks.</p> <p>Replace all internal and external doors</p> | TNPA | |

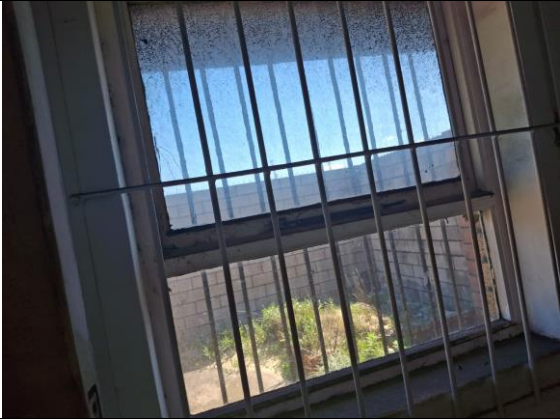
| <b>Interior</b> | Dirty window glasses and frames. Some are cracked and broken. | | Replace all window frames and glasses | TNPA | |

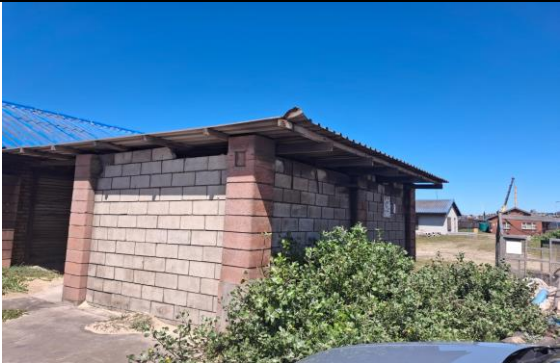
| <b>Exterior</b> | Broken external wall | | Re-build the broken wall. | TNPA | |

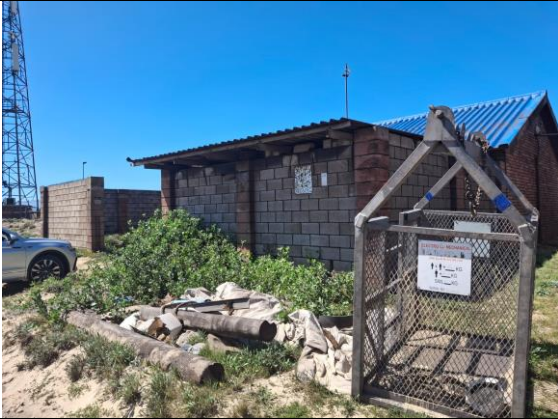
| <b>Exterior</b> | Wooden material and debris stored outside. | | Overall cleaning and remove all the unnecessary material. | TNPA | |

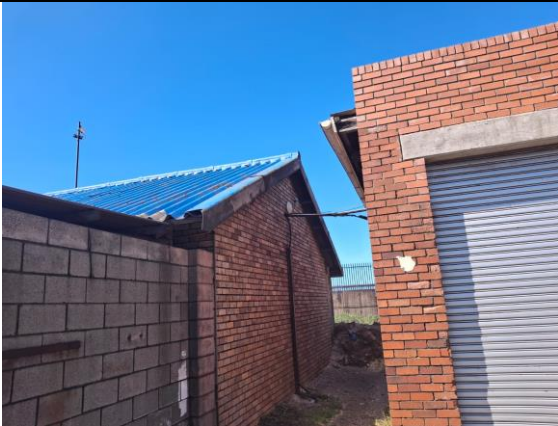
| <b>Exterior</b> | Old and damaged asbestos gutters. | | Replace all the downpipes, fascia boards and the gutters. | TNPA | |

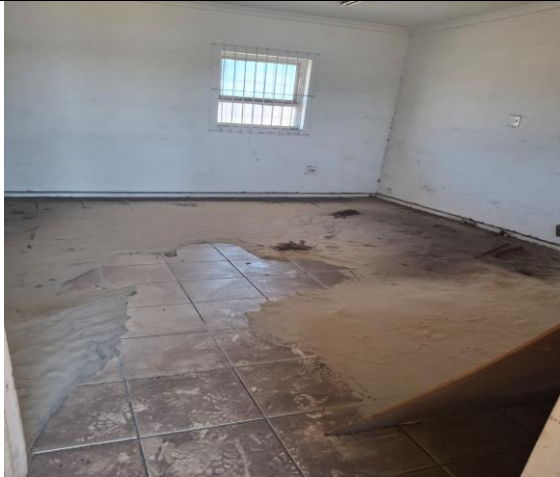
| <b>Interior</b> | Walls internally are dirty. | | Repaint the walls. | | |
