MILLSITE DEPOT TANK 2 INFORMATION

Tank diameter : 10.02 m
Height : 11.825 m
Tank capacity : 930 m³
Product : Diesel
Roof type : Fixed

Visual inspection photos

Description of the service: The modification and alteration of diesel storage tank, at Transnet Freight Rail Millsite depot, for a service period of 6 months.

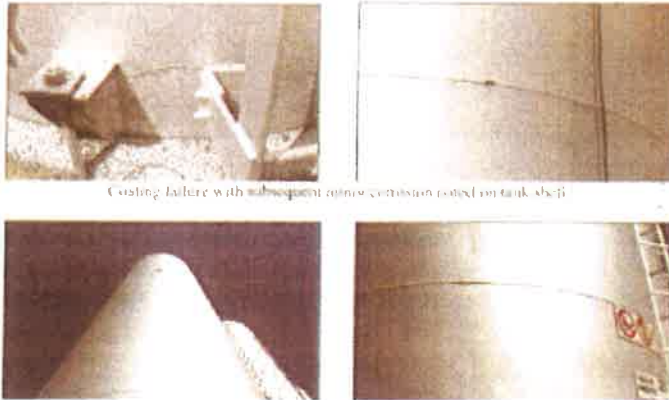
Coating failure with subsequent minor corrosion noted on tank shell

- i. prepare and wire brush where corroded and paint the entire tank shell. Using an approved primer and Transnet aluminium zinc metal paint (apply 2 coats).
- ii. Sandblast the entire tank before painting (371.45 m²).
- iii. Apply one (1) coat priming for the entire tank, with an approved primer (371.45 m²).
- iv. Apply two (2) coat painting on the entire external tank shell (371.45 m²).

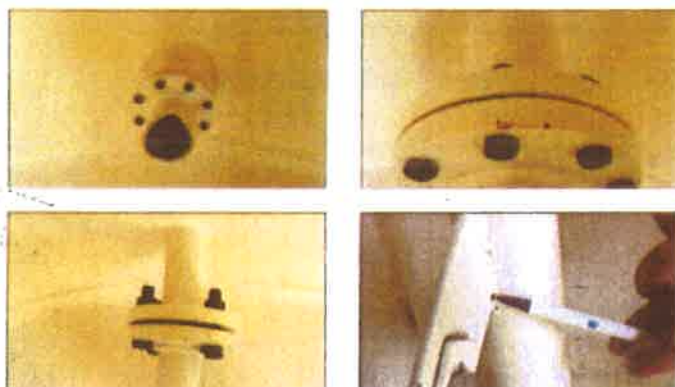
Inadequate spacing of water draw-off pipe to tank bottom

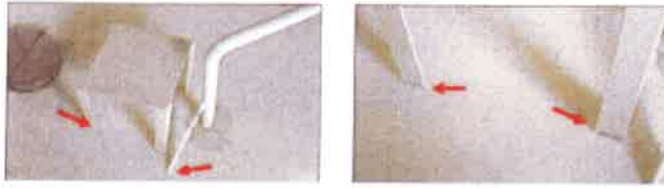
Supports welded directly to tank floor

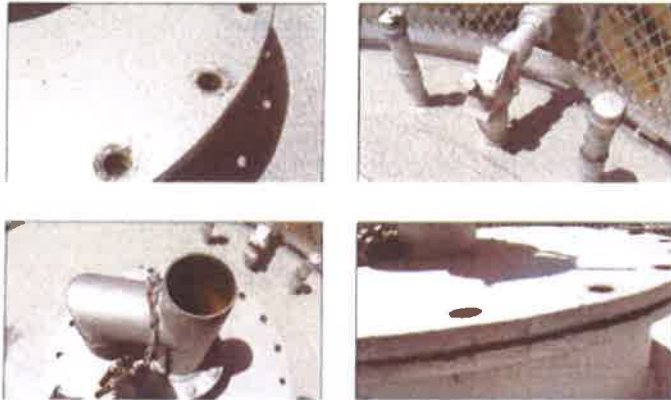
Roof plates coated with non-slip

- i. supply and install anti-slip strip on the roof, to cover all service points,
- ii. supply and install atmospheric normal vent that is equipped with a screen mesh that complies with API 650 section 5.8.5,
- iii. supply and install an emergency venting system, and
- iv. prepare and wire brush and paint tank roof including all nozzles. Using an approved primer and Transnet aluminium zinc metal paint (apply 2 coats).
