CONDITION ASSESSMENT REPORT FOR THE KZN ROWING ASSOCIATION

Project Name : Condition Assessment (KZN Rowing Association)

Owner : Transnet National Ports Authority

Print Date: 24/11/2023

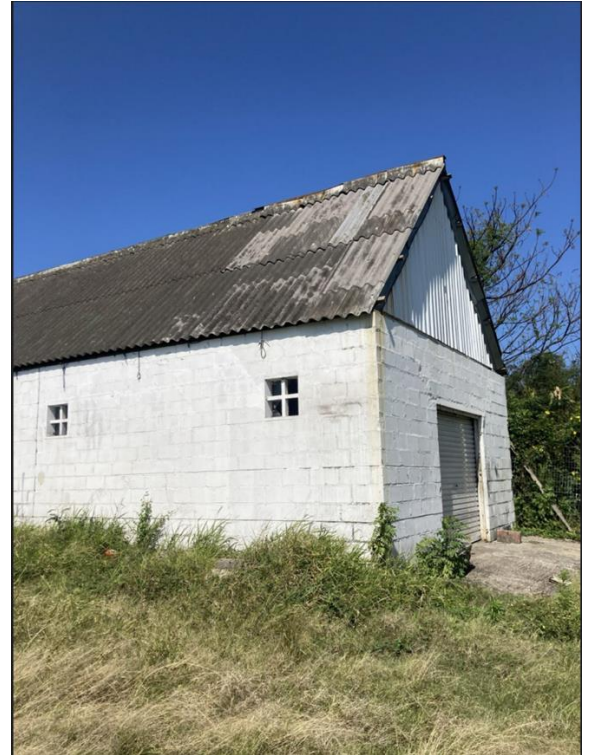
Figure 3: Building Exterior

- The building has a length of 22m and a width of 7m which makes an area of approximately 154m²
- The entire roof structure is covered by asbestos material, which is in relatively good condition, however the material will have to be replaced due to Health and Safety standards by TNPA.
- The roof has no drainage system, as well as the entire property. There's no evidence of a stormwater management system within the boundary of the property.

- a) Organize the necessary equipment (scaffolding or otherwise) for the inspection of the roof drainage system.
- b) The general drainage system on the property was not identified, hence the scope for refurbishing the property must include the establishment of a comprehensive drainage system.
- c) Refurbish the brick wall, floors, doors, and windows.
- d) Structural Assessment of the foundation of the buildings must be conducted by a Professional Service Provider.

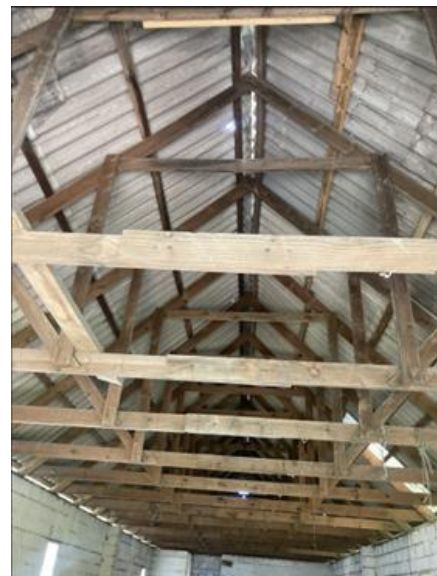
Figure 4: Roof Structure

- The timber roof structure visually in good condition, there were no observable defects, no sagging nor loose connections.
- Small panel gaps from the asbestos roofing were identified, which can cause water damage of the timber frames.

The structural timber members of the roof have no significant damage, however there are signs of prolonged exposure to the elements, hence the residual strength of the timber members must be assessed. The key elements of the structure (Walls, Roof, Foundation) require a further assessment by a professional engineer to establish their residual strength.

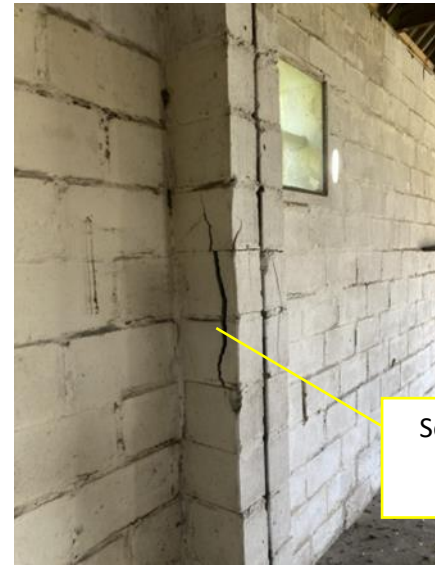
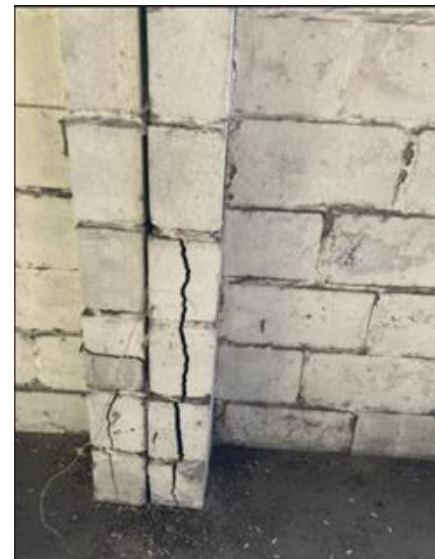
Figure 5: Structural Cracks

- The interior walls show visibly pronounced structural cracks which could be a sign of settlement.
- The expansion joints have widened, which could be another sign of uneven settlement of the entire building.

The general condition of the property is poor; however, the main buildings is still salvageable through major refurbishment. The major concern are the structural cracks observed on the walls and on expansion joints which could be an indication of uneven settlement of the building.

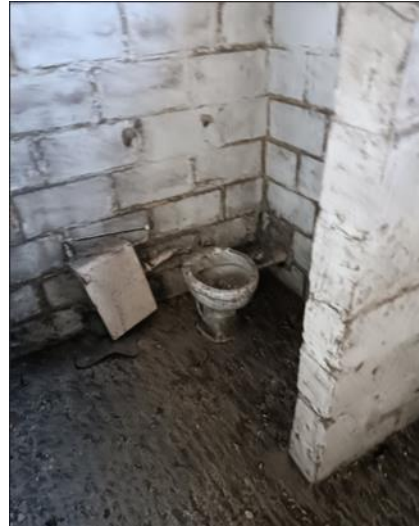
Figure 6: Ablution Facilities

- Ablution facility damaged and unusable.
- The floors are not adequately finished.
- There's no evidence of water supply within the building.
