Technical Report
2015/05/02/GENV

Port of East London:
HFO Tank Site Geo-Environmental Assessment

May 2015

Prepared for: **Transnet National Ports Authority**

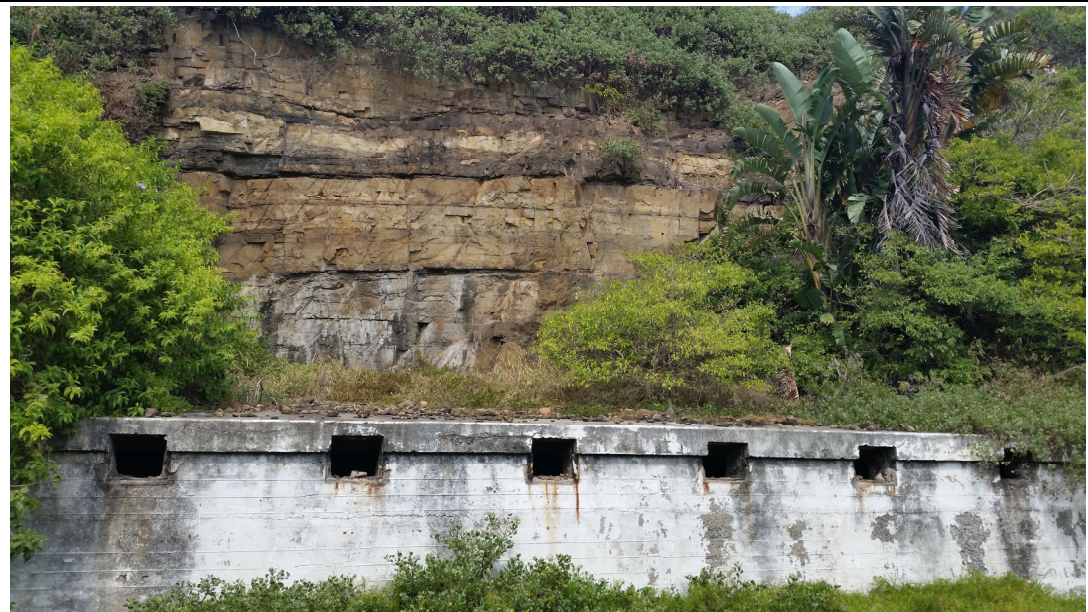
The sandstone deposits that can be observed near the site are horizontally orientated with changes in mineralogy and texture, due to different depositional environments and proximity to the dolerite sill intrusion which has baked and altered it. This changing character can be noted as layers of different colour and texture as can be seen in Photo 1.

Photo 1: Layered sandstone exposure north of the HFO site

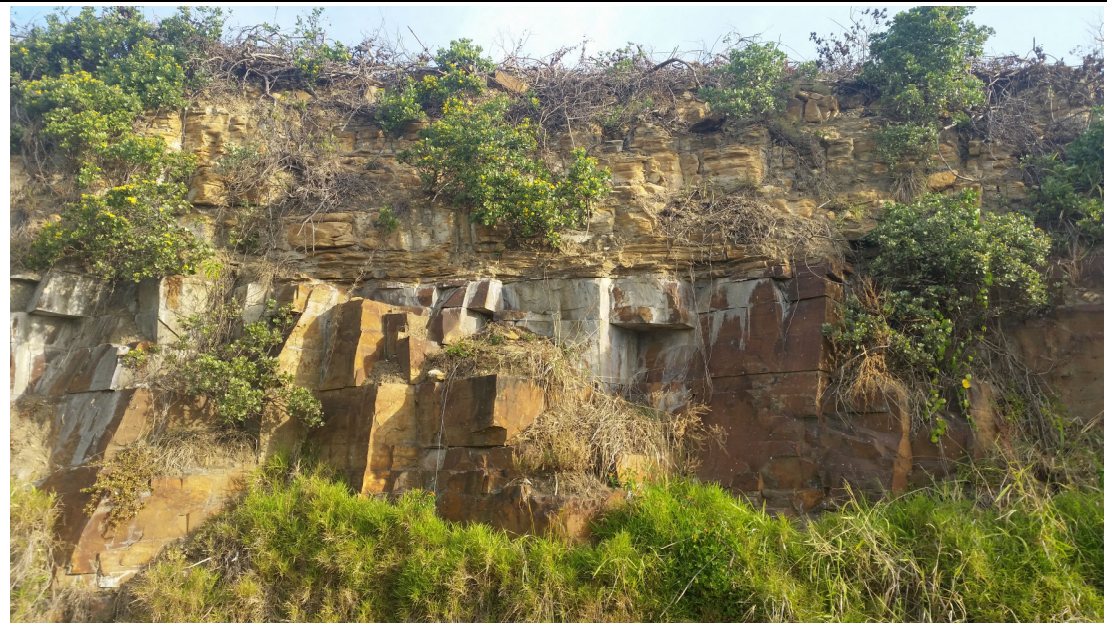
It was further observed that groundwater flow takes place along horizontal bedding planes where more resistive sandstone layers are encountered, hampering vertical infiltration along joints. (Photo 2).

Photo 2: Horizontal bedding planes showing signs of groundwater percolation below weathered zone

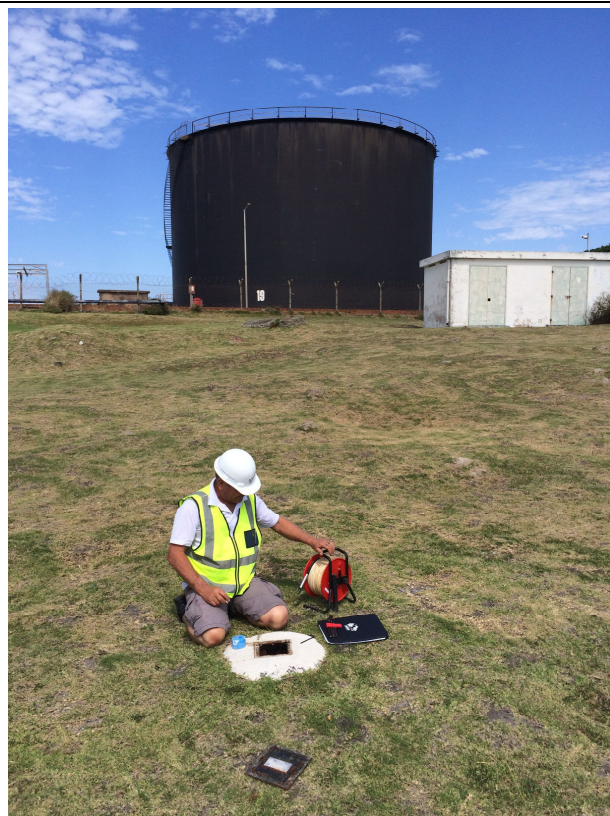
Photo 3: Groundwater level measurement at BP HFO2

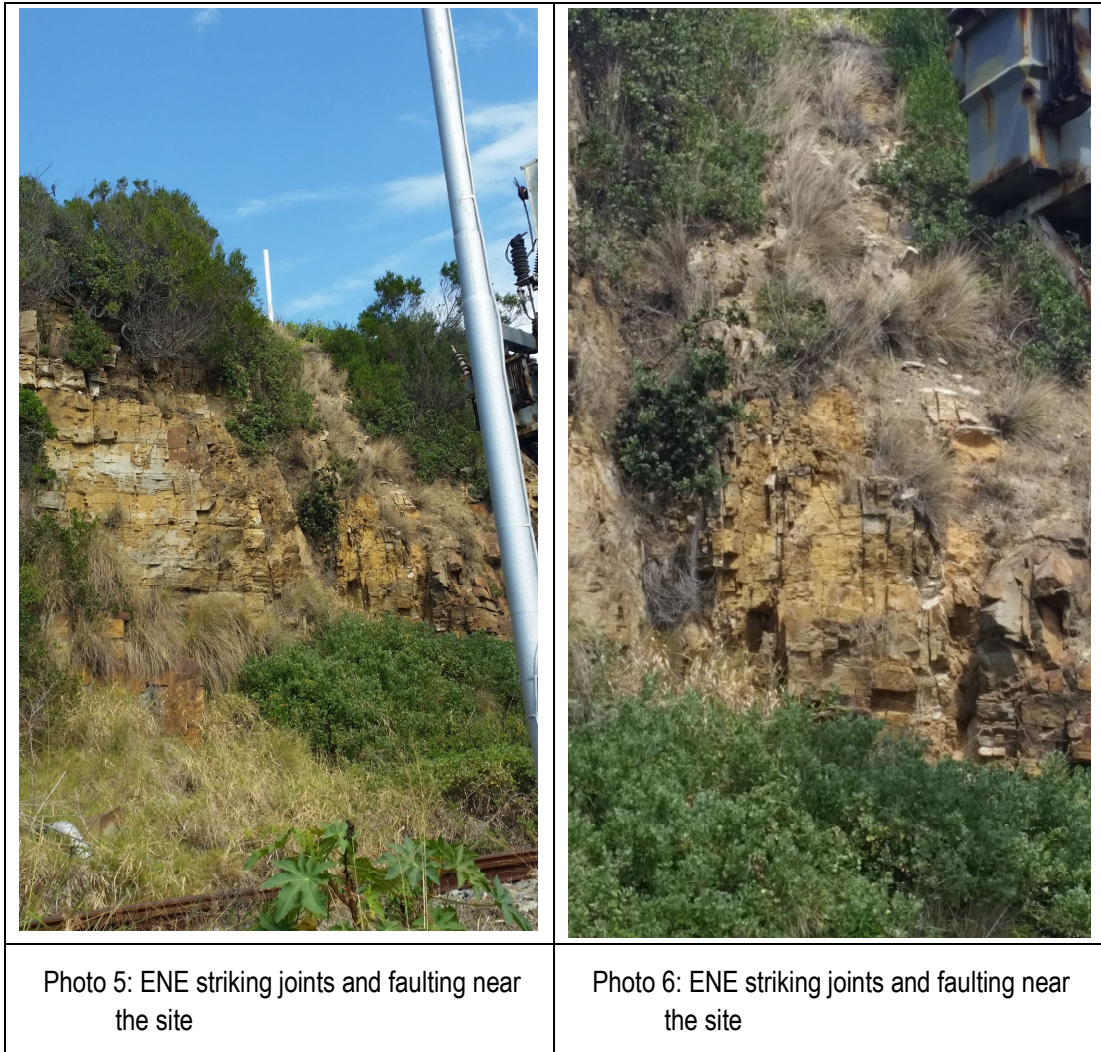
Outcrops 200m east of the site show the character of vertical joint sets that can be fault related and which can form preferential flow paths for groundwater. (Photos 5 & 6).

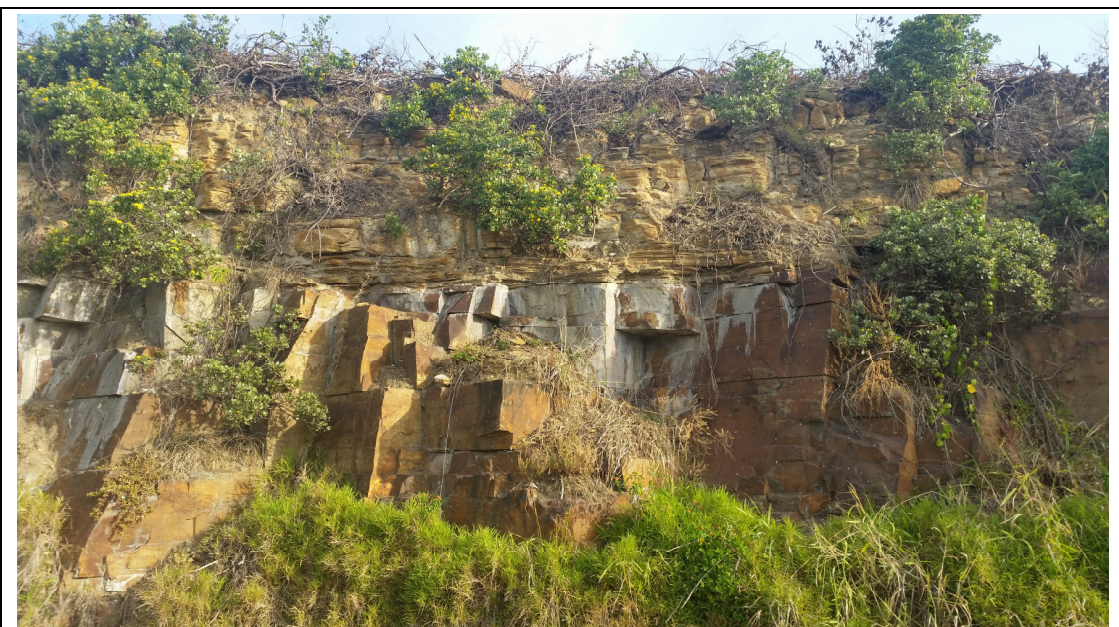
Illustrated in the model is the expected groundwater flow within the perched shallow aquifer as well as vertical flow along joint sets that were observed on site. It is expected that most of this flow will be from the perched shallow aquifer along vertical joints until it intersects resistive horizontal bedding planes. This is clearly visible in outcrops as reported earlier and repeated here in Photo 7.

Photo 7: Visual indication of groundwater flow and seepage from horizontal bedding planes

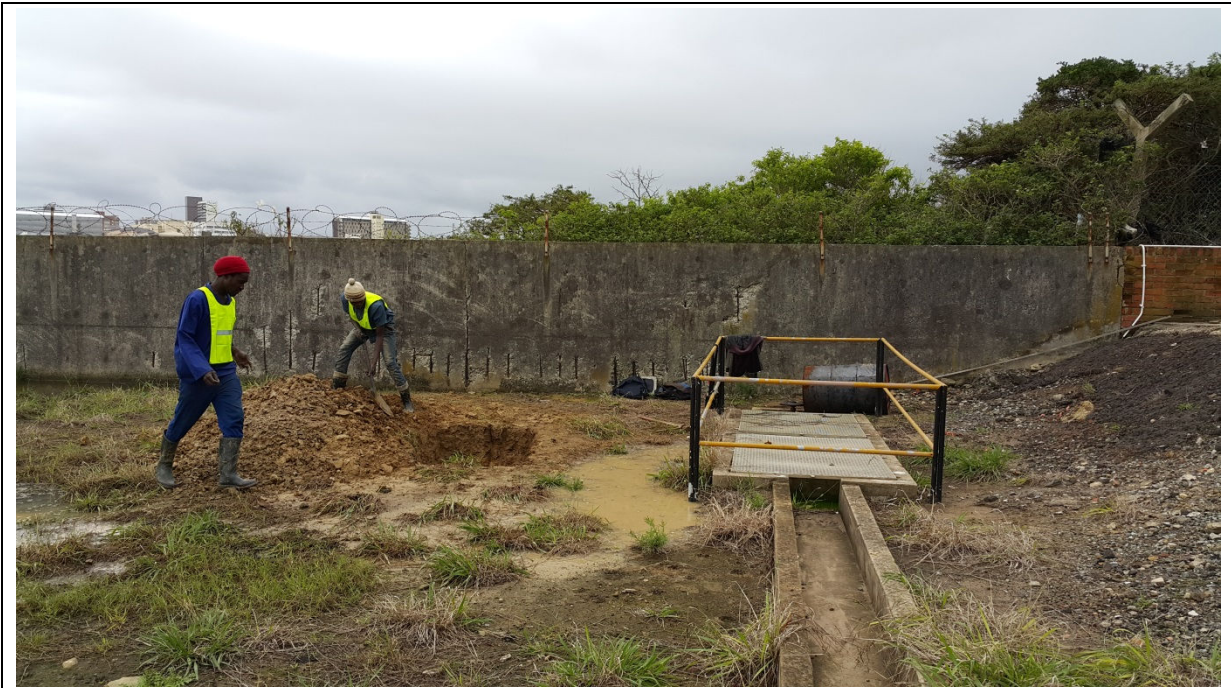
- HFO TP1 – this test pit was placed inside the perimeter of the HFO tank in the position where surface drainage water collects as well as in the vicinity of the existing grease trap where maximum soil contamination is expected in the case of a spillage.

Photo 9: Position of test pit HFO – TP1

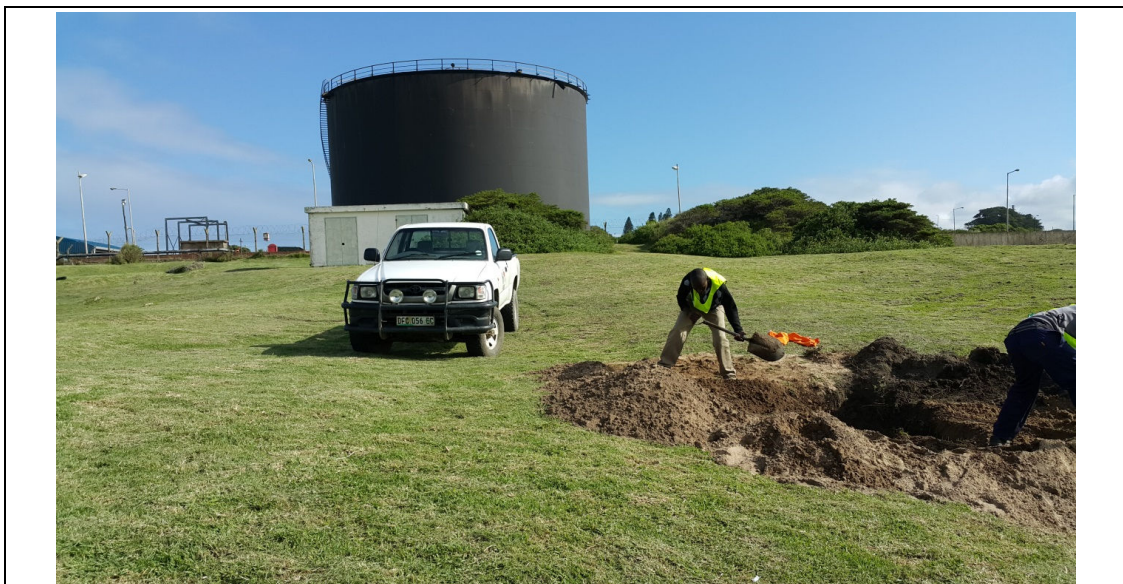
- HFO TP2 and TP3 – These test pits were placed in deeper sandy material in order to verify reported TPH pollution at borehole BP HFO 2 which is located slightly up gradient. The positions of these test pits were therefore to assess if TPH pollution was limited to groundwater or if it is encountered in the surrounding soil material as well.

Photo 10: Position of test pit HFO – TP2

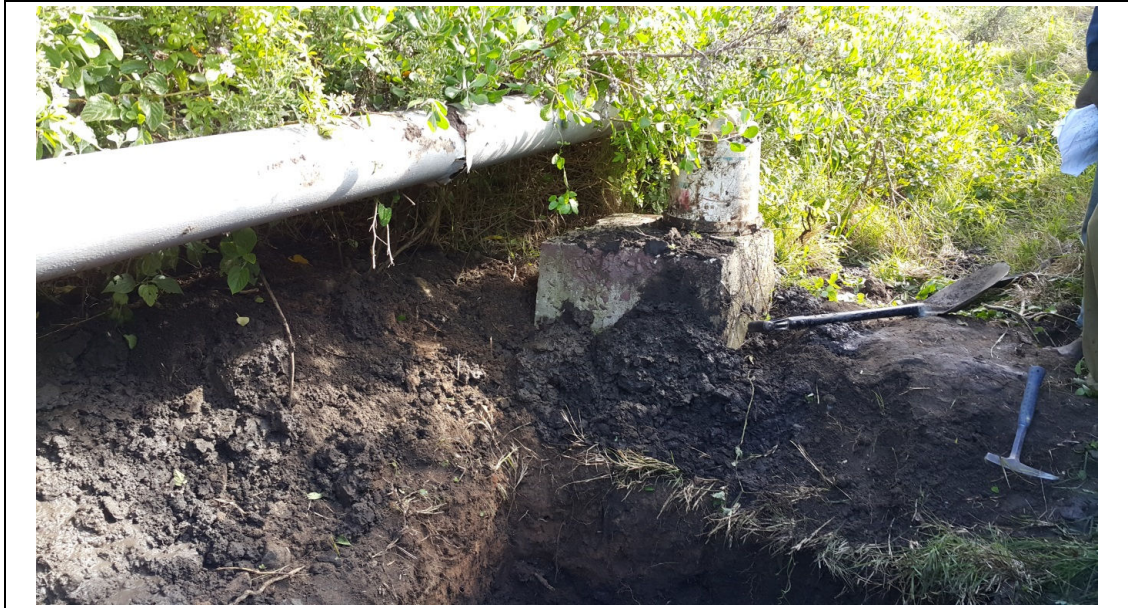
- HFO TP4 – This test pit was placed at the beginning of the small drainage in which one of the metal pipelines that transport fuel from the harbour to the HFO tank and back is located. Any possible pollution from the pipeline would most likely be identified in this test pit.

Photo 11: Position of test pit HFO – TP4

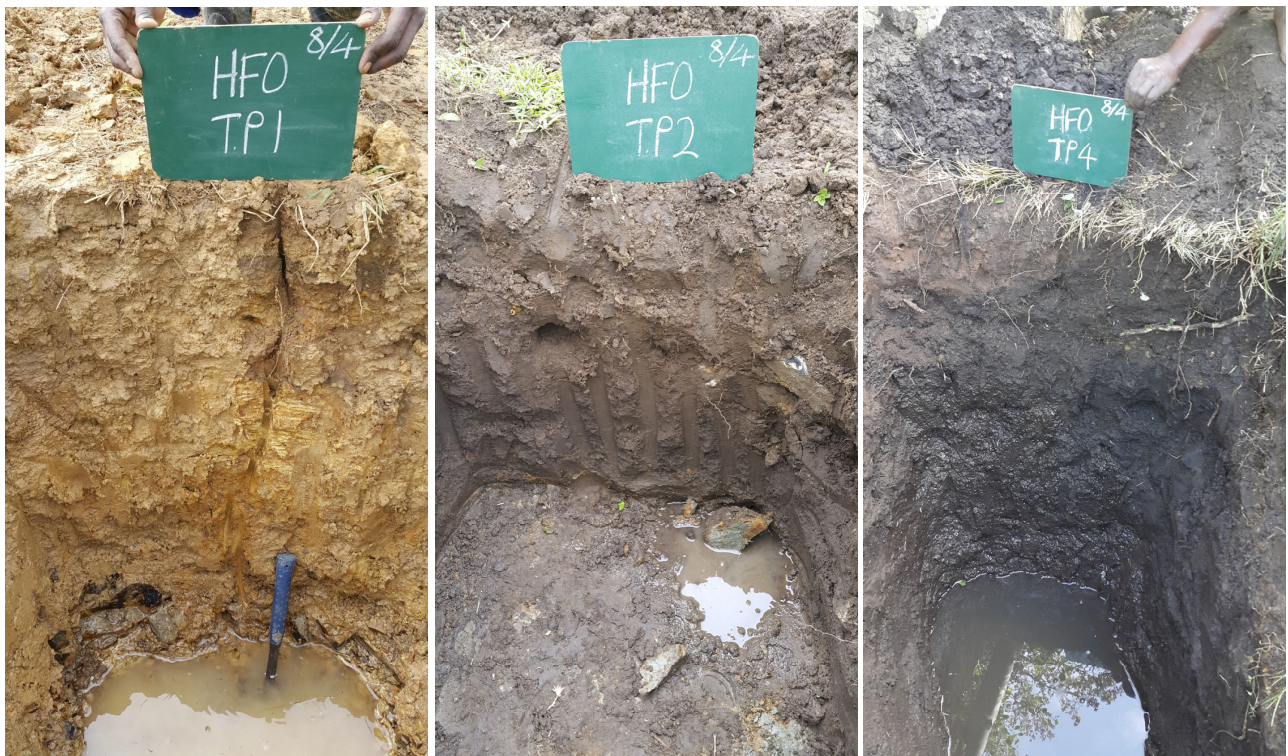
Photo 12: Groundwater seepage encountered in test pits
