## **CONDITION ASSESSMENT REPORT FOR THE (former) CORAL REEF CHARTERS AT BAYHEAD PARK**

Owner : Transnet National Ports Authority

The Bayhead area within the Port of Durban is a multifaceted region, encompassing storage container yards, ship repair facilities, and various supporting services. This technical report is dedicated to presenting the results of a condition assessment carried out on the Ex-Coral Reef Charters warehouse in Bayhead on October 26, 2023.

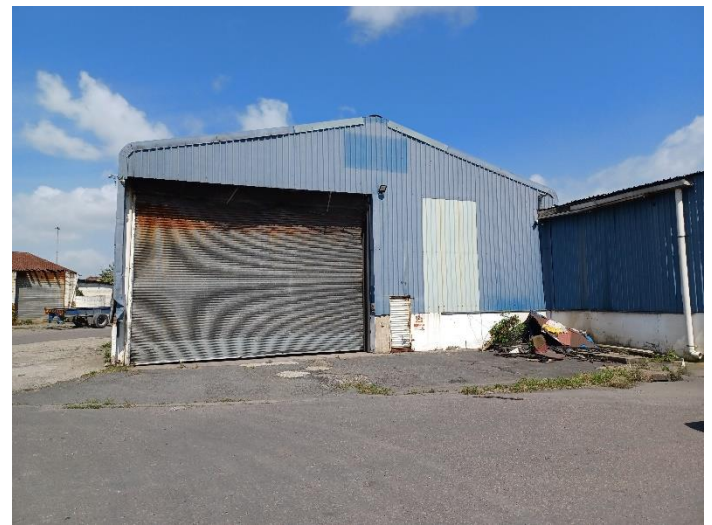
Figure 3-2: Exterior of Warehouse 1.

- The steel roller door at Warehouse 1 has corroded on the top. On the left of the roller door, the IBR sheeting is broken, as shown in Figure 3-2.
- The steel frame of the entry door is corroded and there are cracks on the concrete, adjacent to the door.
- There are cameras and light fittings that are not connected.

- a) Repairs to the cracks in the masonry walls.
- b) Repairs to the spalled reinforced concrete.
- c) The corroded and missing steel cladding in the warehouse must be replaced.

- d) Refurbish the brick wall, floors and roller and entry doors for the warehouses.
- e) Steel members (purlins, sag bars, girders, column, etc.) to be further assessed to establish residual strength of members, however there were no major visible defects observed during the investigation, just minor corrosion.
- f) Mild to moderately corroded steel sections to be de-rusted prior to applying a corrosion protective coating.
- g) The general drainage system on the property was not identified, hence the scope for refurbishing the property must include the establishment of a comprehensive drainage system.
- h) Structural assessment of the foundation of the buildings must be conducted by a Professional Service Provider.

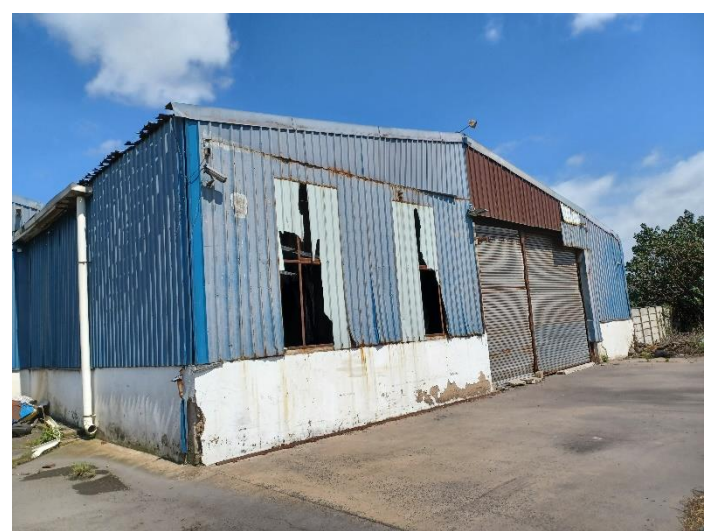
Figure 3-3: Exterior of Warehouse 2.

- There are broken IBR sheeting panels as shown in Figure 3-3.
- The IBR sheeting and steel sections are corroded at certain places.
- There are cameras and light fittings that are not connected.
- The plaster on the brickwork has peeled off at certain sections.

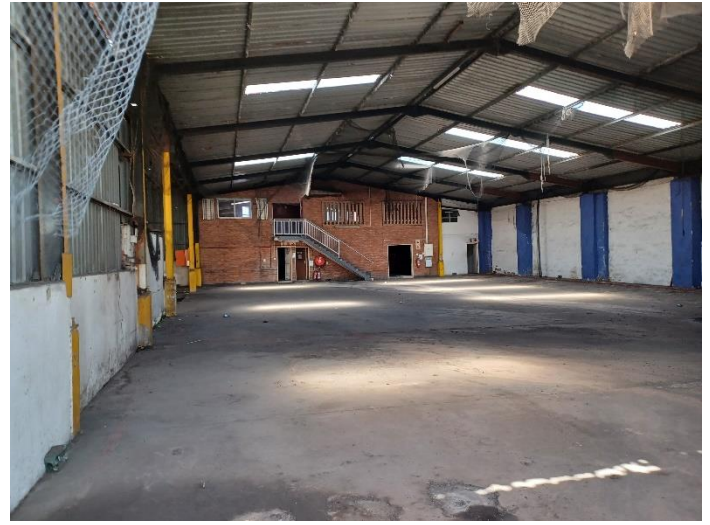
Figure 3-4: Interior of Warehouse 2.

- The interior of Warehouse 2 was captured by the opening created by the broken IBR sheeting panels.
- As shown in Figure 3-4, the brickwork on the building is in good condition.
- The steel sections are corroded at certain sections.

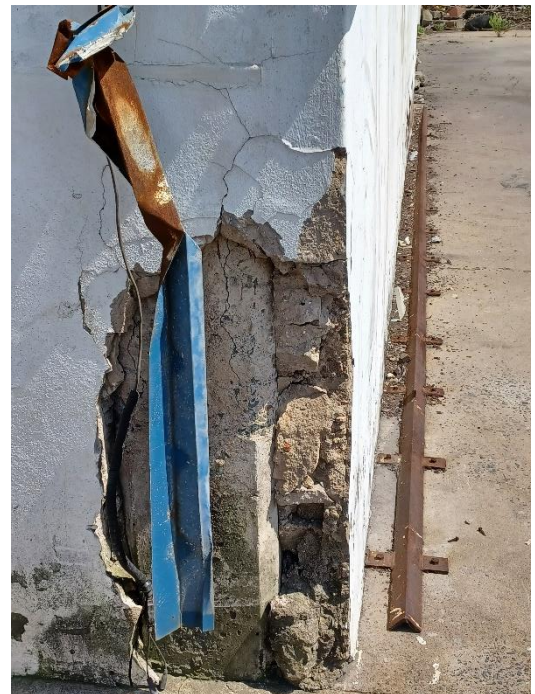
Figure 3-5: Broken brickwork/masonry at Warehouse 2.

- The brick/masonry work has broken off, hence exposing the concrete column.
- There are longitudinal cracks on the concrete column, probably due to impact that caused the brick/masonry to break off.
- The IBR sheeting has broken off and is exposed as shown in Figure 3-5.
