TRANSNET NATIONAL PORTS AUTHORITY
CONDITIONAL ASSESSMENT REPORT
STRUCTURAL REPORT

SITE: EXPRESS WAREHOUSE, MAYDON WHARF,
DURBAN
COMPILED: TNPA PORT ENGINEERING
DEPARTMENT
DATE: JUNE 2023

TRANSNET NATIONAL PORTS AUTHORITY CONDITIONAL ASSESSMENT REPORT

SITE: DG WAREHOUSE, MAYDON WHARF,
DURBAN

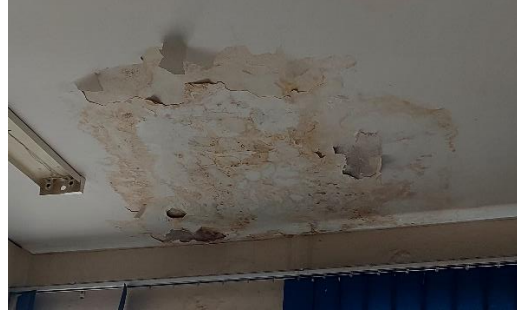
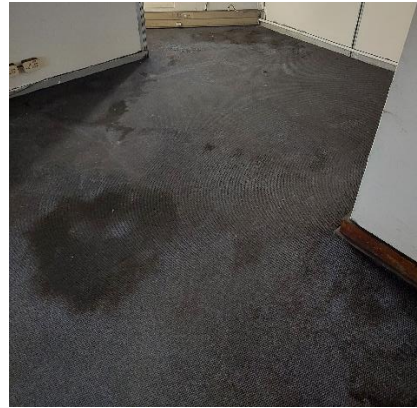
Observations	Photographic records
<p>Water Ingress</p> <p>It was noted that throughout the building, there was apparent signs of water ingress on the floor, walls and ceilings. It was noted that the water ingress was concentrated on the McBride Road side of the building. The water ingress can be</p>

attributed to poor seals on the windows, or failure of roof water proofing.

The building overall is structurally sound with no major defects noted on the main structural elements. The façade brickwork doesn't show any signs of cracking nor does the columns or beams of the structure. The building does display significant water damage to the walls, ceilings and floor. The damage is indicative of unsealed windows and water ingress from openings in the wall via old aircon units. The water proofing and drainage on the roof will have to be investigated further to determine the extent of the damage however signs of waterproofing failure of the roof is evident from the water damage noted on the underside of the slab.

- Strip and reapply roof waterproofing,
- Unblocking roof fullbores and gutters,
- Remove and seal old aircon unit cavities in walls,
- Replace or repair all existing windows.

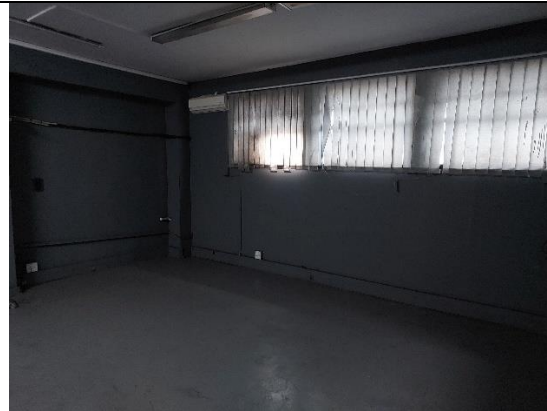
Refurbished rooms

It was noted that some rooms on the ground floor was recently refurbished (painted and flooring redone) to be used for employee engagements.

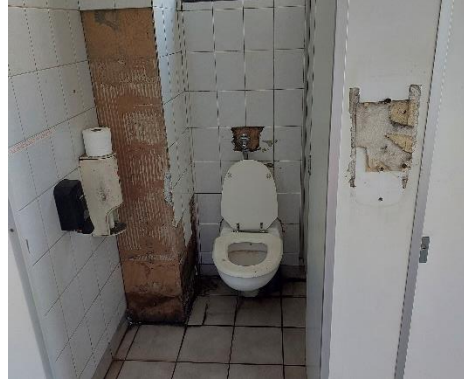
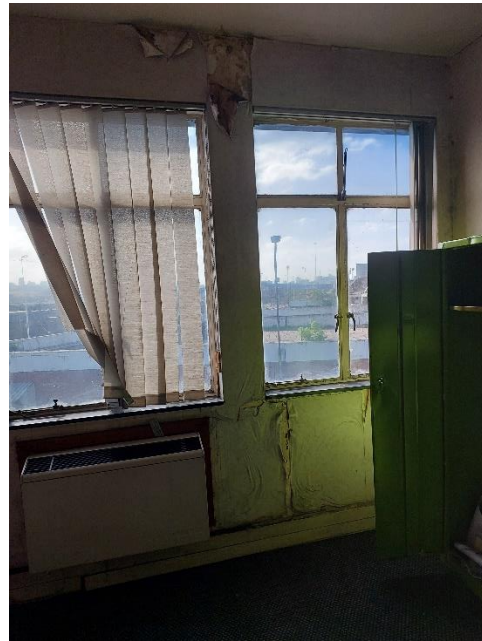
General aesthetics

The general aesthetics of the building is in a poor state especially in the upper floors, however there was not structural defects noted on the main structural elements.

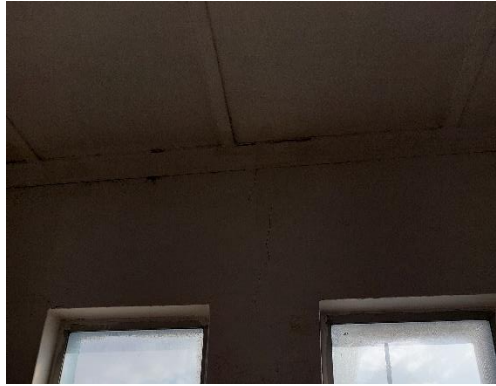
Observations	Photographic record
<p>Minor Cracking</p> <p>Minor plaster cracks were noted on the second floor northwest facing wall. The crack with in consistent with plaster crack and should pose no structural significance.</p>

- Cracking patched with suitable structural repair mortar,
- Partitioning brickwork be broken out and replace with new brickwork with stitching bars inserted to form a brickwork joint.

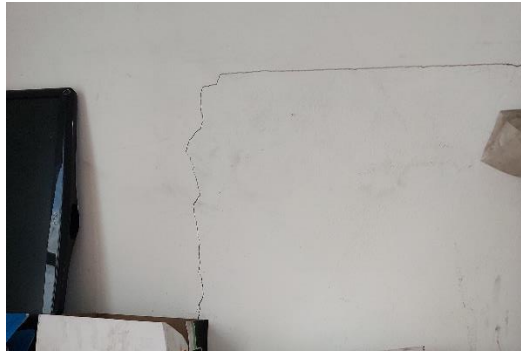
<p>Loose Brickwork</p> <p>There was loos brickwork noted on the partitioning wall between two office rooms on the second floor. The brick work was constructed to fill in an opening in the wall. Due to poor construction the brickwork shows signs of dislodging from the existing brickwork.</p>

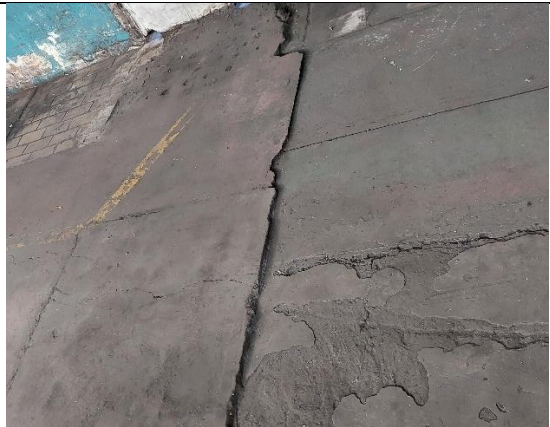
Observations	Photographic record
Warehouse surfacing It was noted that the warehouse surfacing is uneven. This could be a result of multiple layers of the surfacing constructed above the previous surface.

- Roof sheeting to be tested for leaks,
- Outer sheeting to be fixed and loose sheeting removed,
- Interior surface to be repaired and leveled,
- Eastern brickwork to be removed and rebuilt with new supporting beam.

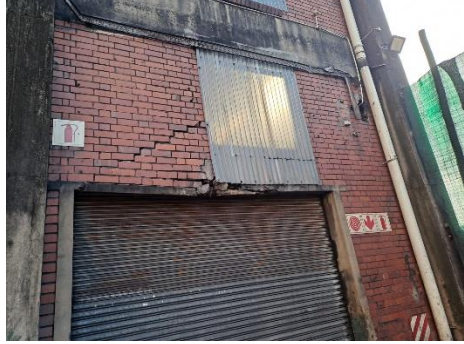
<p>Damaged brickwork</p> <p>It was noted that the brickwork and lintel on the eastern face of the workshop is damaged. The brickwork is completely detached and represents a safety hazard.</p>

The workshop structure is in good condition with the only serious damage noted on the brickwork on the eastern entrance of the structure. The remainder of the structure does not display any serious structural defects. The roof trusses are in good condition and does not display any notable corrosion. The roof sheeting has some holes visible from the inside of the building which may lead to leaks into the structure.

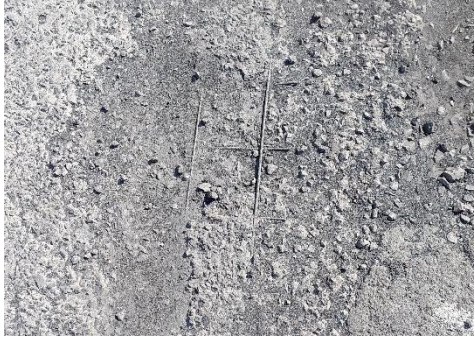
<p>Exposed reinforcement</p> <p>The mesh reinforcement on the surfacing is exposed in certain areas of the stacking yard. The exposed rebar is a safety hazard and exposed to accelerated corrosion.</p>

- Yard surfacing is reprofiled and resurfaced,
- Proper drainage and pollution measures are implemented to control runoff and contain pollution,
- Perimeter fence is repaired.

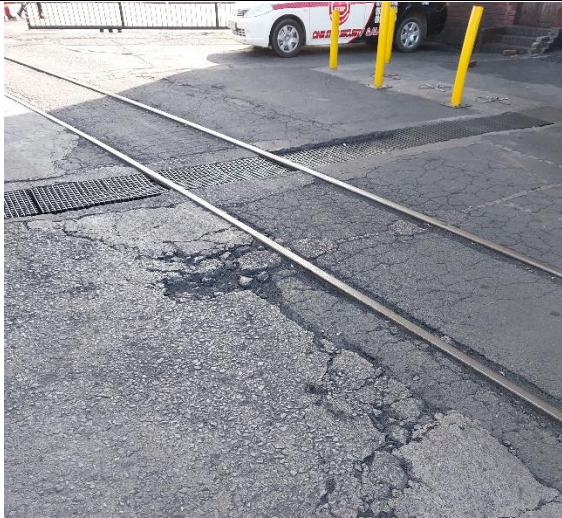
<p>Cracked surface and deformed grating</p> <p>It was noted that the surfacing in the yard has multiple potholes and cracks. This leads to an uneven surface and pooling of water.</p> <p>The grating used over the slot drains are also deformed and need to be strengthened.</p>

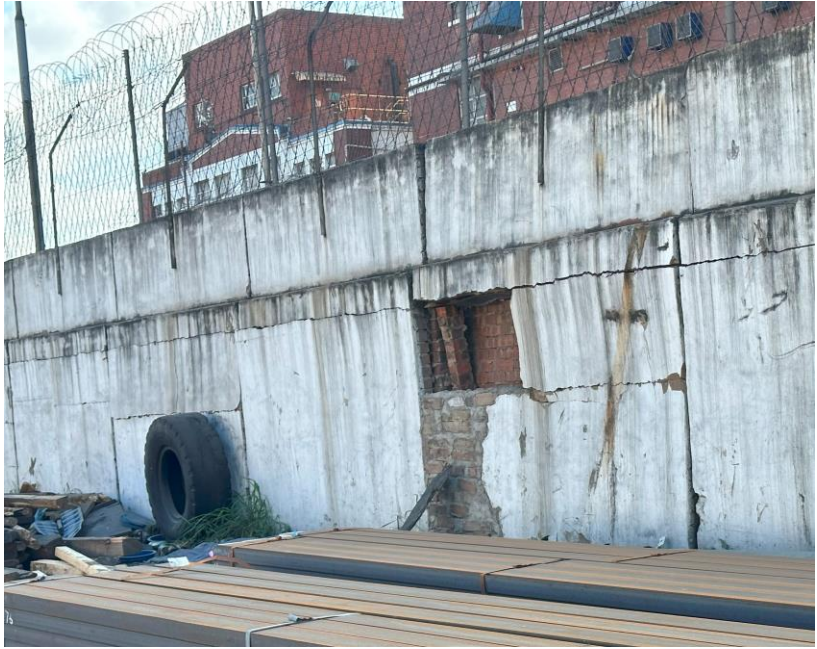
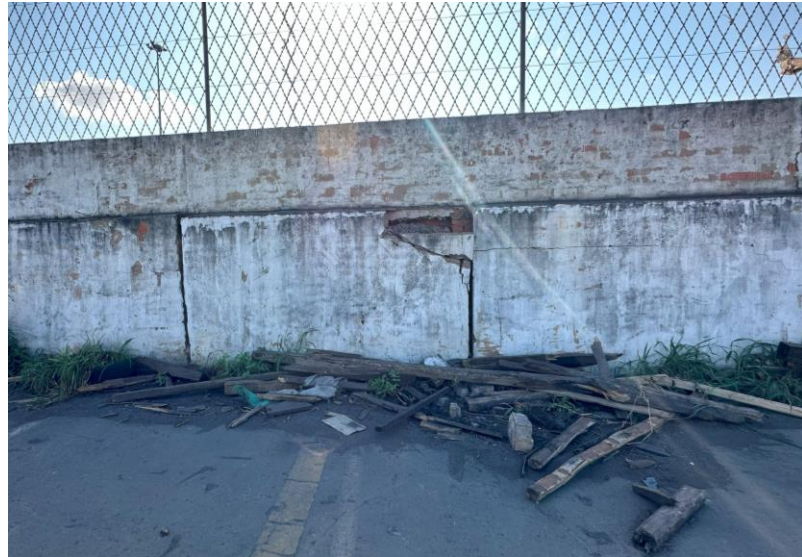
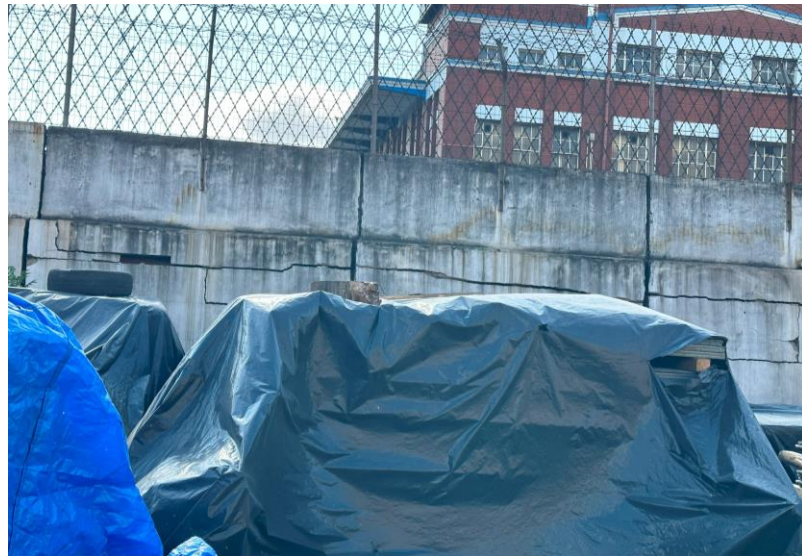
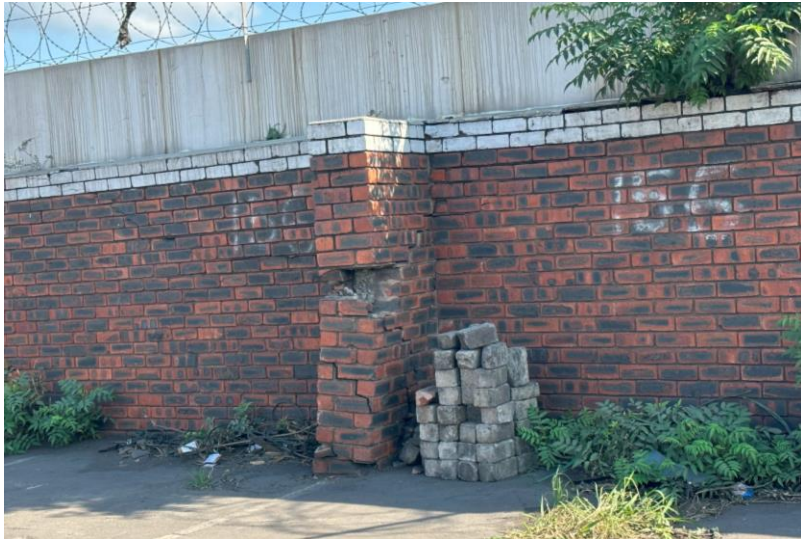
Element	Observations	Photographic records
Boundary Wall	Deep cracks on the wall were observed at various location. These cracks could be because of accidental damage from stacking of goods.

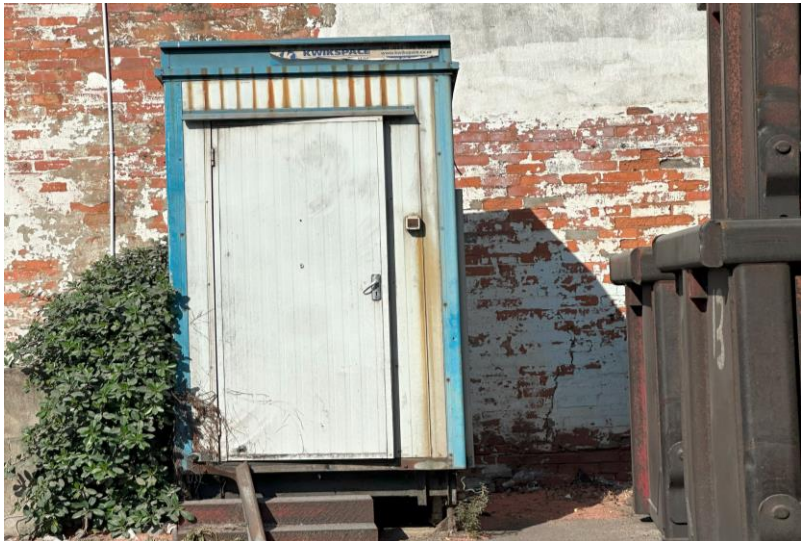
A photograph showing a corner of a brick wall. The wall is constructed from red and dark grey bricks. In the foreground, there is a stack of grey concrete blocks. To the left, a chain-link fence is visible behind the wall. Some green plants are growing at the base of the wall.
Ablution	There is a lack of proper ablution facilities on site. There is a temporary ablution facility present on site, but it is not stationed in a current position

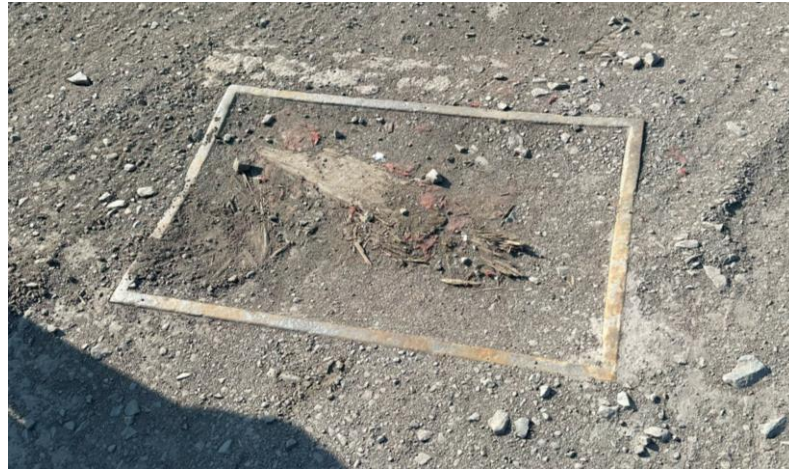
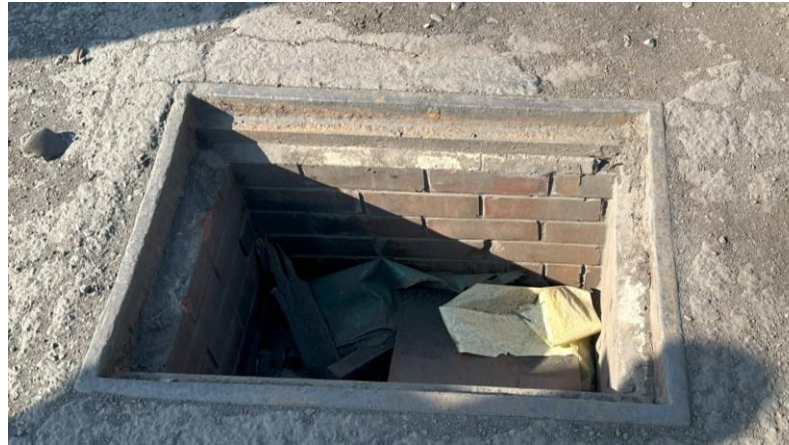
Surface	<p>Partially in good conditions with some sections that require resurfacing.</p>	 
Drainage	<p>The stormwater drains and manholes are blocked.</p> <p>The site does not show any visible signs of flooding, but the condition of the drainage infrastructure requires attention.</p>

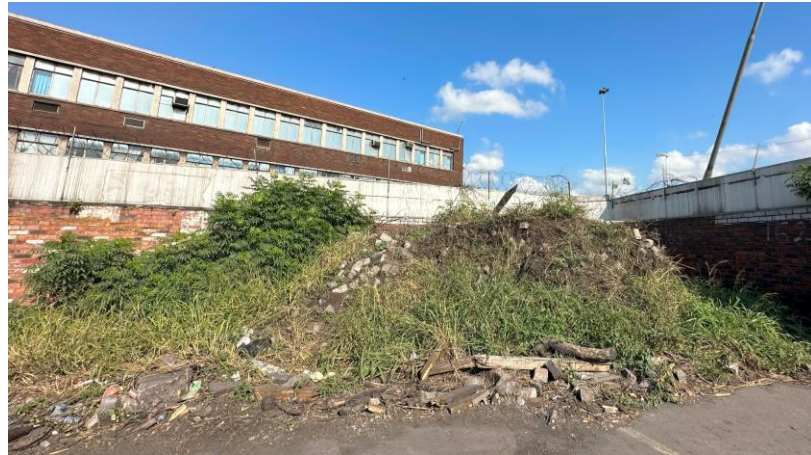
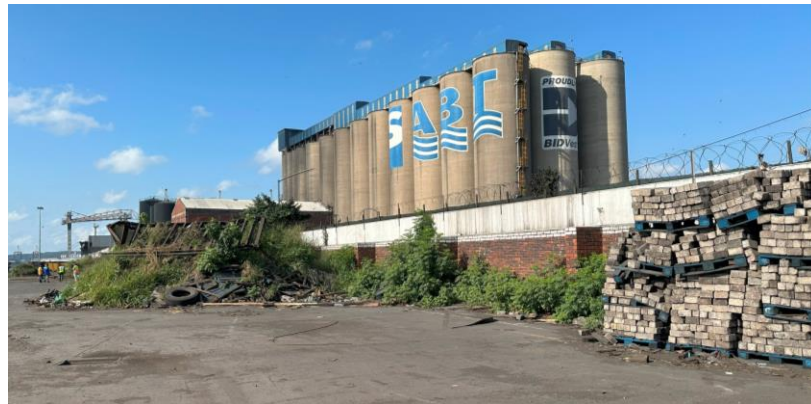
Housekeeping
/ other

There are mounds and stockpiles of rubble in different areas of the site. There is untidiness, disorder and poor storage of material cross the length of the site.
