**TRANSNET NATIONAL PORTS AUTHORITY  
CONDITIONAL ASSESSMENT REPORT  
ELECTRICAL REPORT**

**SITE:** EXPRESS WAREHOUSE, MAYDON WHARF, DURBAN  
**COMPILED:** TNPA PORT ENGINEERING DEPARTMENT  
**DATE:** JUNE 2023

**SITE:** DG WAREHOUSE, MAYDON WHARF, DURBAN  
**COMPILED:** TNPA PORT ENGINEERING DEPARTMENT  
**DATE:** 23/06/2023

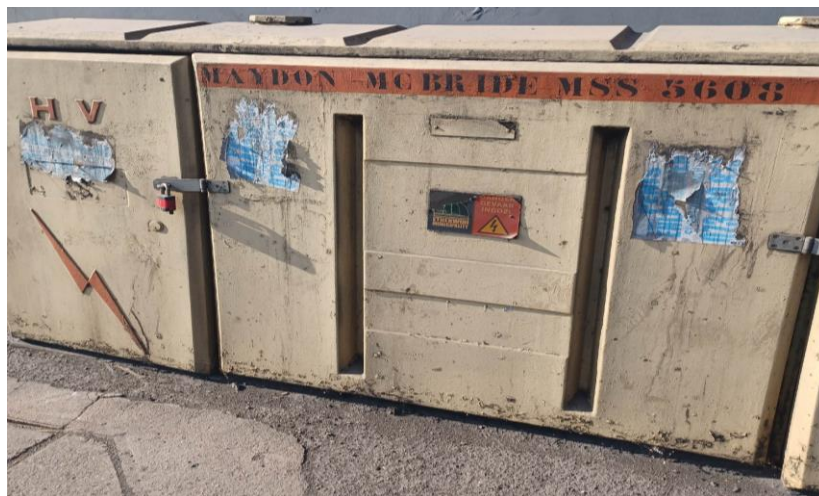
The facility receives its electrical power from eThekweni Municipality via a mini substation on Maydon Road adjacent to the admin building. The kVA rating of the mini substation could not be determined however the voltage ration is 11kV/400V 50Hz.

**Figure 1:** Main Municipality Supply mini substation

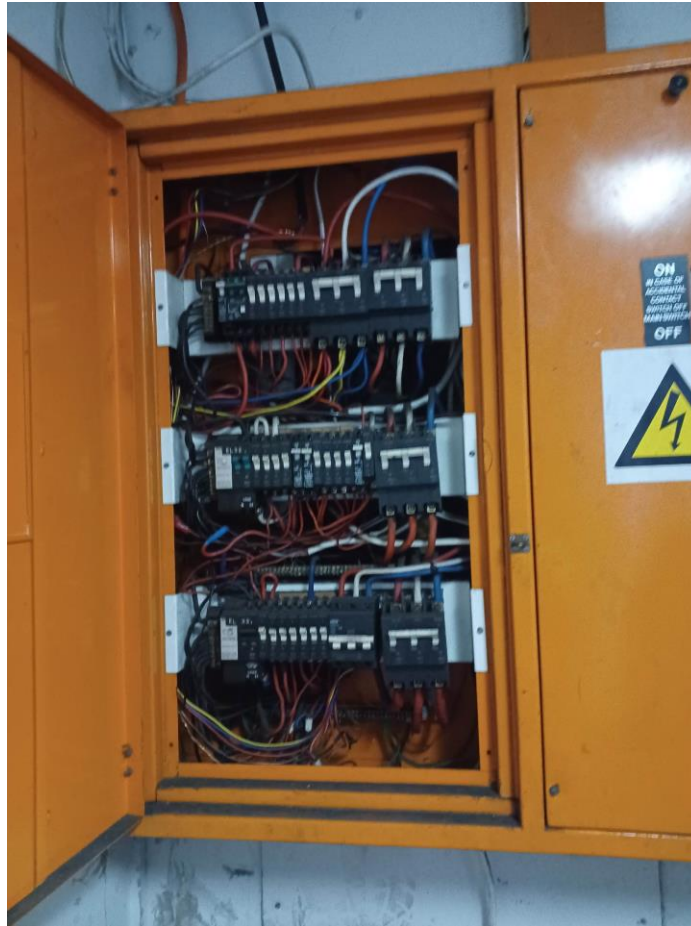
maintained in these two floors. The electrical installation on the 2<sup>nd</sup> floor which is not occupied needs some attention, in some offices lights and socket outlets have either been removed or stripped. There are numerous distribution boards (DB) that exist in the admin building and each floor has its own main 3 phase DB. The condition of the DBs in the first and second floor is good all circuits are clearly labelled and covers, and doors are in place however, the main isolator on the DB on the 3<sup>rd</sup> floor is switched off due to the floor not being occupied. On the ground floor the main 3 phase DB doesn't have a cover the conductors and live bars are exposed needs attention as shown on the figure below.

**Figure 2:** Main DB on the Ground Floors with no cover.

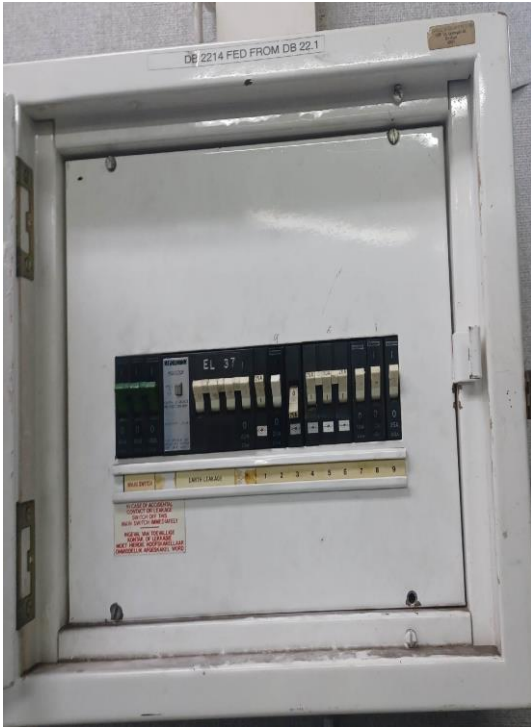
- 1 x single lever switch working.
- 2 x fluorescent light fittings both working.
- 1 x double lever switch working.
- 20-way single phase DB in good condition and properly labelled C.O.C to be shared with TNPA.

**Figure 3:** Ground Floor Passage DB in good condition.

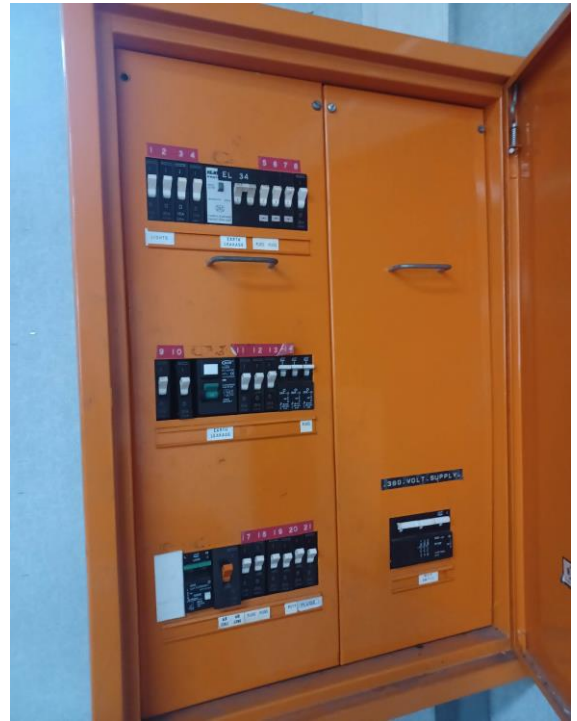
**Figure 4:** Ground Floor DB in good condition.

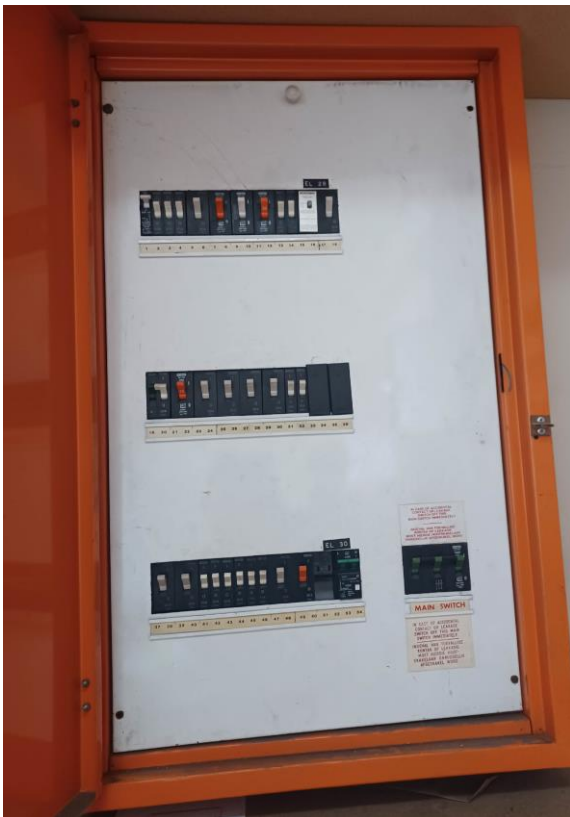
**Figure 5:** First Floor DB in good condition.

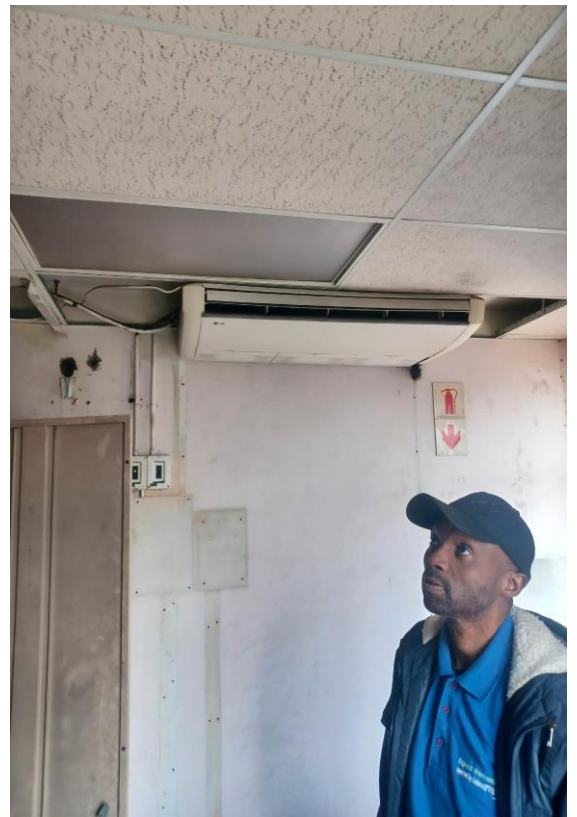
**Figure 6:** 3<sup>rd</sup> floor AC isolator disconnected.

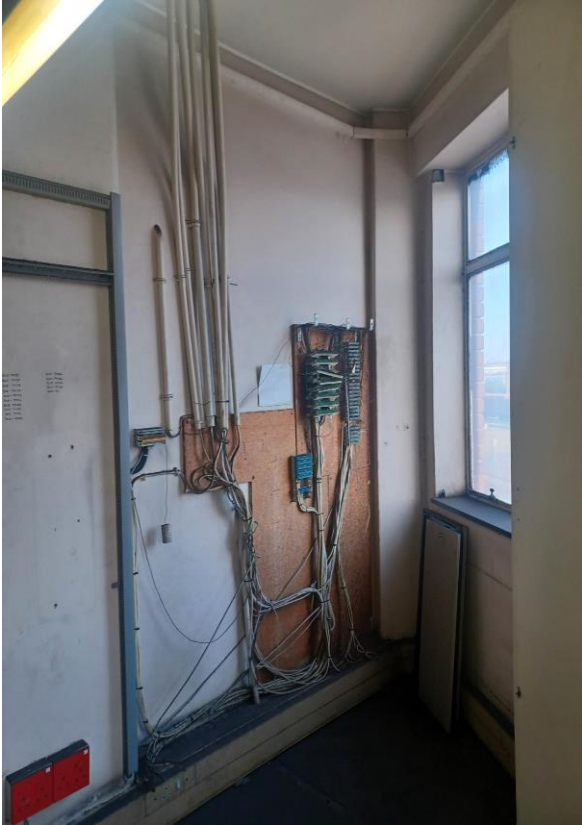
**Figure 7:** 3<sup>rd</sup> Comms Cables Not Housed Properly.

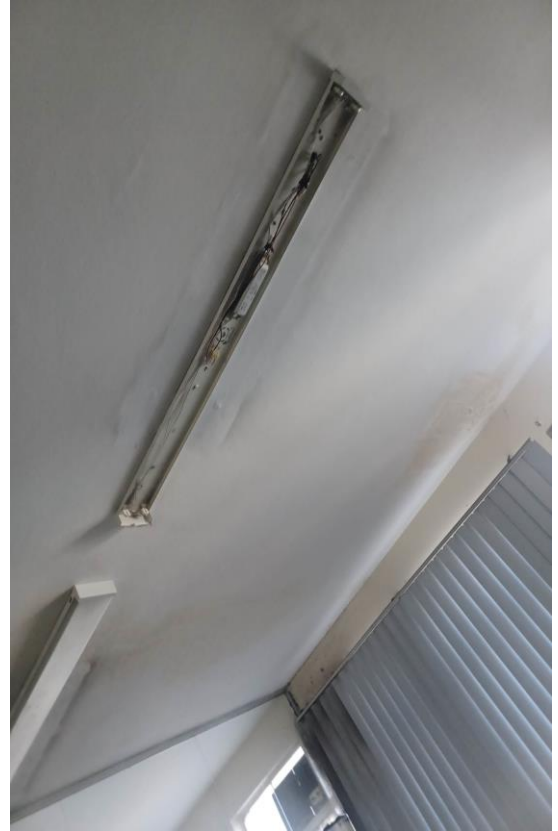
**Figure 6:** Light needs re-lamping.

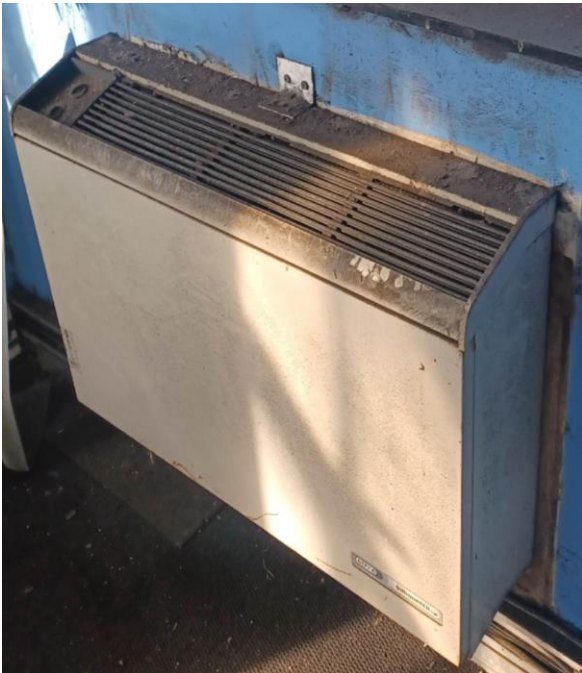
**Figure 7:** Condition of an AC unit on the 3<sup>rd</sup> floor.

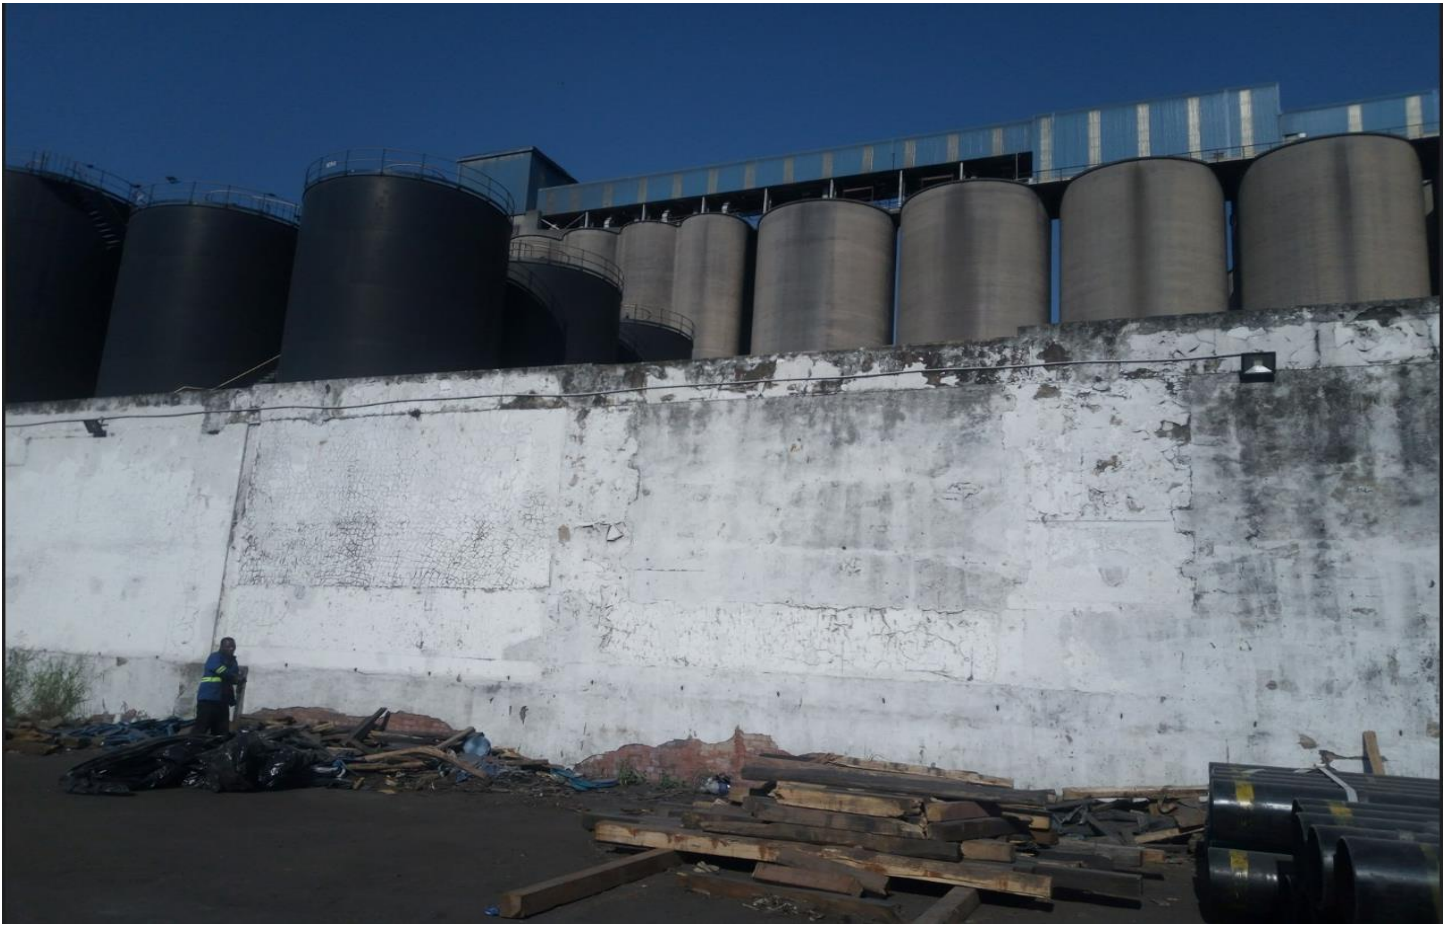
Existing temporal lighting of 11 LED flood lights mounted on the wall are fed from portable generator only when required at night not every day.

**Figure 1: Flood lights mounted on the wall**

When the site changes its operations and require lights, they can request from TNPA.

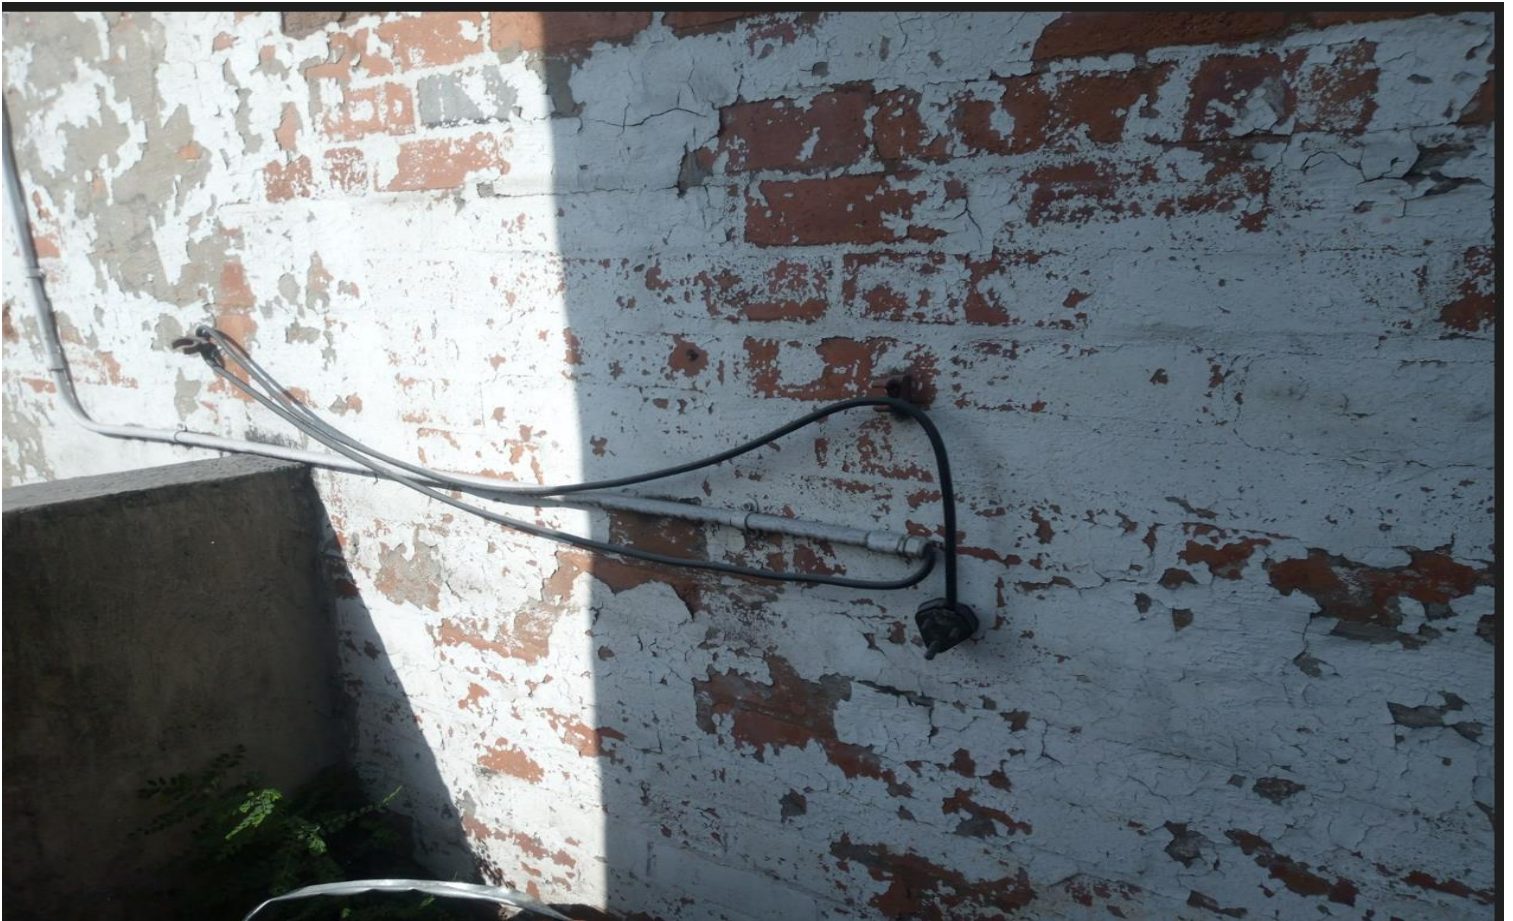
**Figure 2: Plug Top where portable generator normally connect to flood lights**

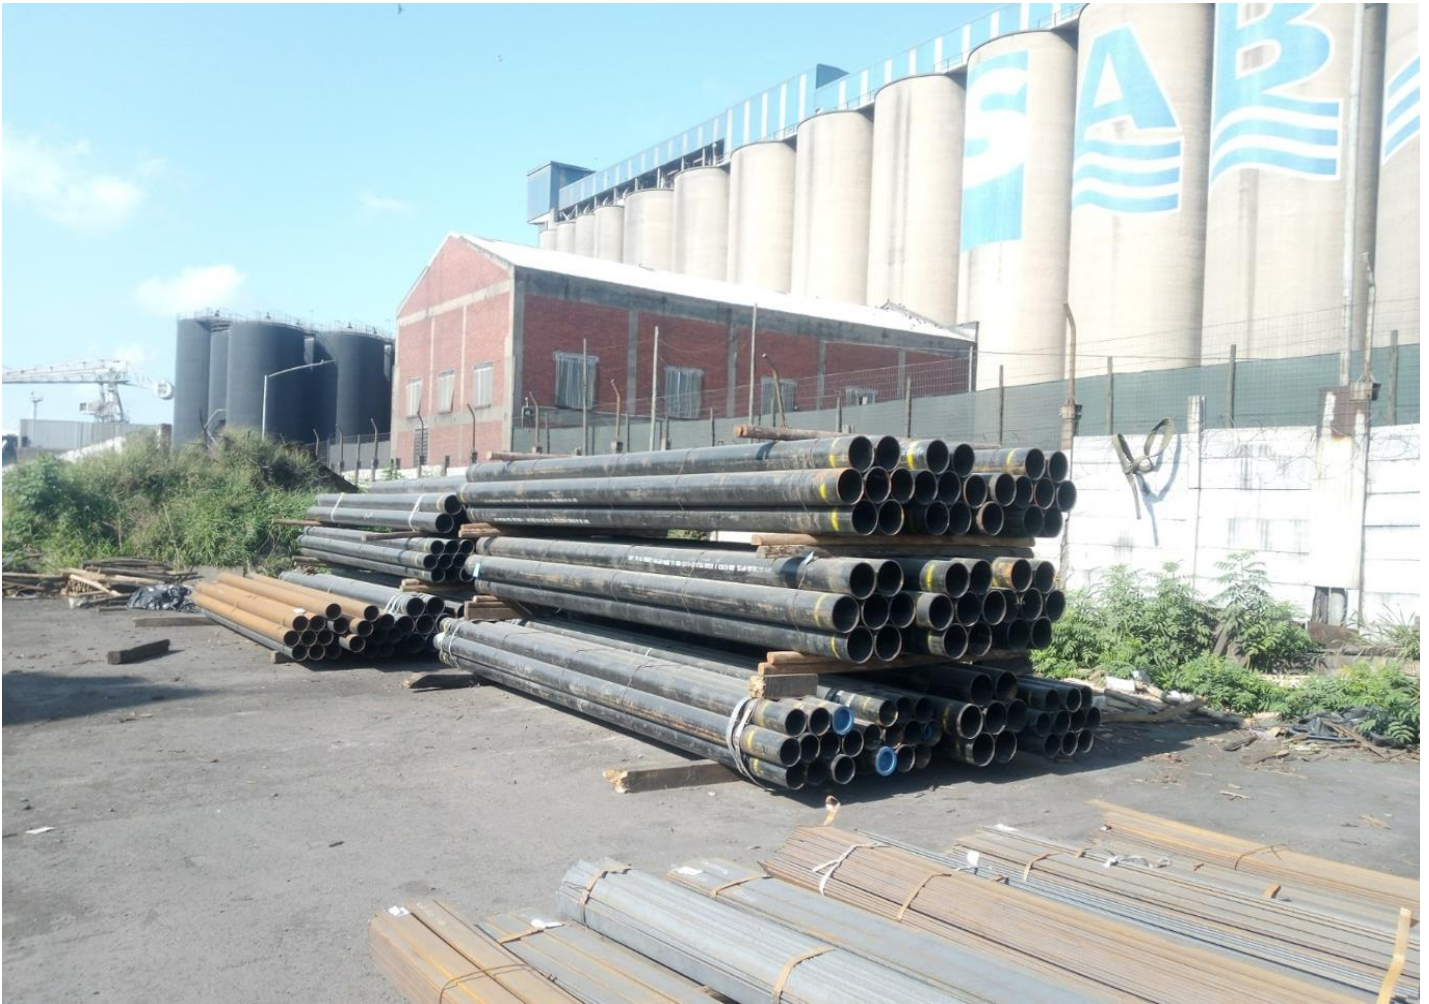
**Figure 3: The area is used for outdoor stacking of dry cargo**

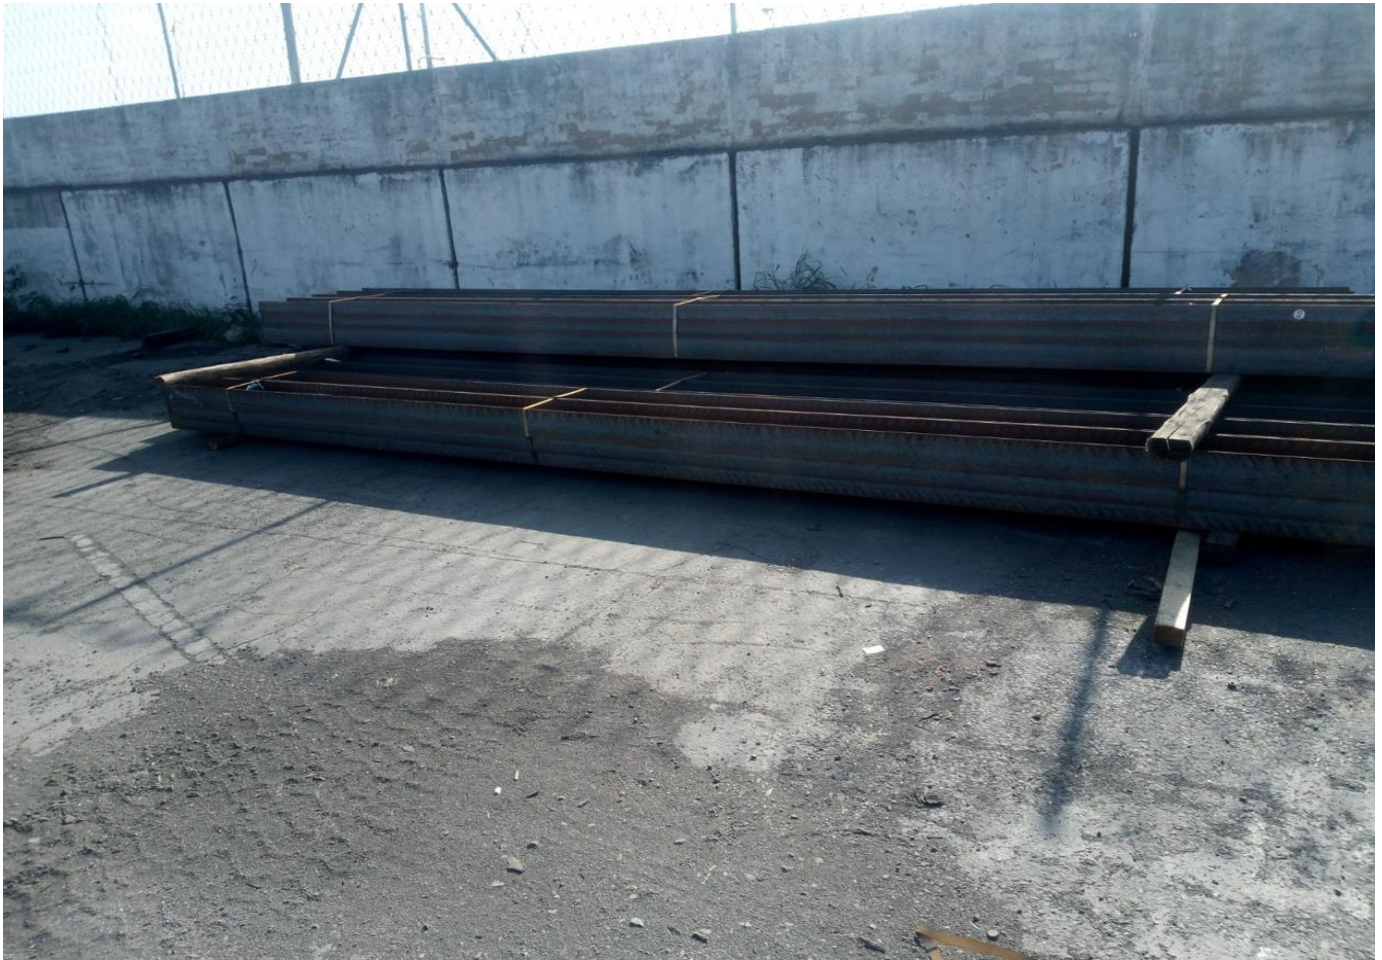
**Figure 4: The area is used for outdoor stacking of dry cargo**
