TPT FUEL FACILITY GAP ANALYSIS

DCT PIER 2 TPT DIESEL DEPOT

PURPOSE: MAINTENANCE AND HOUSEKEEPING

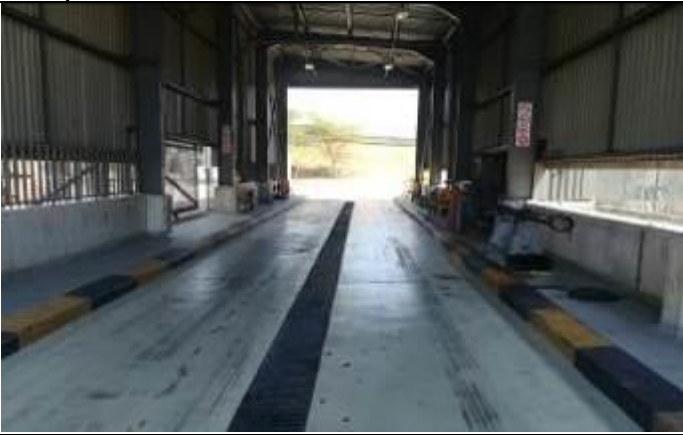
The site has not been upgraded lately. The tanks are in fairly good condition. There are signs of rust forming. It is still early stages if not attended to could cause major damage. The upgrade was only done to the tanks as they were in a very bad condition and was about to rupture. The kerb side pumps need attention. The canopy has a major dent in it and requires repairs. There are rust build up due to neglect. No major maintenance has been done on the site in the last 2 years. Repairs are done if something breaks.

Some rust starting to form

1. Calibration of the pumps and flowmeters
2. Calibration of the pressure gauges
3. New tank strapping done
4. Tank refurbishments. (Good practice at the ports is every 2 years this in return keeps the maintenance cost down on tank maintenance and increases the life of the tanks).
5. The spill drains are blocked these need to be unblocked and kept clean
6. Repair the fuel line where the leaks are taking place.
7. Replace all flange gaskets
8. Pressure test the lines and tanks

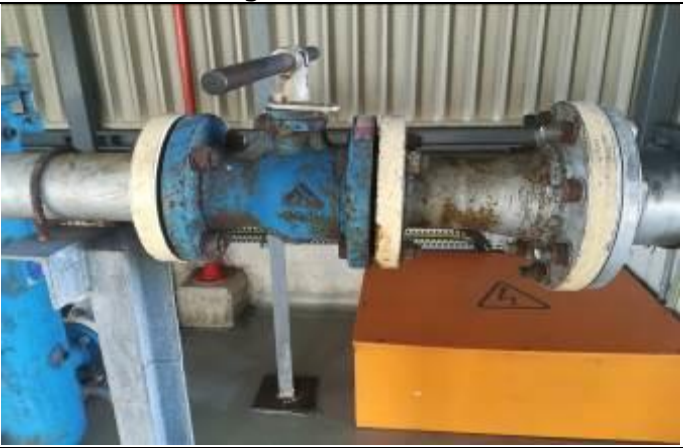
Valves need attention

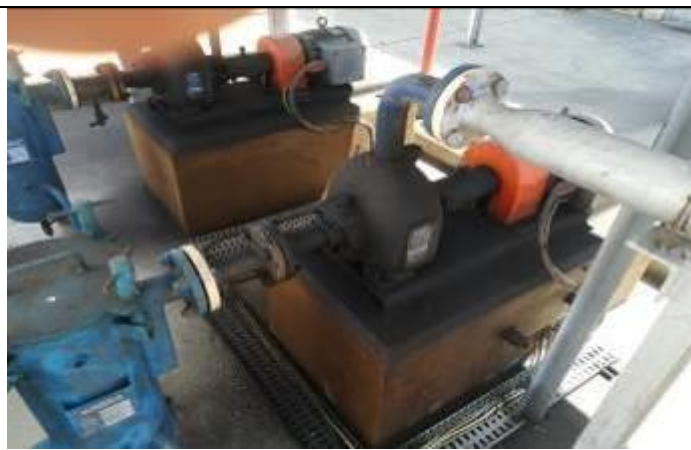
The pump sets need to be serviced as it is visible that they are extremely strained as some have small leaks others have excessive sweat. Due to lack of housekeeping the site looks worse than what it really is. There is a firefighting

Pump sets need service

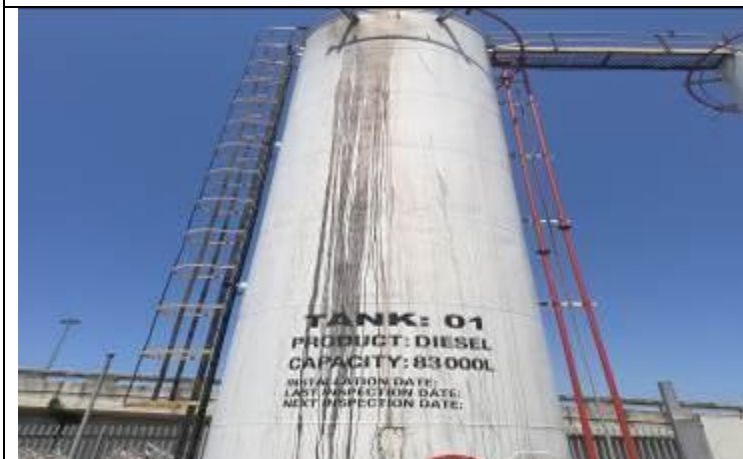
Tank 1 visible spillage

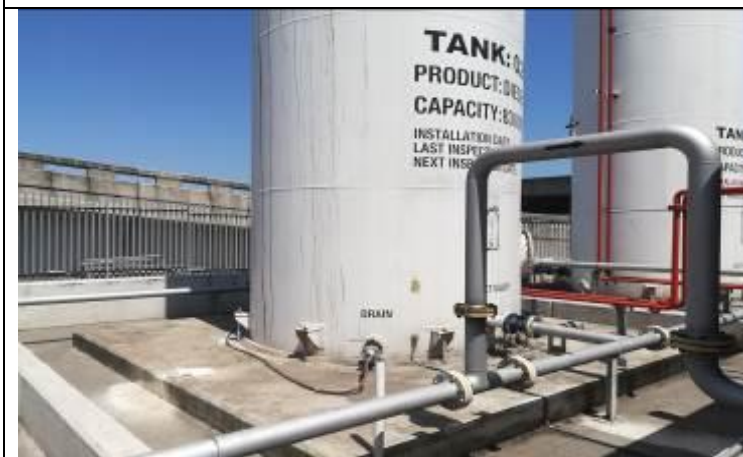
Tank 2 spillage

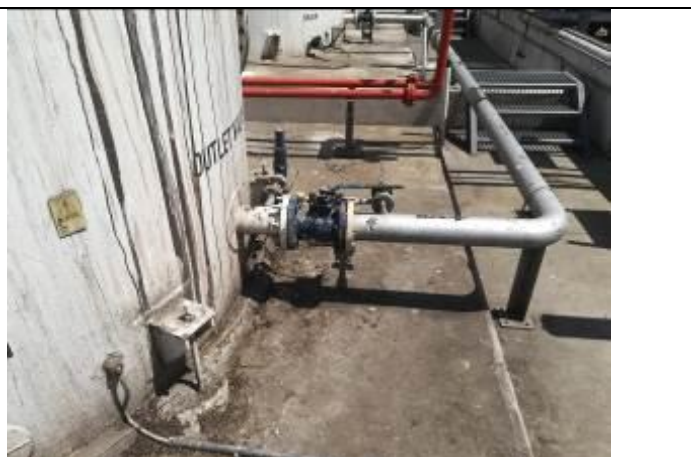
Condition of valves on the tanks

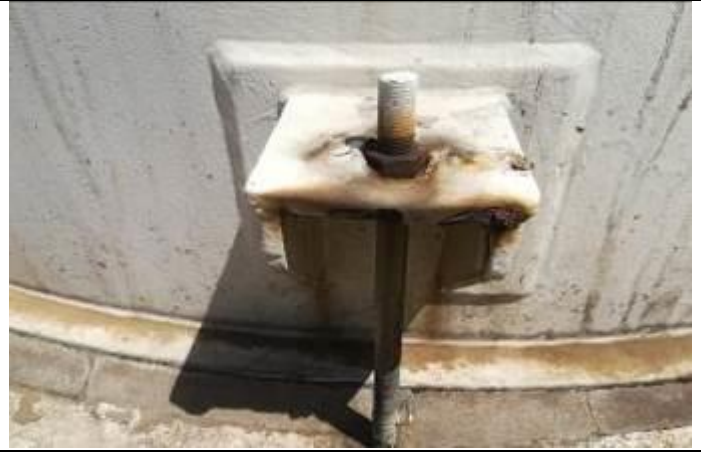
Rusted tank anchor

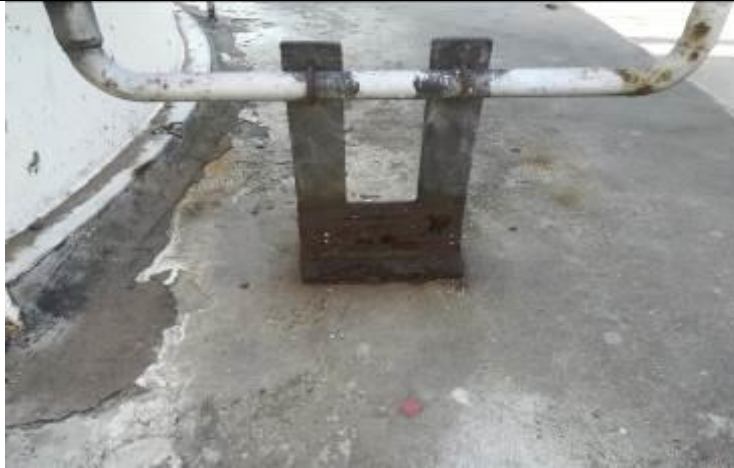
Rusted thermal relief plinth

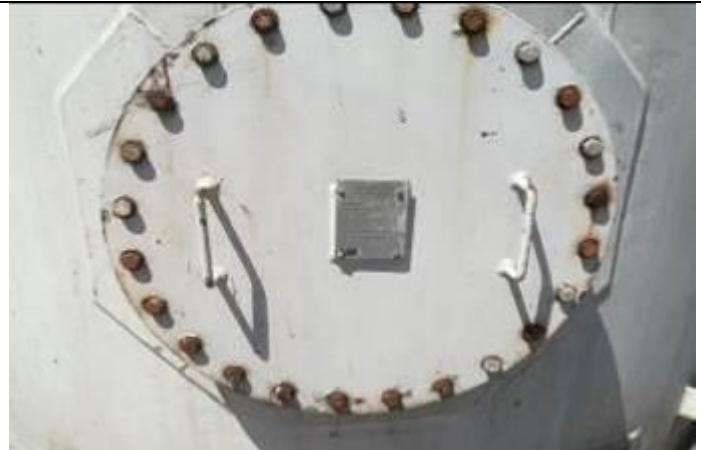
Rusted manhole bolts

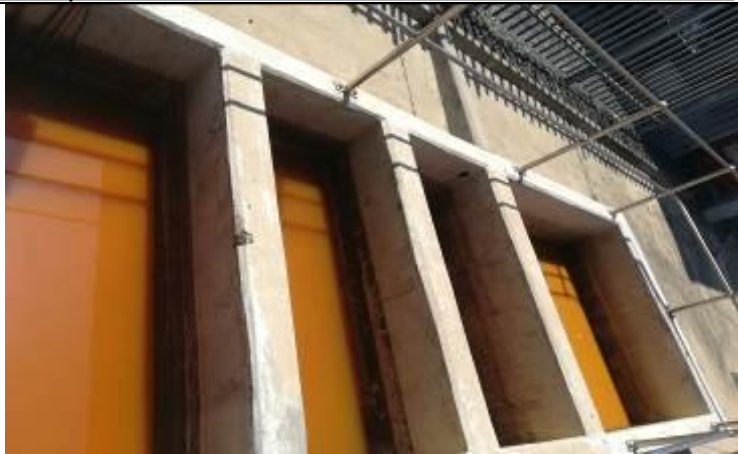
The oil separator pit needs constant draining and staff need to be trained at monitoring this unit. In the event of overfilling the oil separator the run off can go into the ocean.

Oil separator pit needs clean up

The oil separator needs to be upgraded to a closed system. This system separates the oil and water faster than the current installed system. The water is then clean enough to be sent to storm water. The water may need to be tested before discharging into storm drains.

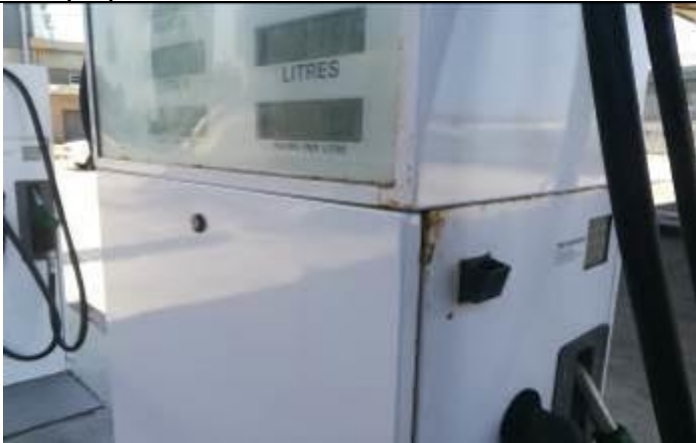
Rust forming on pumps

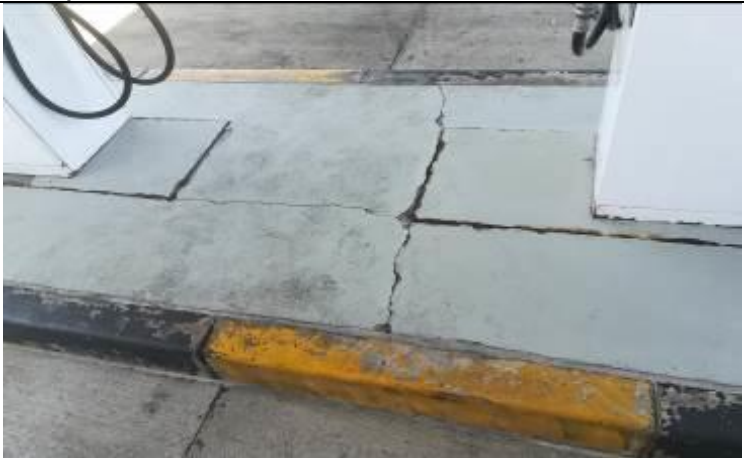
The pump islands are cracking badly, this could be related to the heavy vehicles fueling. The new islands must be specked to accommodate these bigger heavier vehicles. The tanks over filling is due to faulty ATG probes in the tanks. The current system is very old and outdated it is basically a legacy system that would not be able to service the current demand.

Pump islands badly cracked

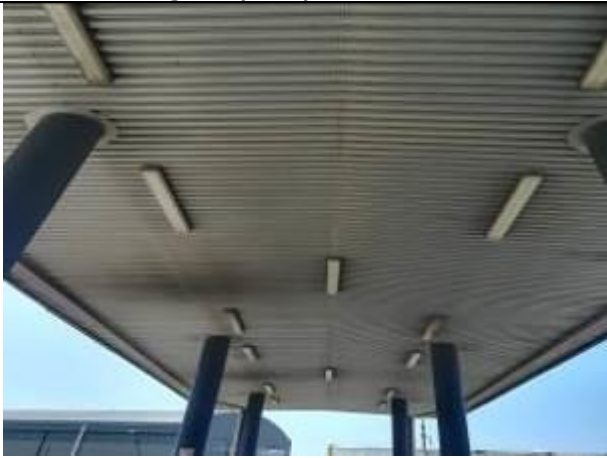
Forecourt canopy rusting

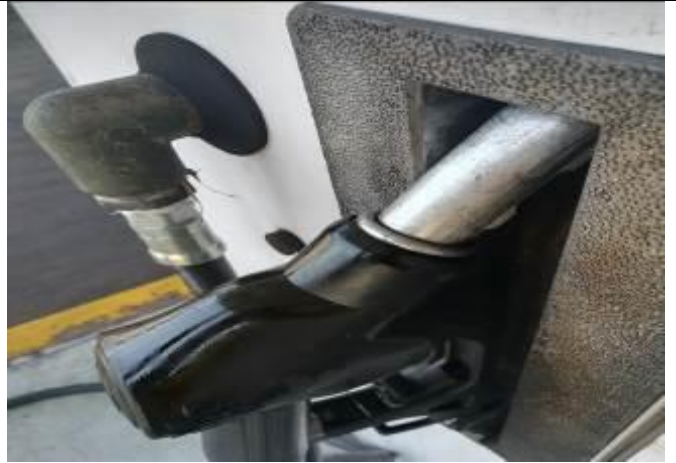
Nozzle leaking needs repairs

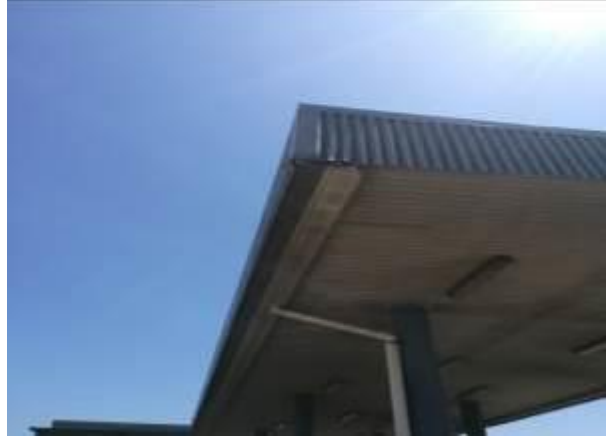
Condition of canopy

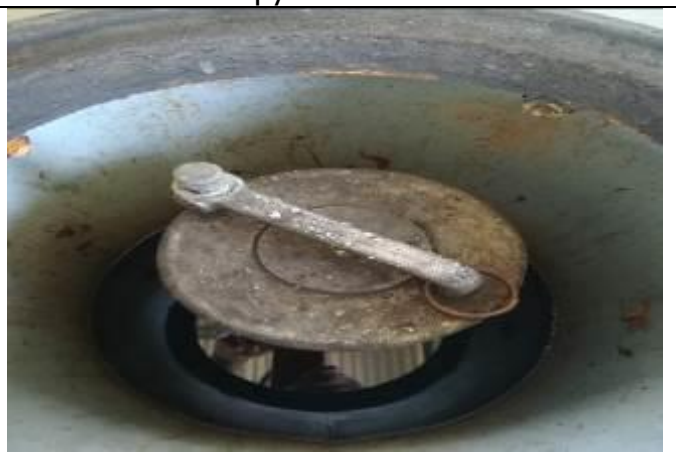
The pumps and flowmeters have not been calibrated in the last year. I found diesel in the receiving hatch for diesel. A pressure test would need to be done to identify a leak. This is a high volume site and a lot more emphasis has to be made on scheduled maintenance and housekeeping.

Diesel in the receiving line (Leaks)
