**PRELIMINARY CONDITION ASSESSMENT
FOR FUEL STORAGE TANKS – PHASE 1**

TPT SITE VISIT REPORT COMPLETED IN AUGUST 2022

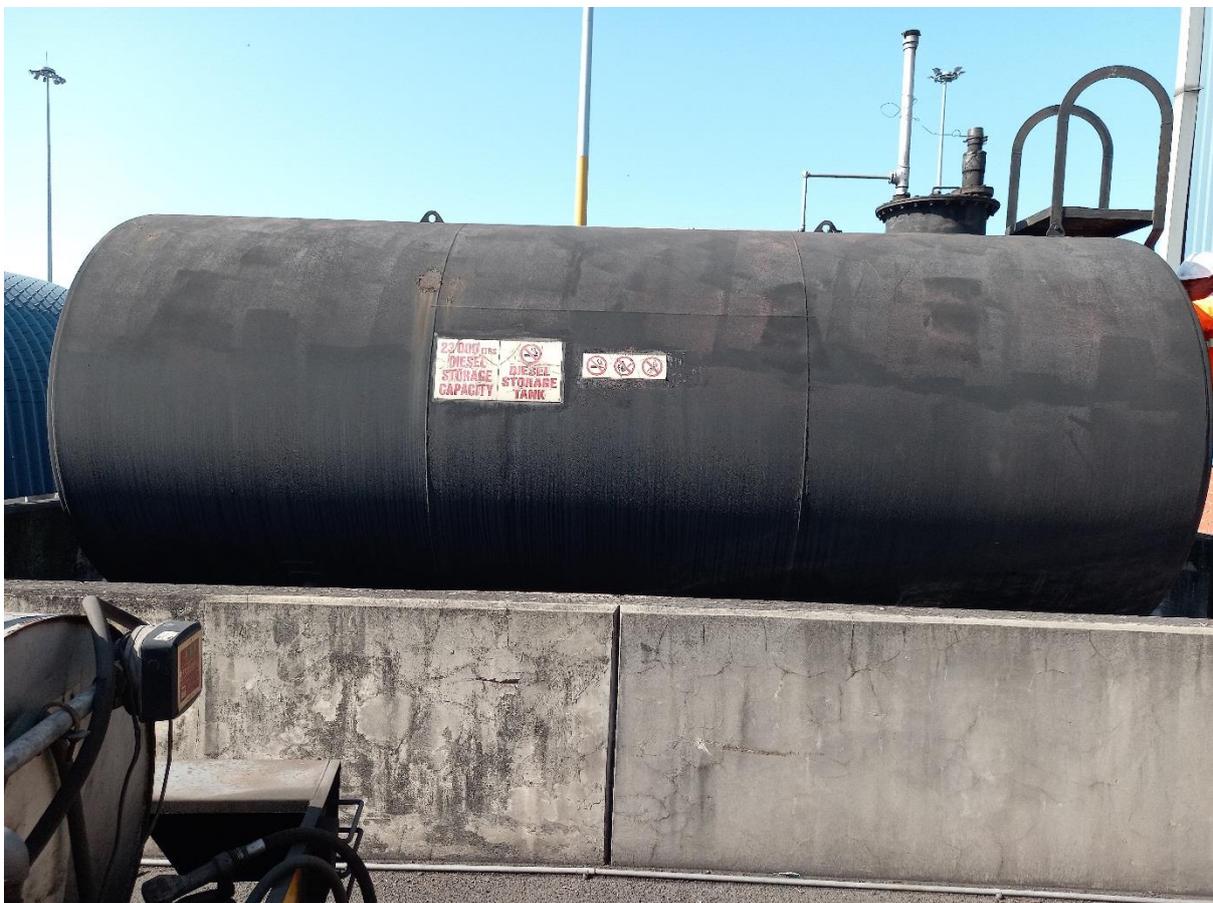
Photograph of the Tank inside the Bund on site

- One horizontal tank with 23 000 L capacity.
- Tanks has flat ends.
- Corrosion is severe on the Tank at various places.
- Coating / Painting is in a poor condition.

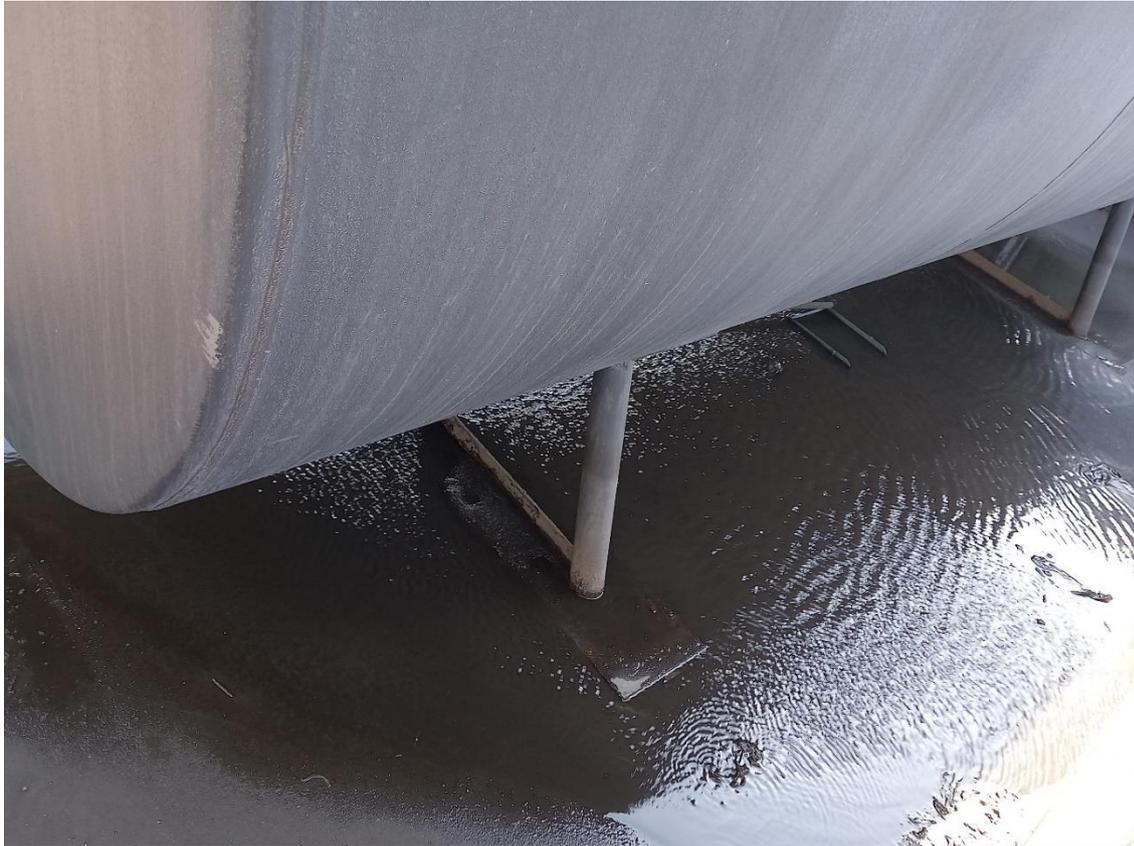
- Base Plate of the support is in the oily storm water and is rusting heavily.
- Tank manufactured by Forgeweld Engineering (PTY) LTD.
- Gaskets needs to be replaced.
- Level Gauge needs to be installed, as currently level is checked by dip stick.

Base plate and supports are getting corroded in the storm water

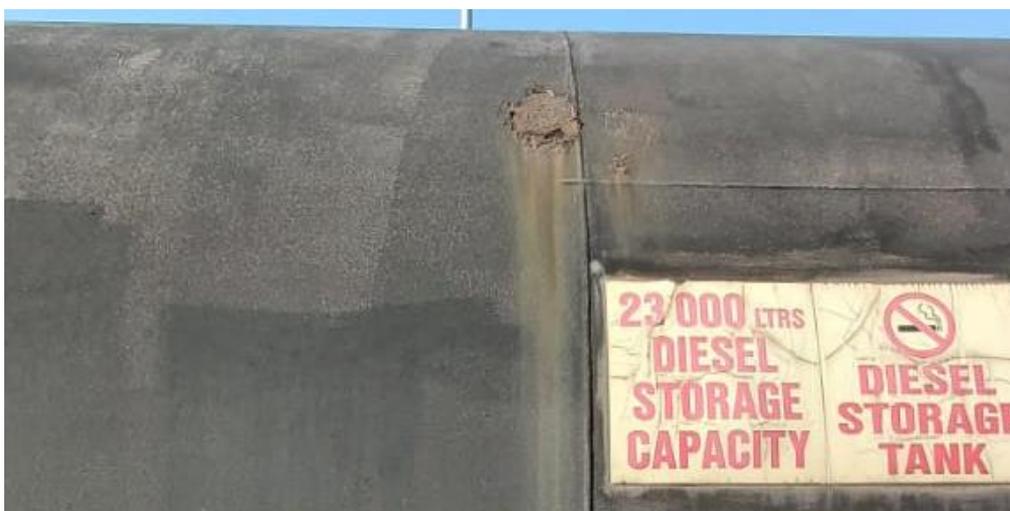
Photo of a corrosion on the Tank

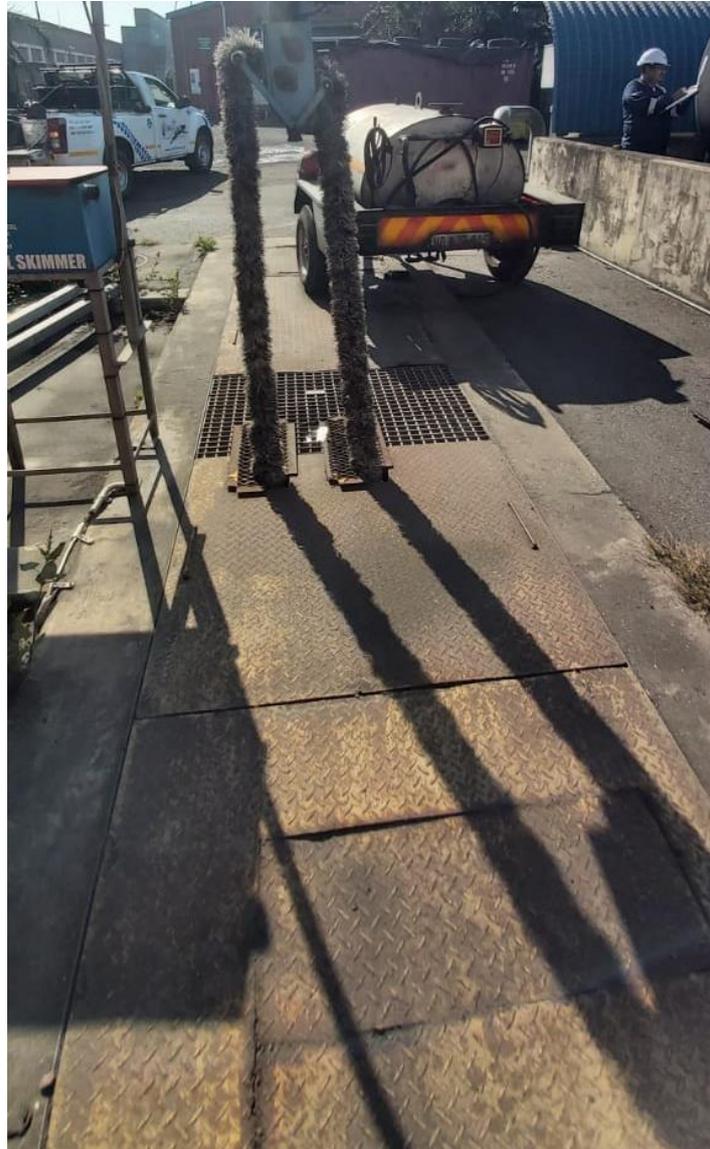
- Oil Skimmer and underground Oil spillage drain was not in a working condition.

- Cover was rusted severely at some locations.

Photo of Rusted Oil Drain Cover

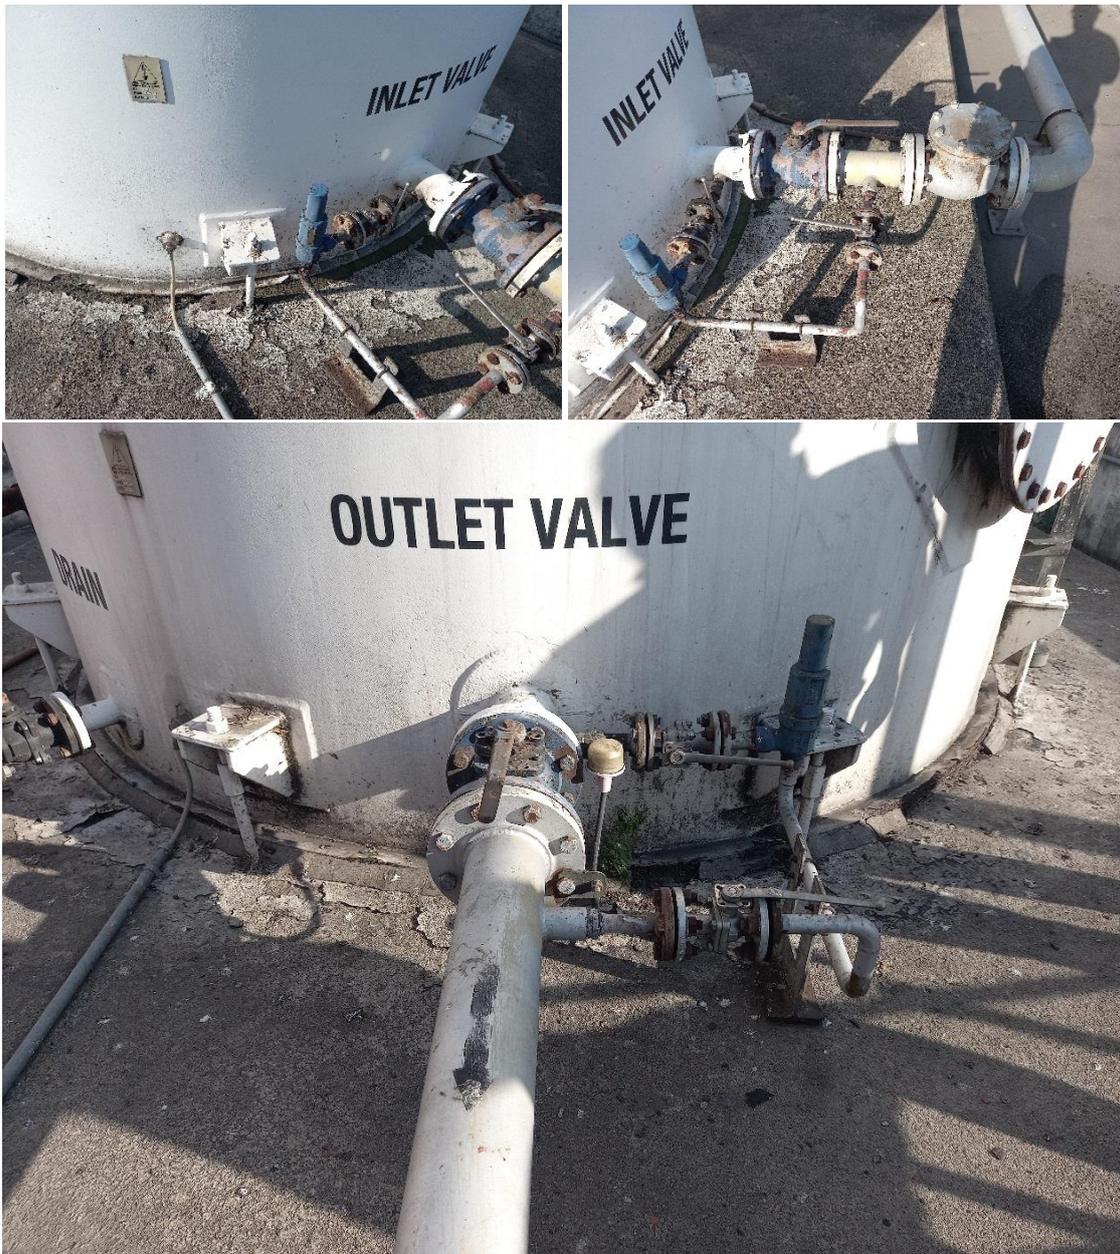
- Annual Ring corrosion protection: Denso wrapping was peeled off and the annular to shell joint is exposed severely to the corrosion. This is the most critical joint of the Tank, which can cause a rupture of a Tank, if corroded severely.
- No overfill protection found.

Annular ring is severely corroded along with piping and valves attached to it

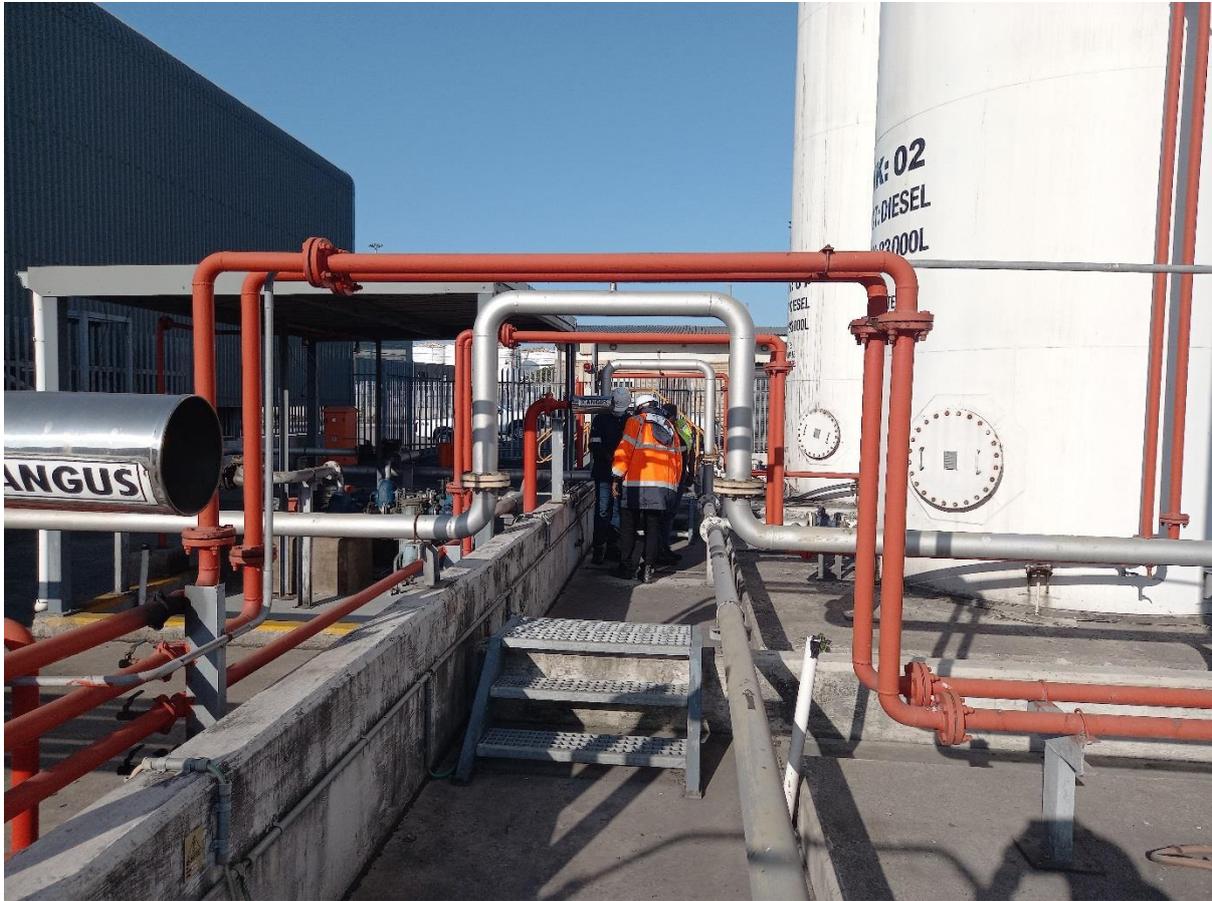
- Piping was corroded at various locations.

Piping around the Tank and Bunded Area

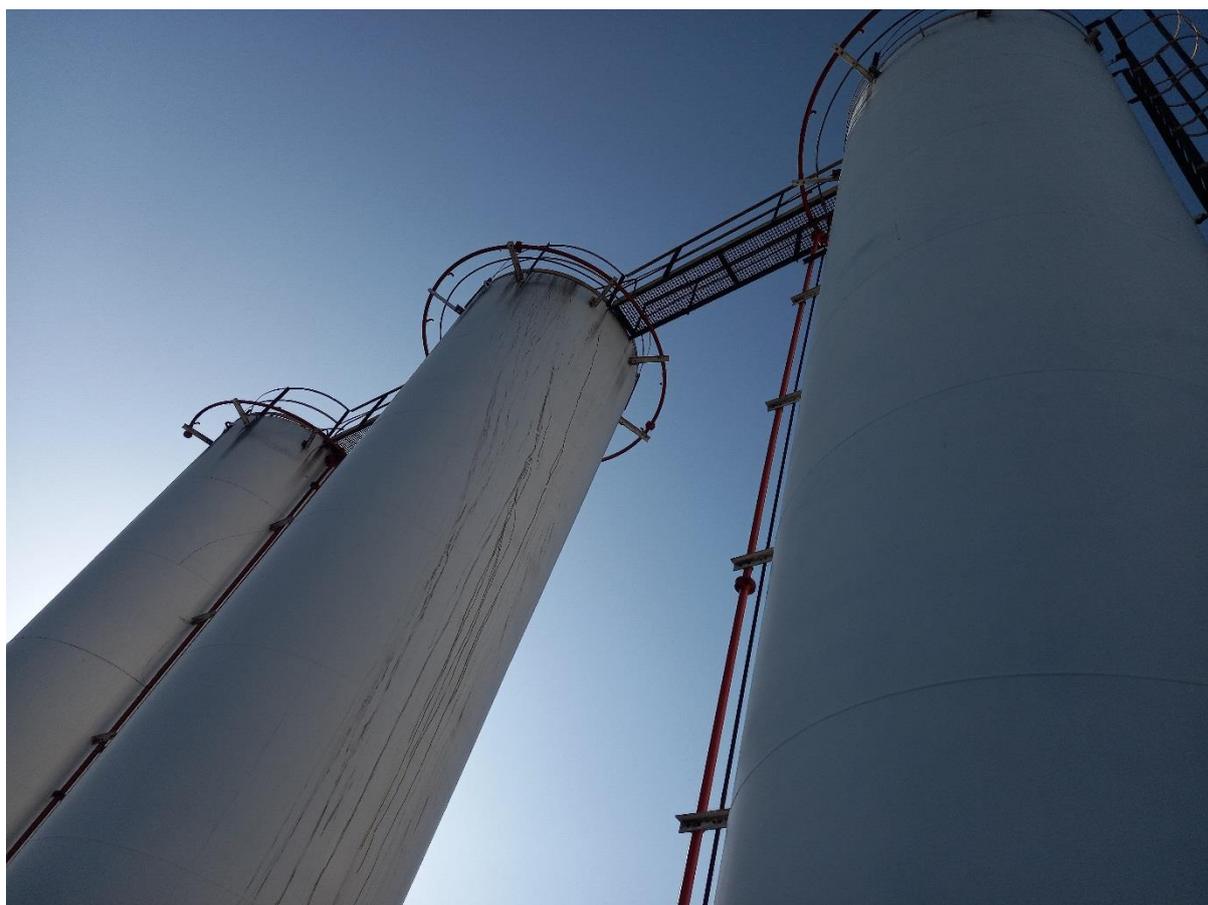
- Instruments needs to be tested.
- Overfill system is not working.

Stain on the Tank indicates that overfill system is not working

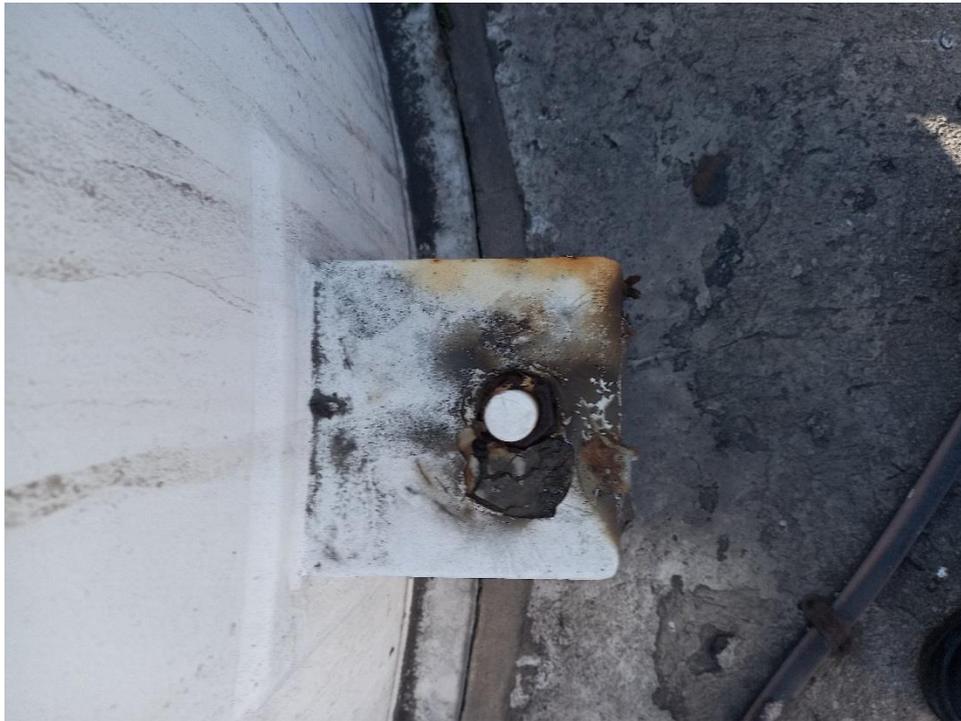
Tank Anchor Chair is severely corroded

- Tank Anchor chair is severely corroded and may fail if any action is not taken immediately. This will cause overturning moment of the Tank if there are heavy winds.
- Bund walls are cracked.
- Distance from Bund wall to Tank does not comply.
- Sump Tank for water drain needs to be recoated.

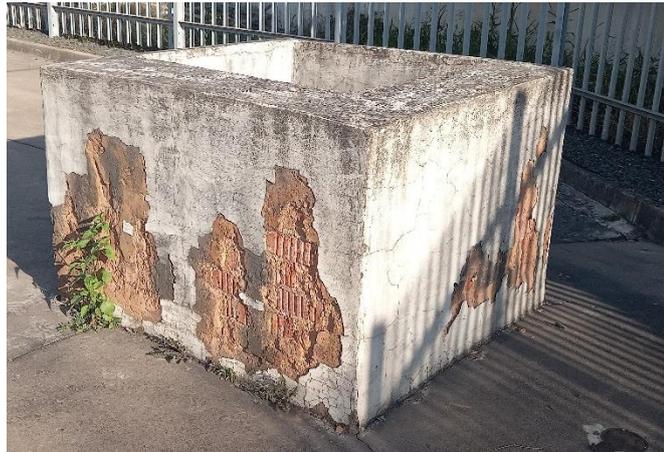
Sump Tank to be coated

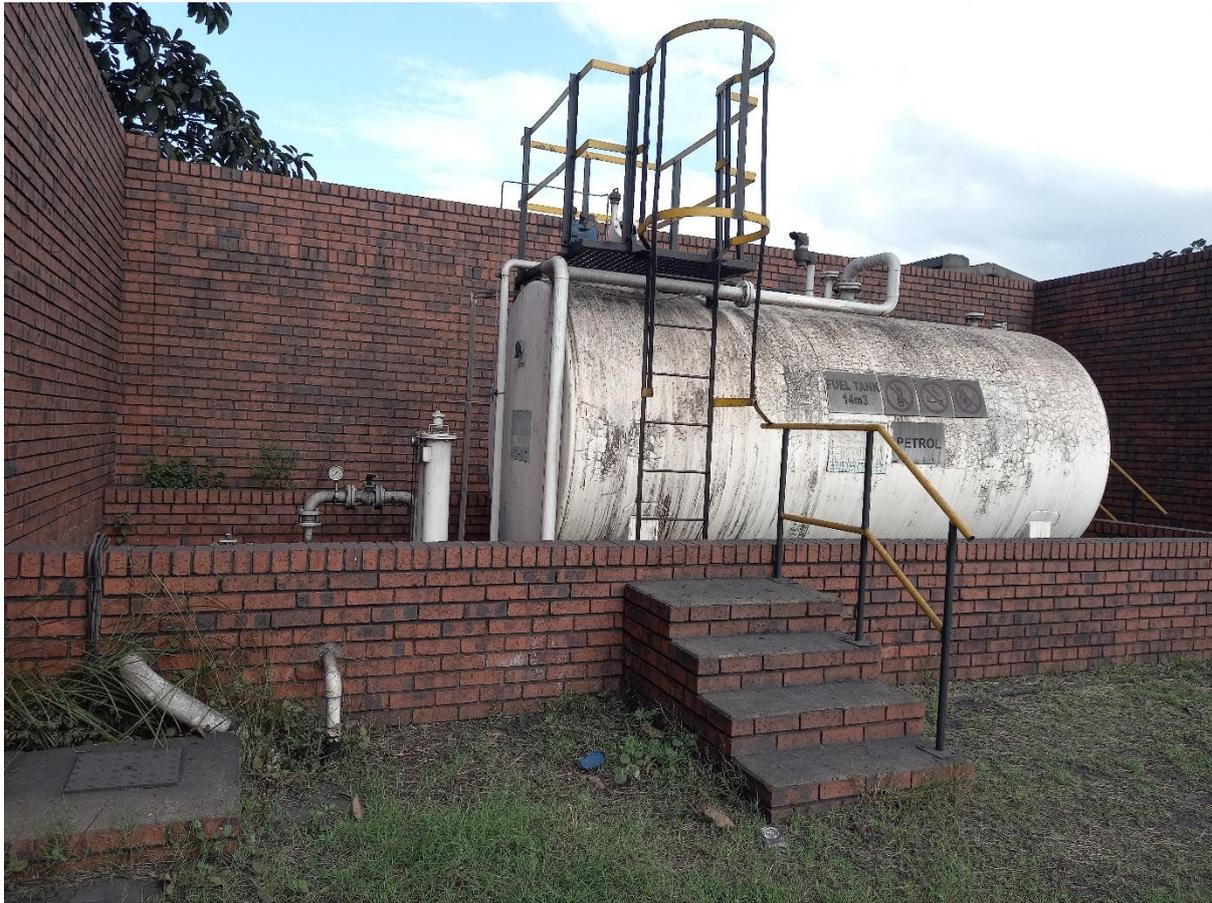
- Two horizontal aboveground Tanks were found on site including piping and other accessories, in which one Tank was for Petrol and one for diesel. The petrol Tank was decommissioned and was not in use.
- Diesel capacity was 60 000 L with size 2.9 m diameter and 9 m long.
- Tank is Manufacturer is unknown.
- Paint/ coating is severely cracked and urgently needs to be re-coated.
- Tank was just mounted on the saddles without any welding, which does not comply any code requirement.

Photo of a Petrol Tank to be demolished along with piping and the bund area

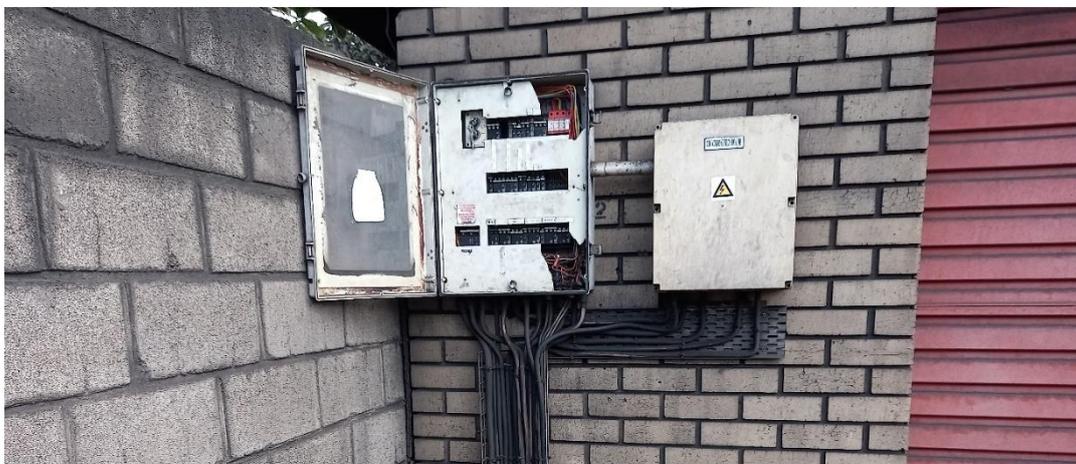
- Wiring is exposed at several locations and DP needs to be reinstalled.
- Earthing cables needs to be organized.

Photo of Electrical cables and the Distribution Board

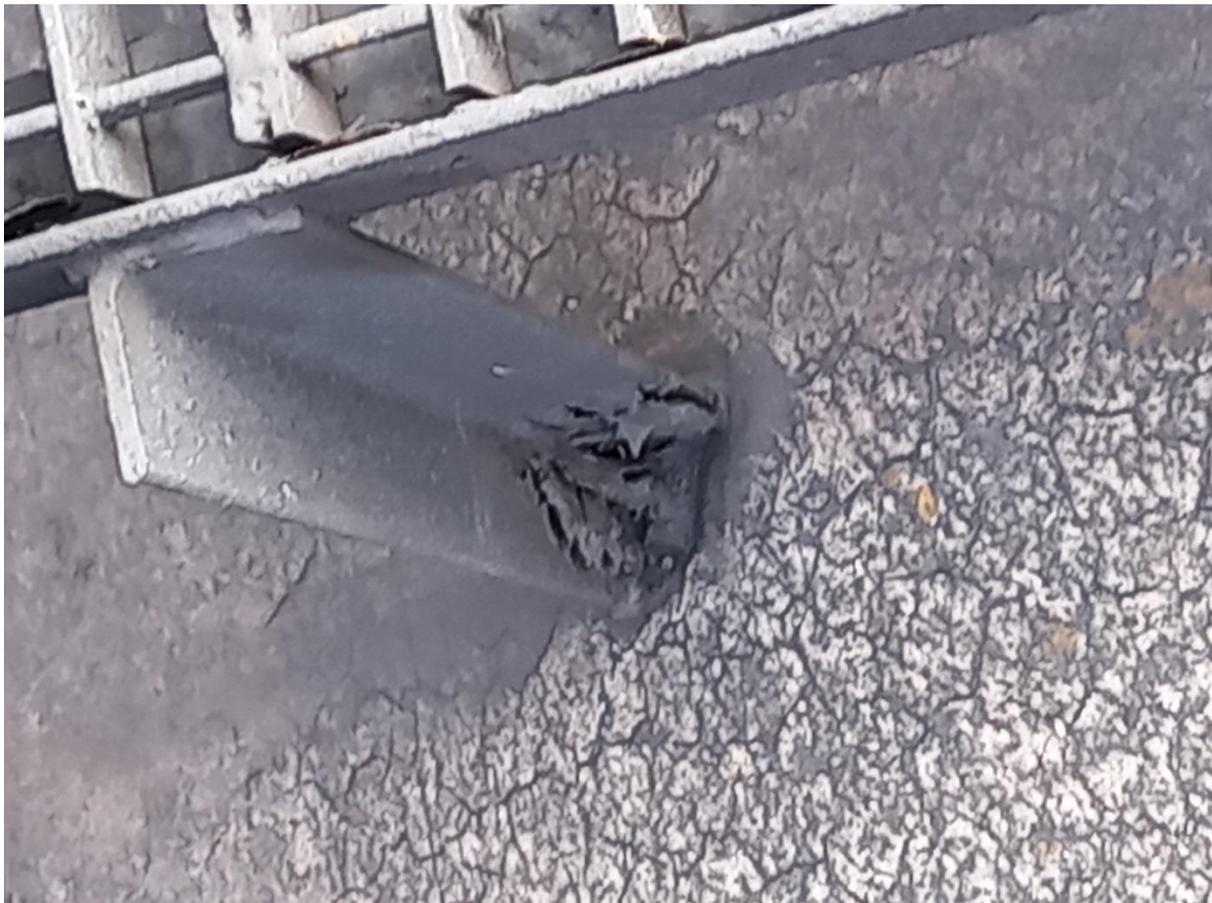
- Ladder and top landing platform need coating at several areas.
- Supports are severely rusted at various locations.

Photo of a rusted support on the Tank for the landing platform

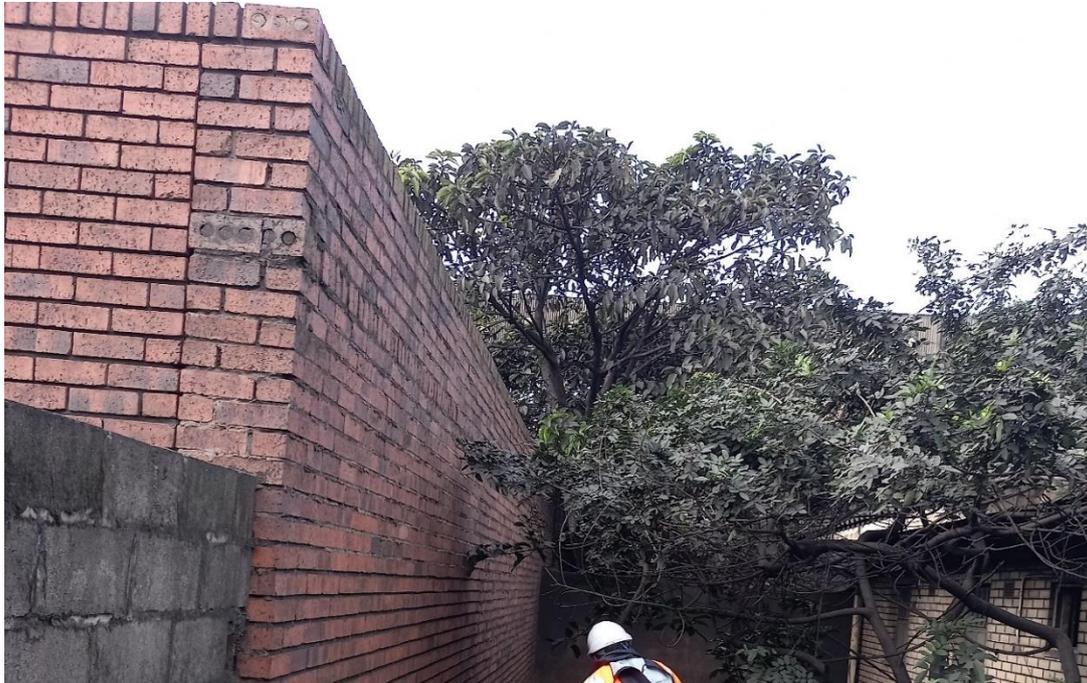
- Bund walls are cracked.
- Huge tree is growing behind the Bund wall, which may be the root cause of cracking of the bund wall.
- Distance from Bund wall to Tank does not comply
- No arrangements are made for diesel Spillage.

Photo of a tree growing adjacent to the Bund-wall

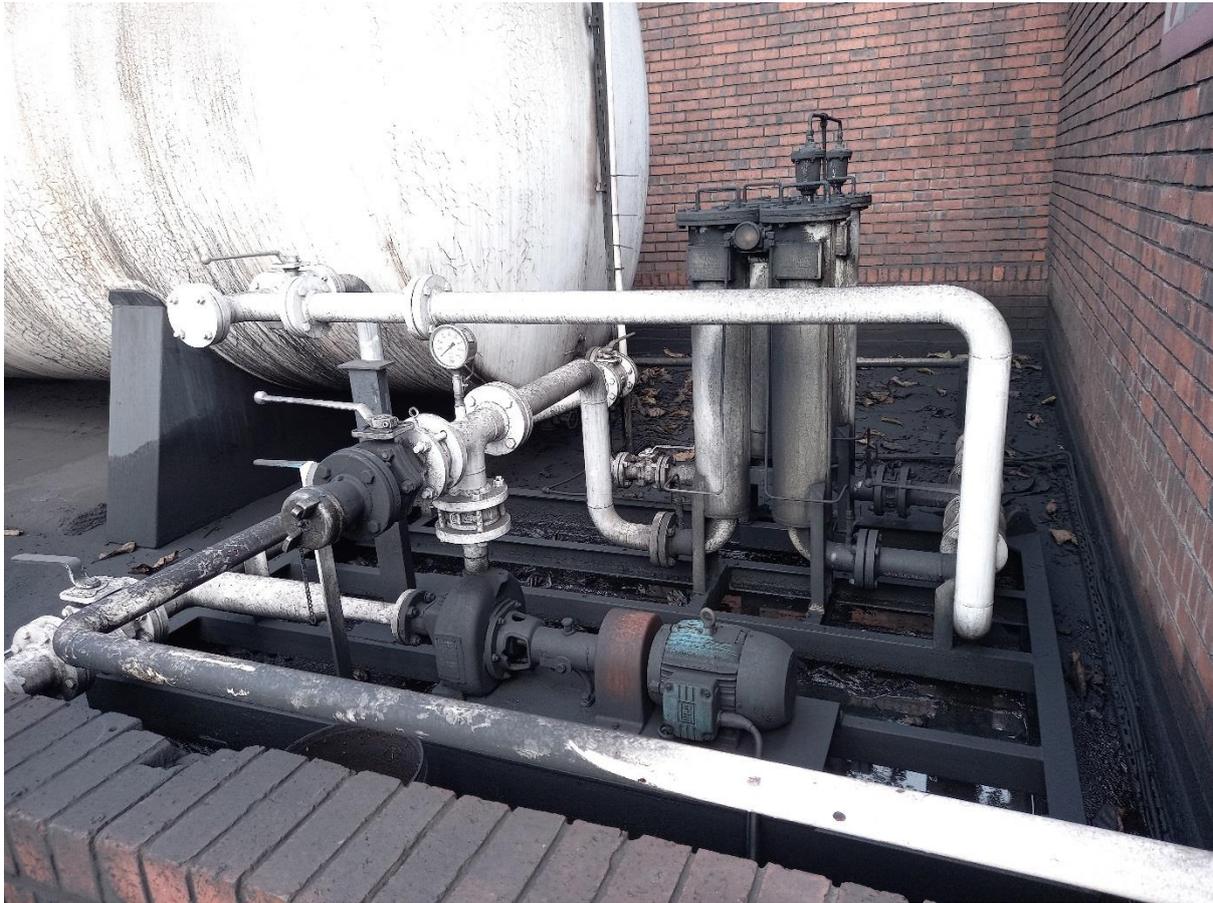
- Piping needs to be cleaned and coated.

Photo of Piping and Filters

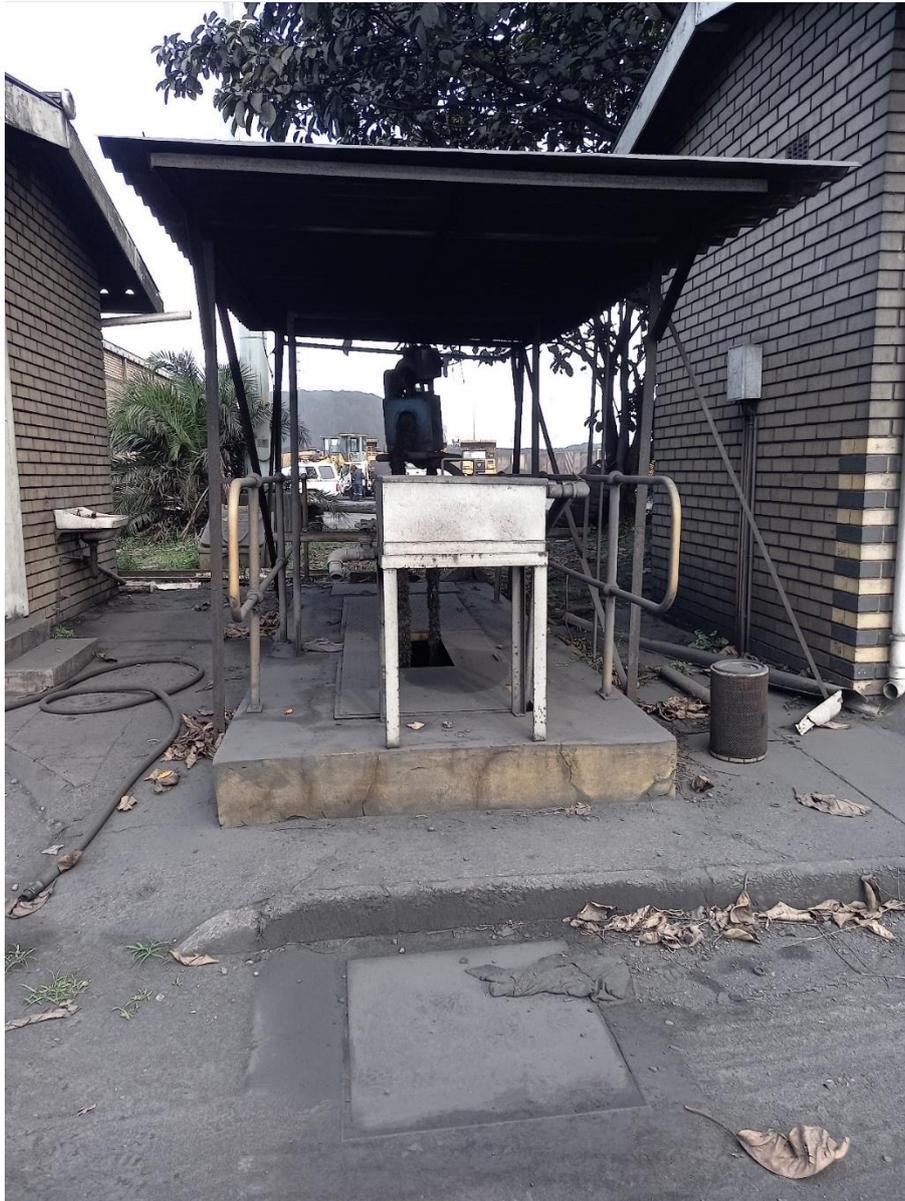
- Oil Skimmer and underground Oil spillage drain was not in a working condition.
- Cover was rusted severely at some locations.

Photo of Oil skimmer

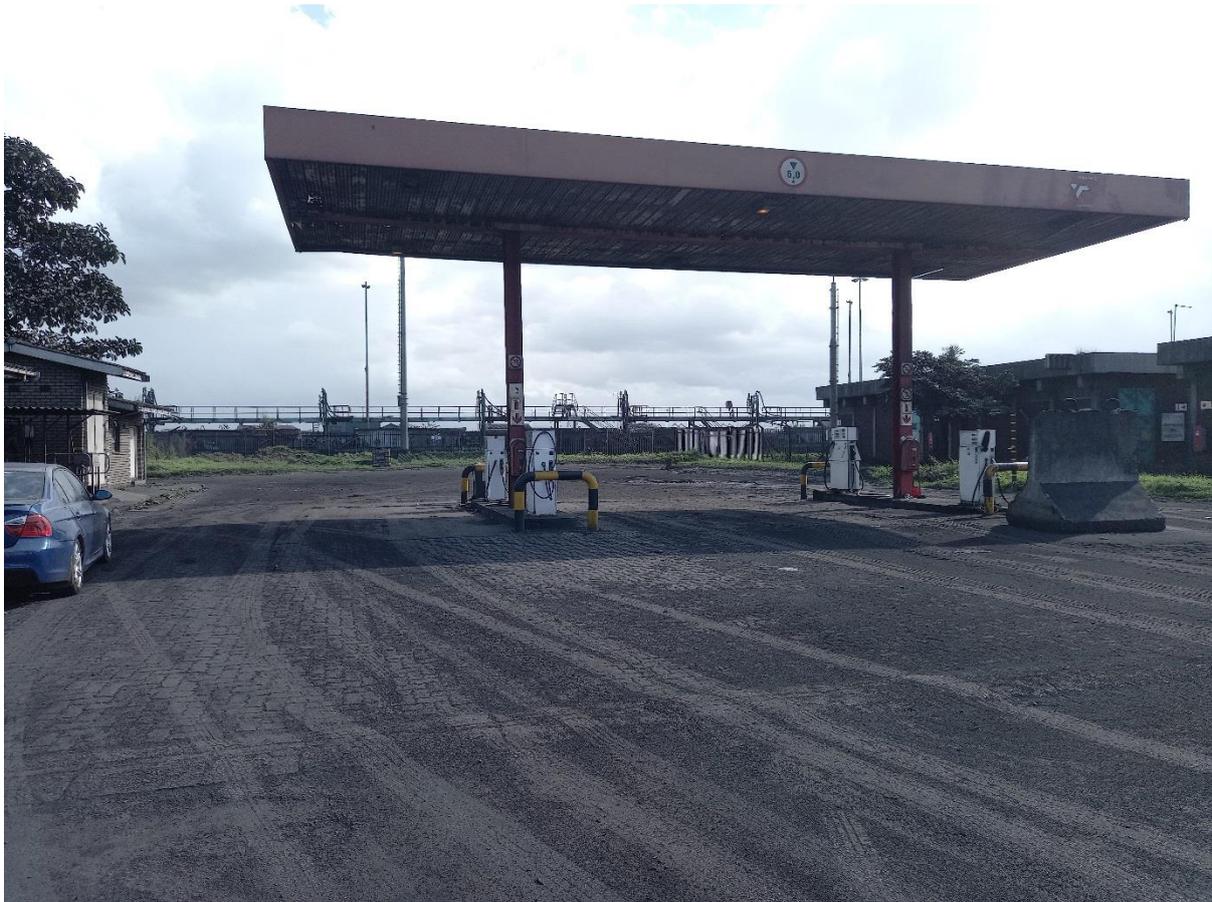
- Existing shade is corroded and is not in a good condition.
- Site team, operating these tanks has requested a big new canopy.

Photo of an existing canopy

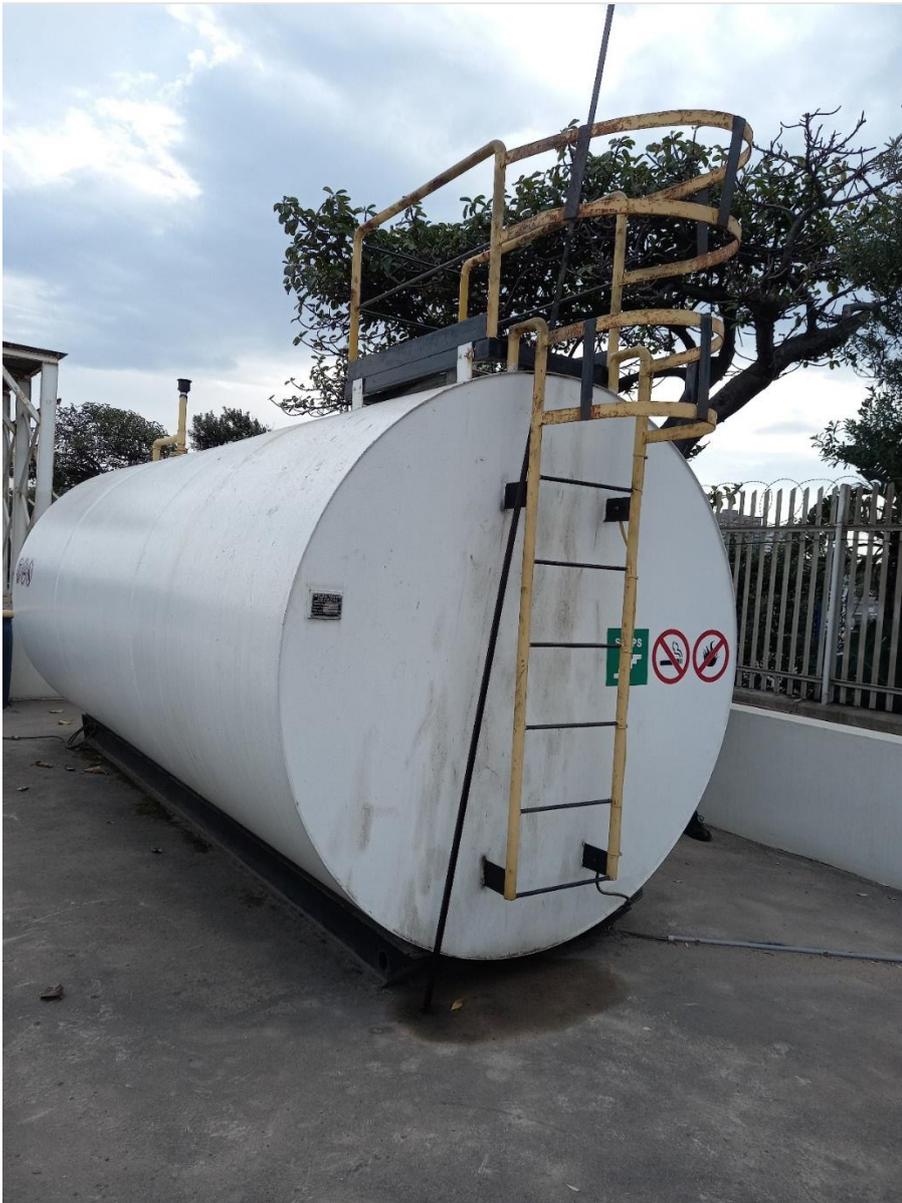
- Ladder and top landing platform need coating at several areas.
- Stairs and railing to enter the bund area are intact and in a good condition.

Platform, ladder etc. are rusted

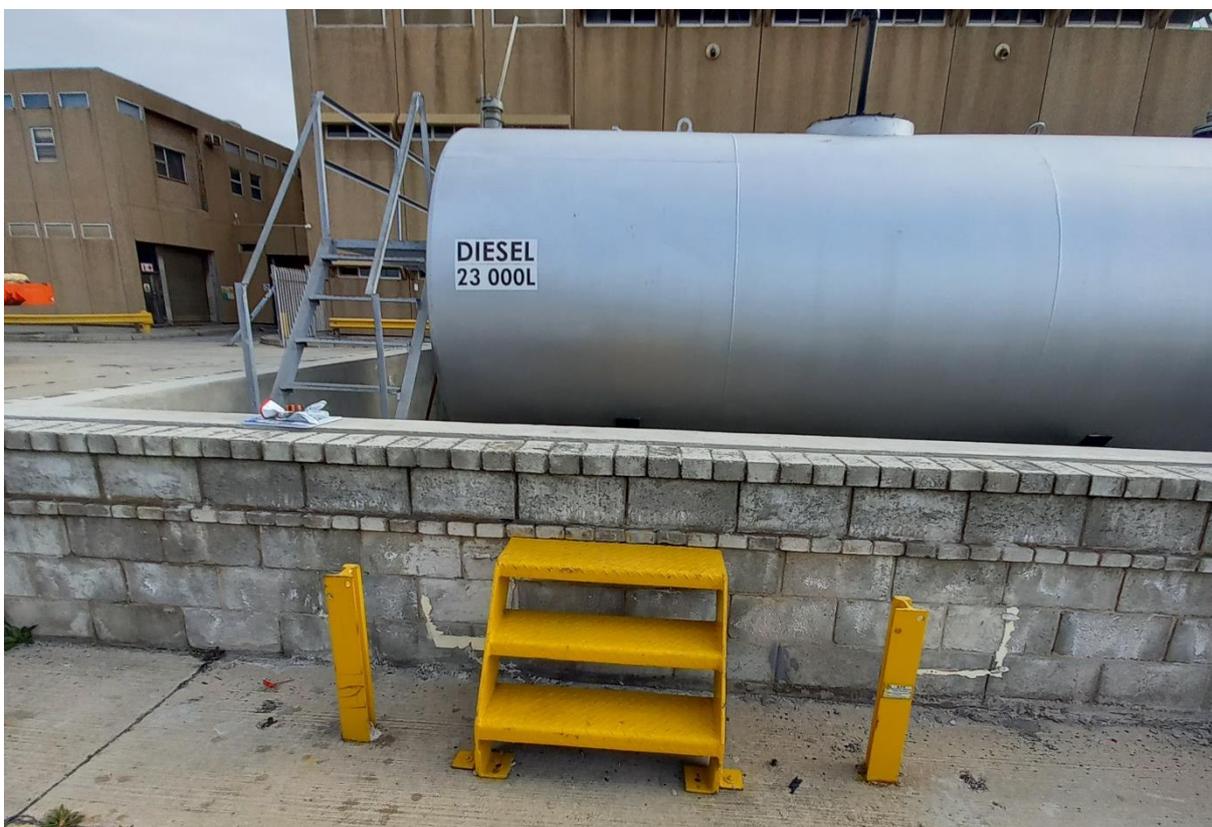
- Ladder needs complete coating.
- No top landing platform was identified.
- Steps sizes are incorrect and too small to climb the platform.
- Steps to enter the bund are also small and don't have handrails.

Small size and short steps with no handrails

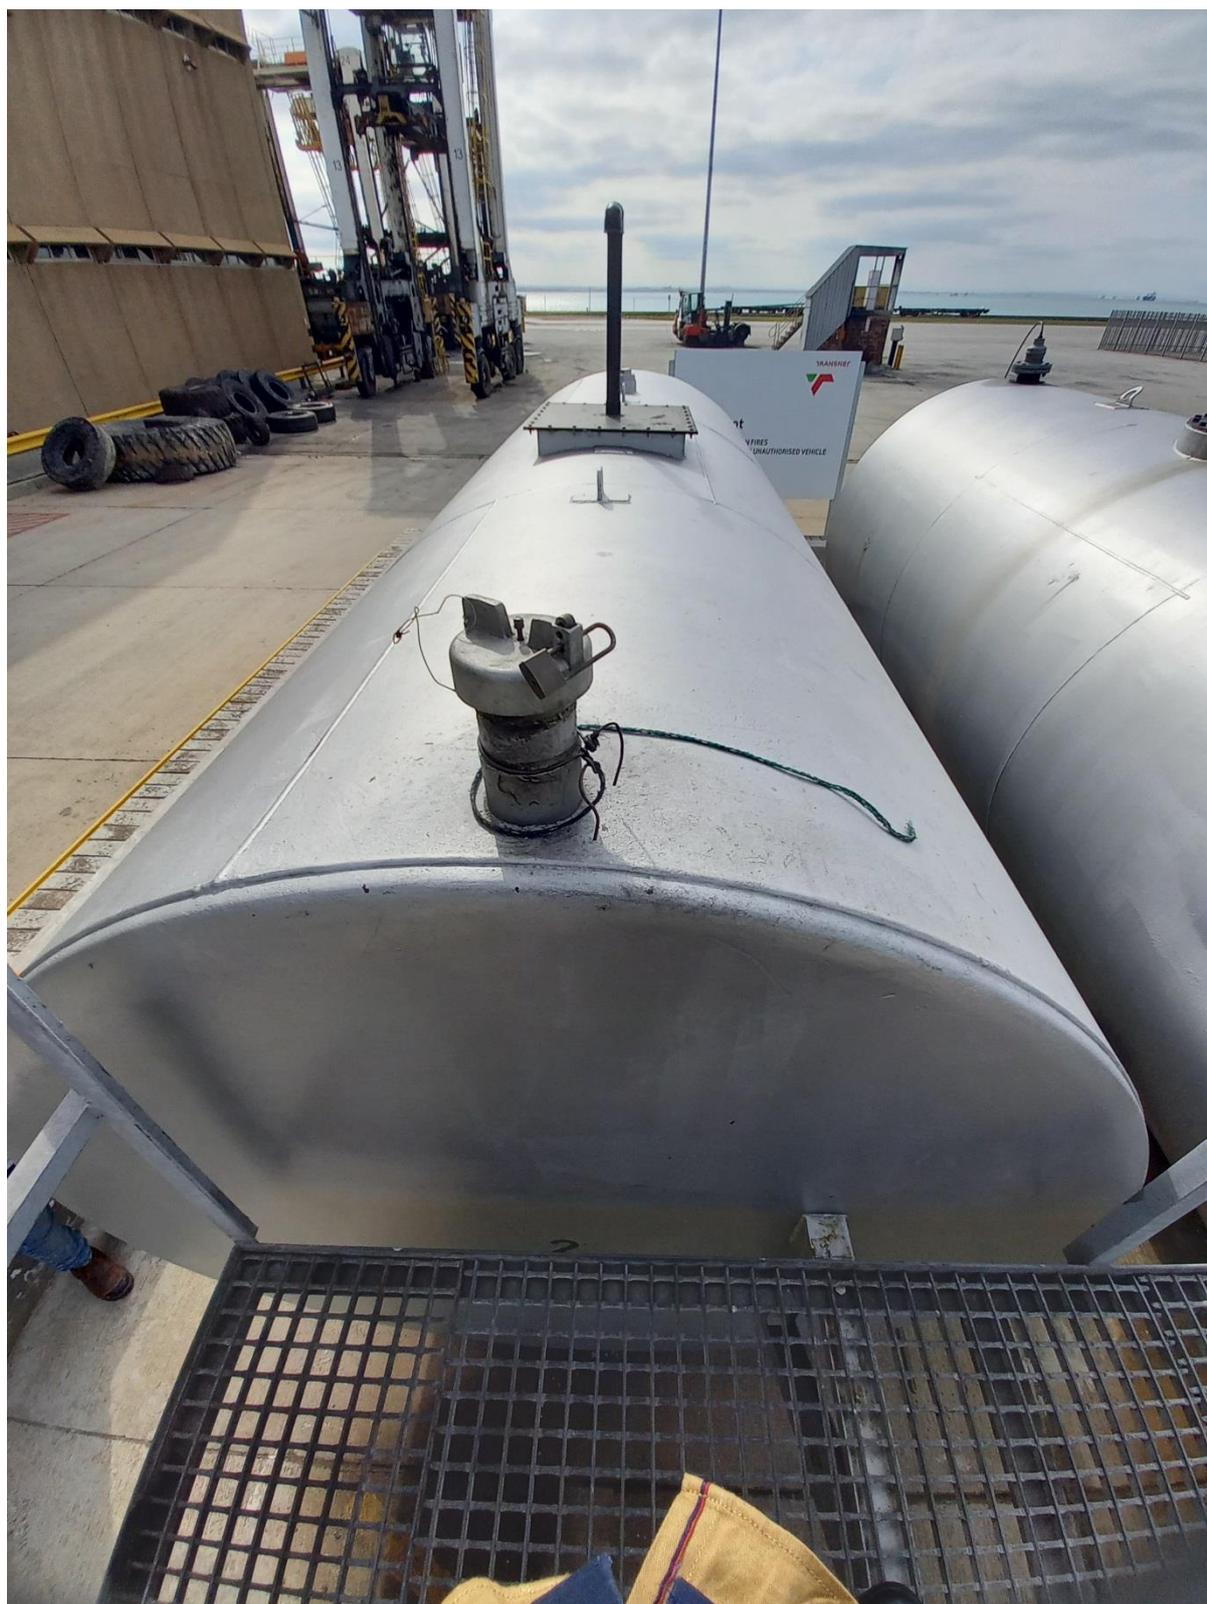
No extended platform to operate/repair/ maintain the nozzles on the top

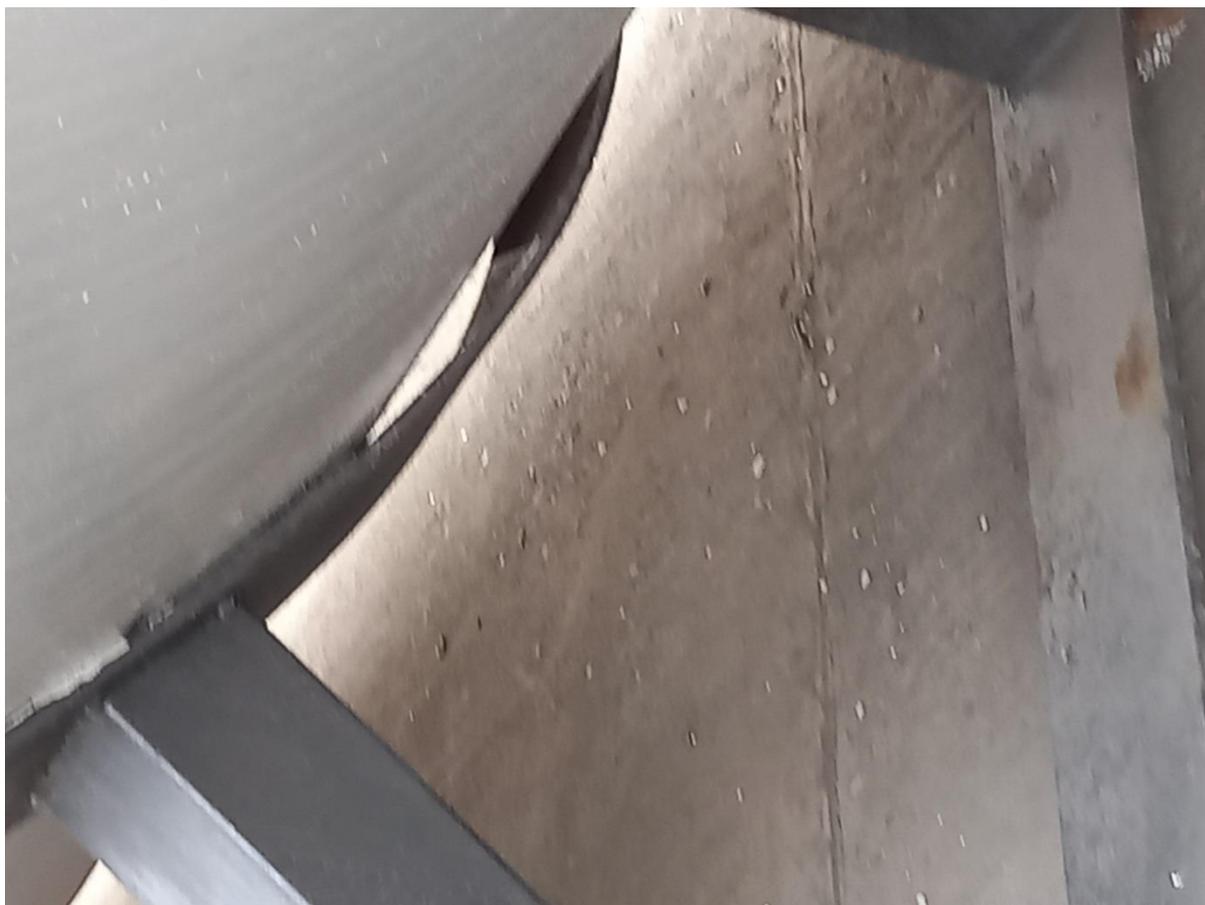
- Two horizontal Aboveground Diesel Tanks were visually inspected on site including piping and other accessories.
- Tank is mounted on the support, which was not welded properly.
- Each tank has Diesel capacity 23 000 L with size 2.3 m diameter and 5.4 m long.
- Tank Manufacturer: unknown
- Paint/ coating was in a bad condition at multiple locations.
- Nozzles are in a good condition.
- Corrosion was spotted at various locations.
- MHI is required.

Vessel is not welded to the support

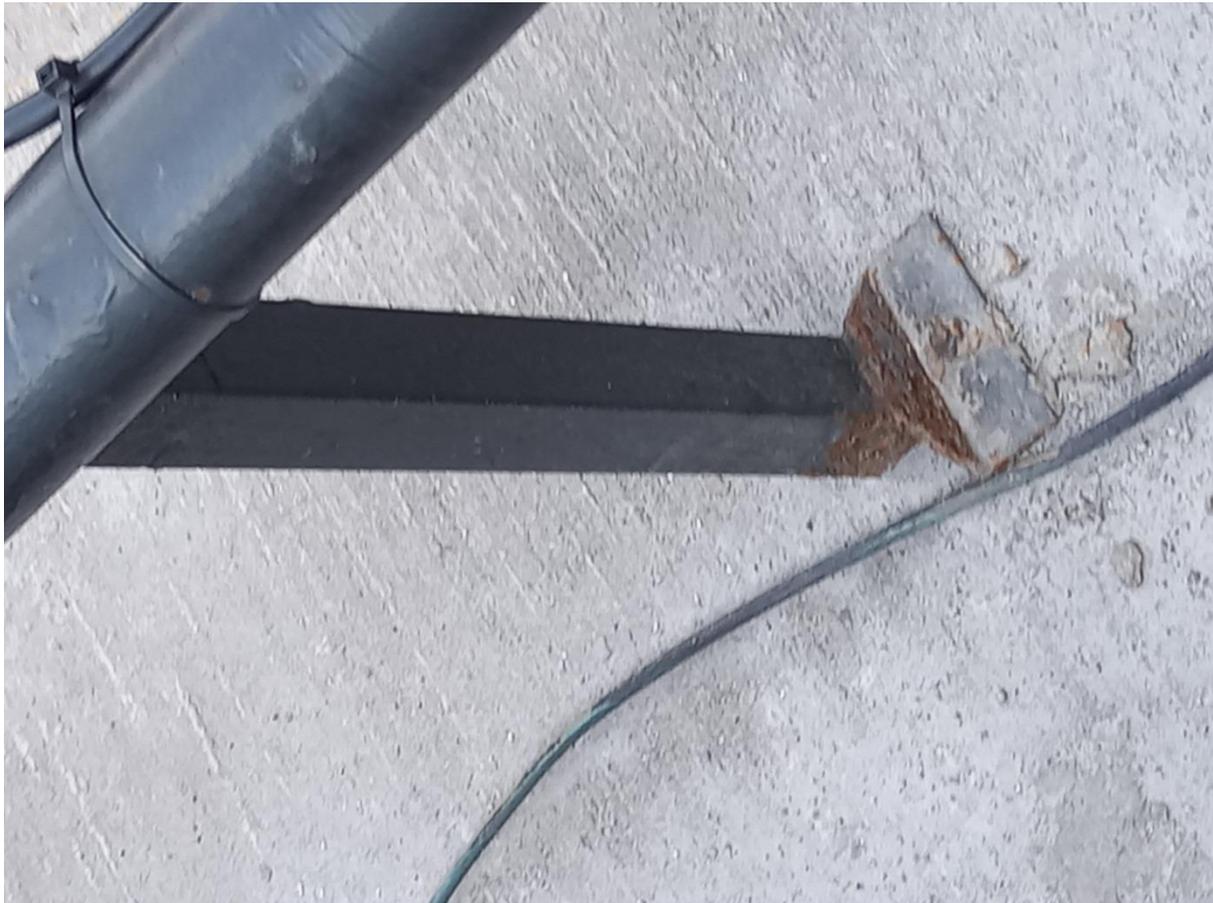
Piping supports needs to be replaced

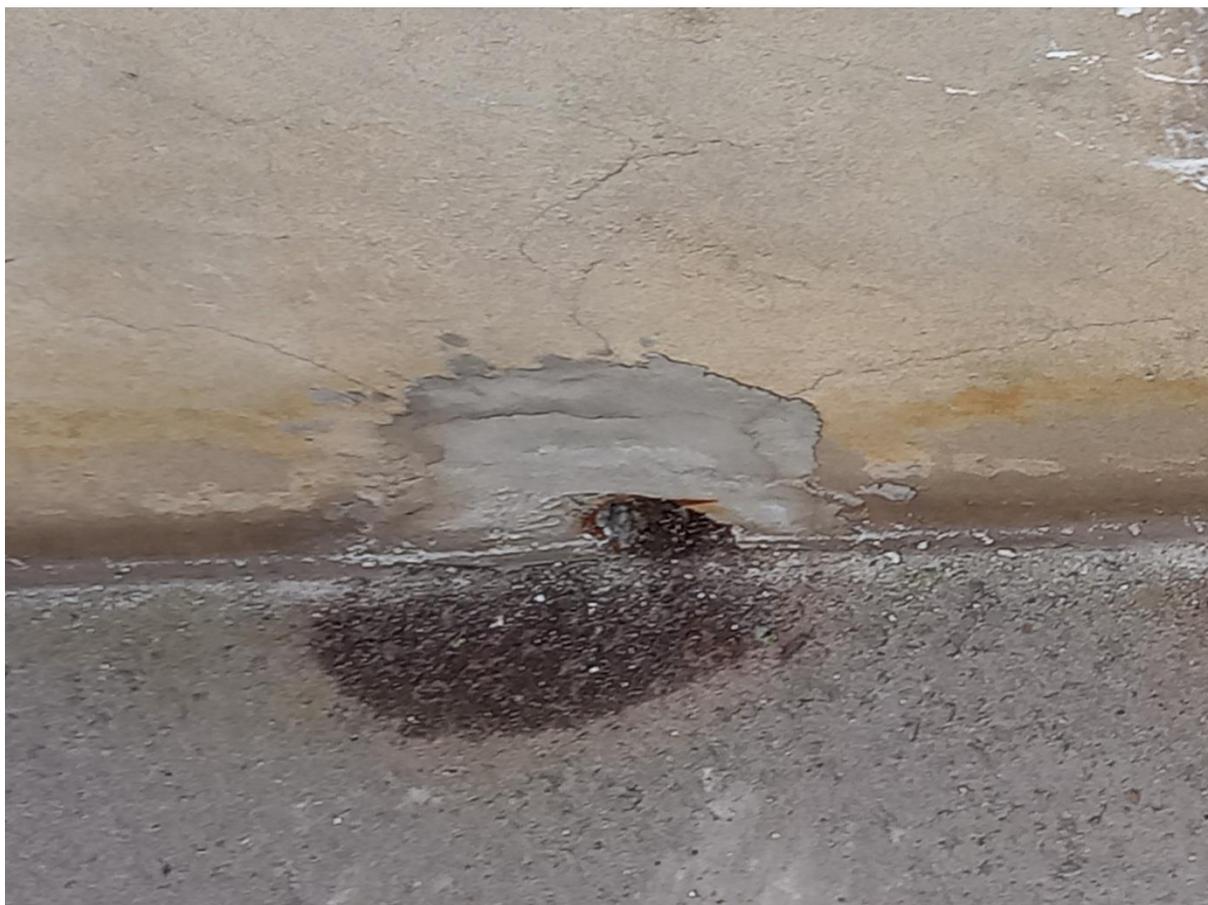
- Bund walls are in a good condition.
- Bund size: 7.6 m wide x 8 m long x 1 m height
- Bund area was clean.
- No vegetation was found around the bunded area.
- Drain from storm water was identified as a small hole to the bund are.

Storm water drain hole
