**PRELIMINARY CONDITION ASSESSMENT
FOR FUEL STORAGE TANKS – PHASE 1**

TPT SITE VISIT REPORT COMPLETED IN AUGUST 2022

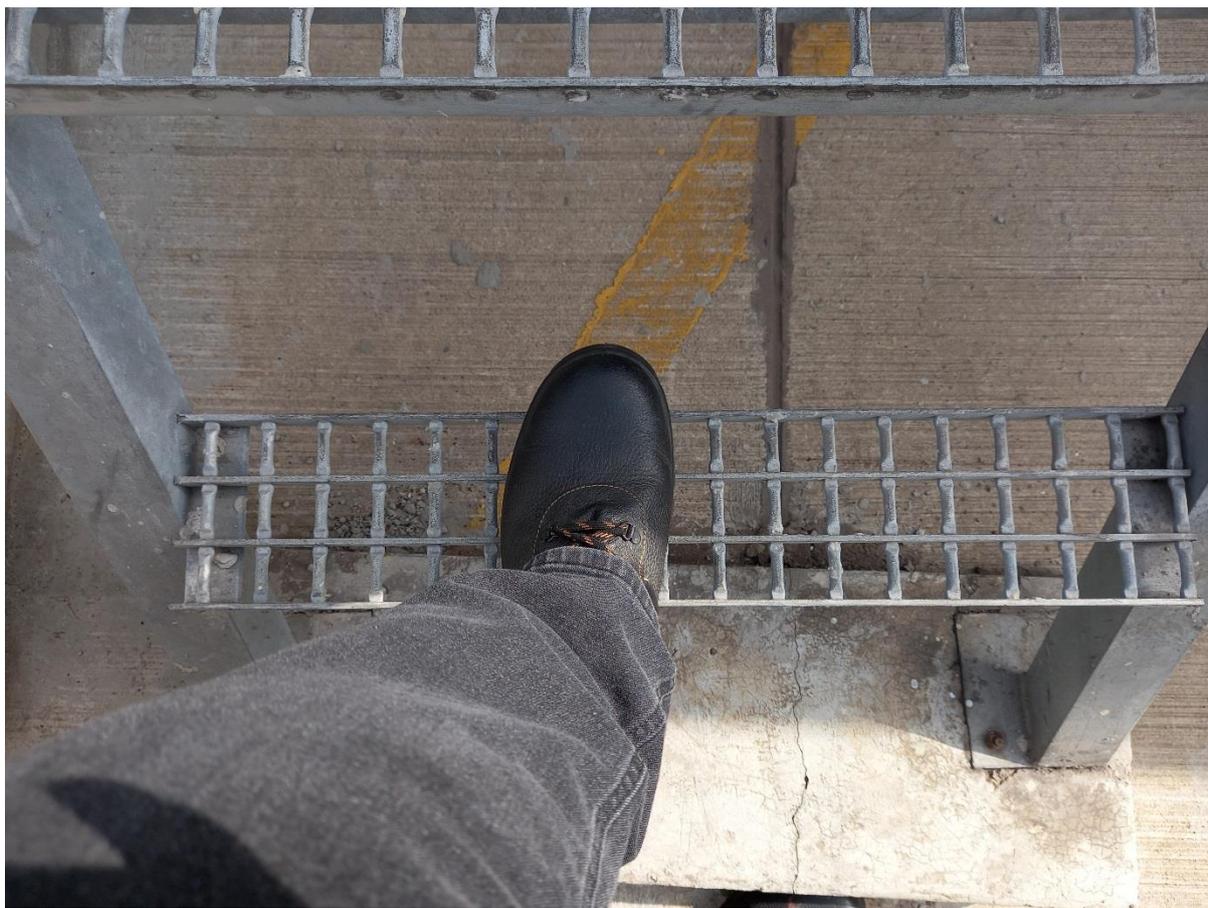
Shot and small step

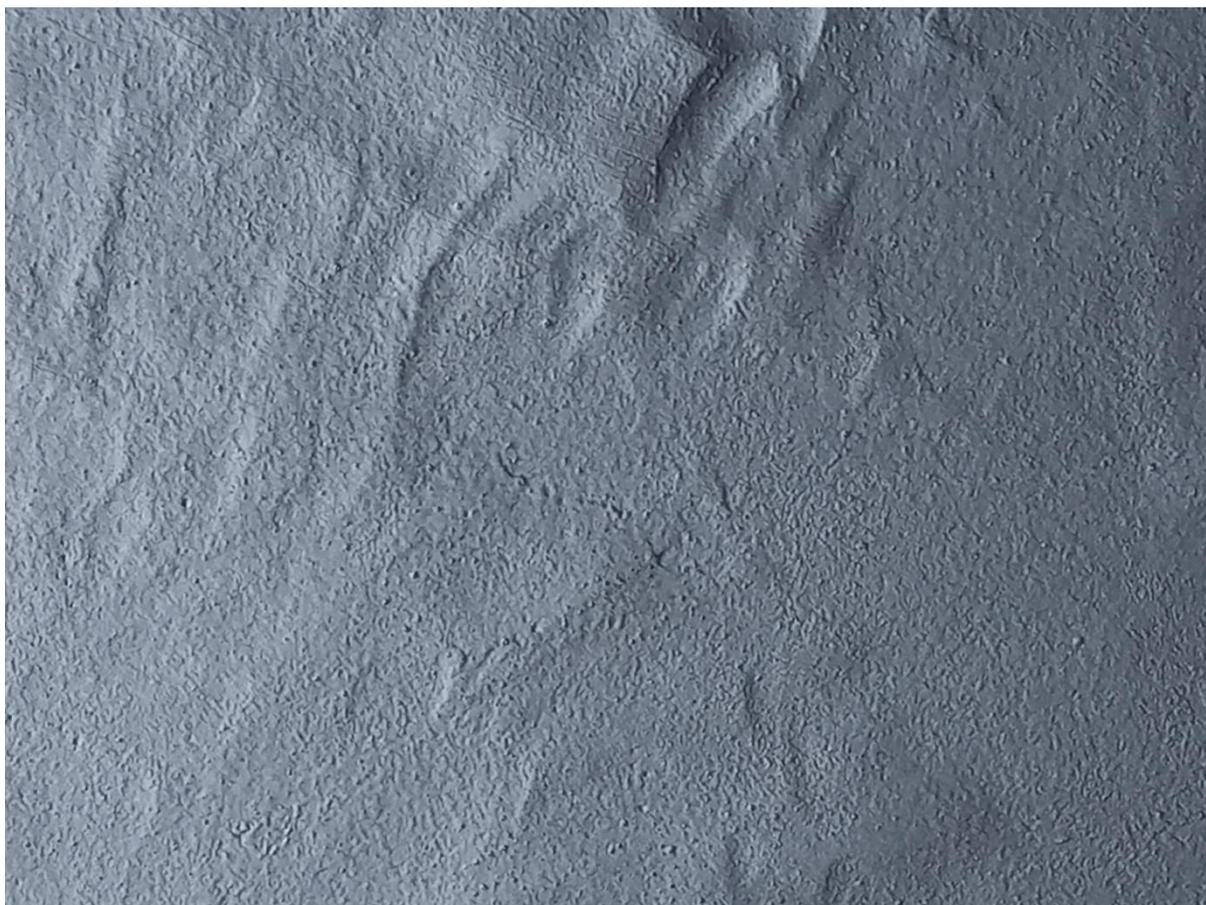
Painting in a bad condition: photo of dished end Surface

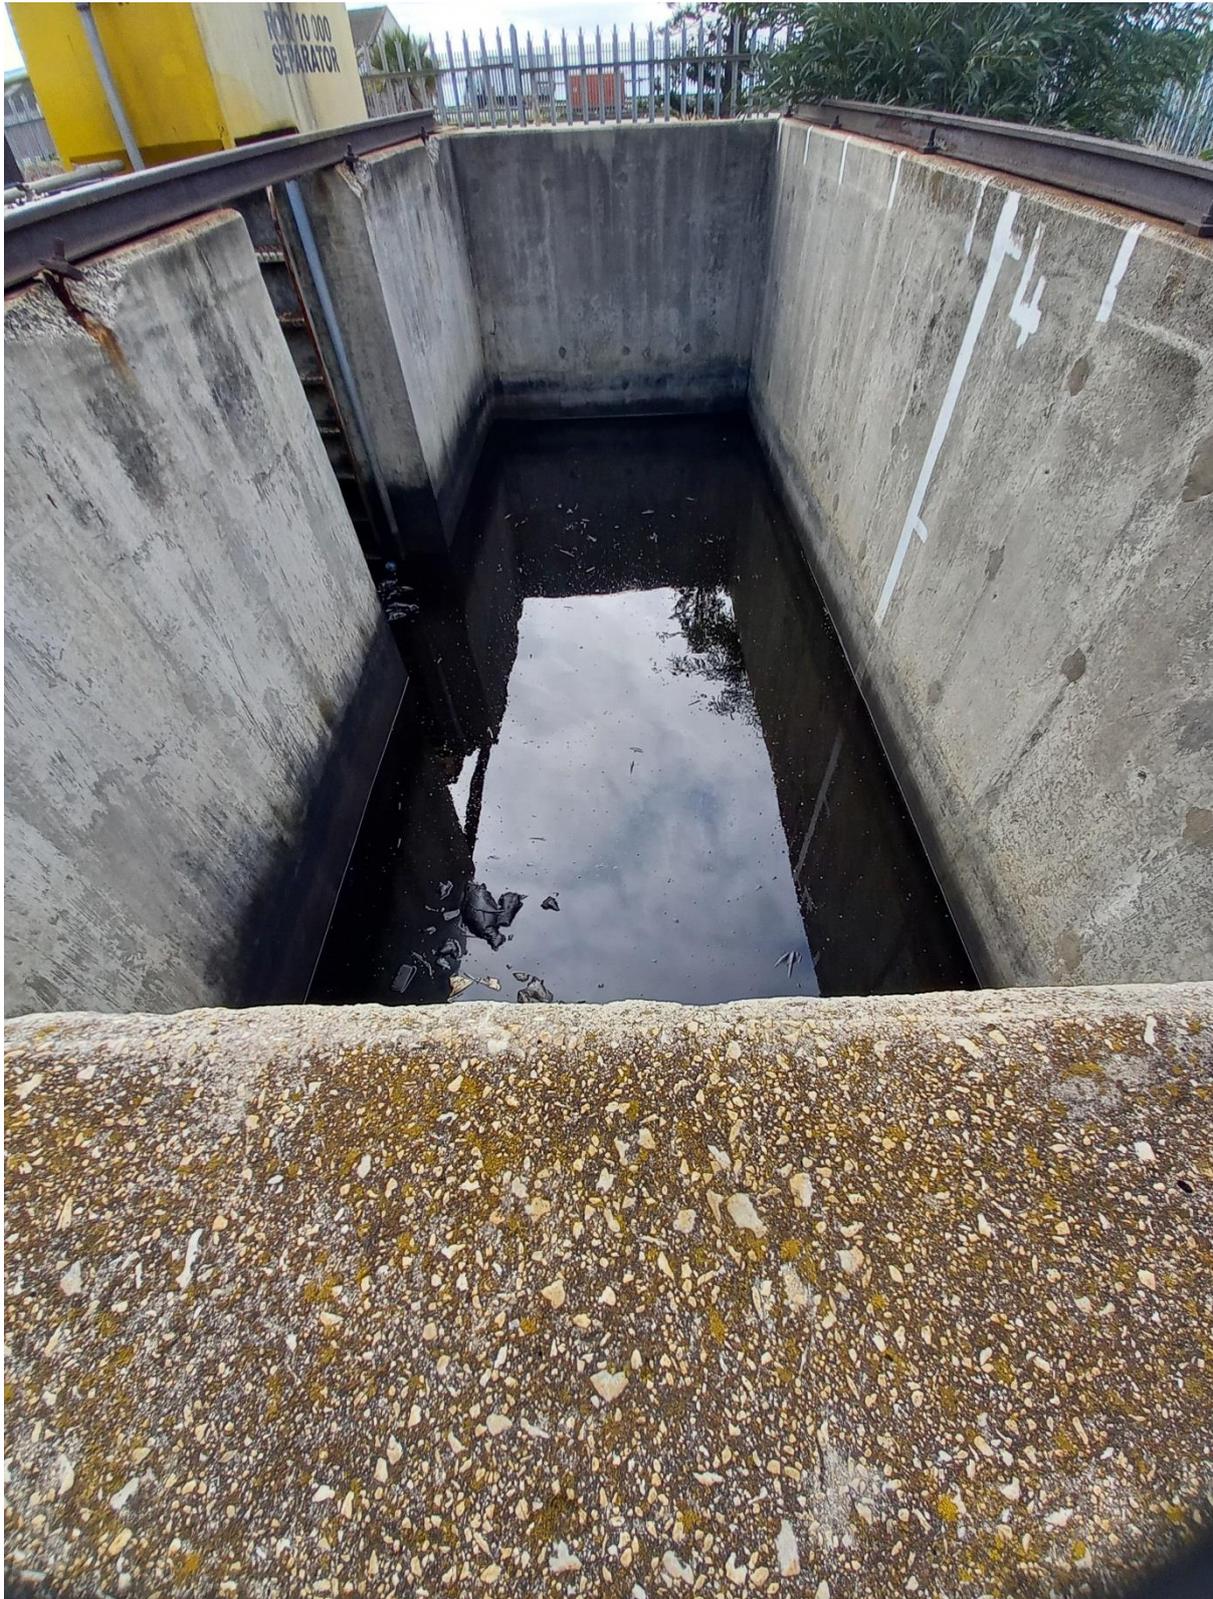
- No Oil/fuel spillage drain was found in the bunded area.
- Oil spillage tank area was in a mess (scrap was found around it).

Oil spillage collection

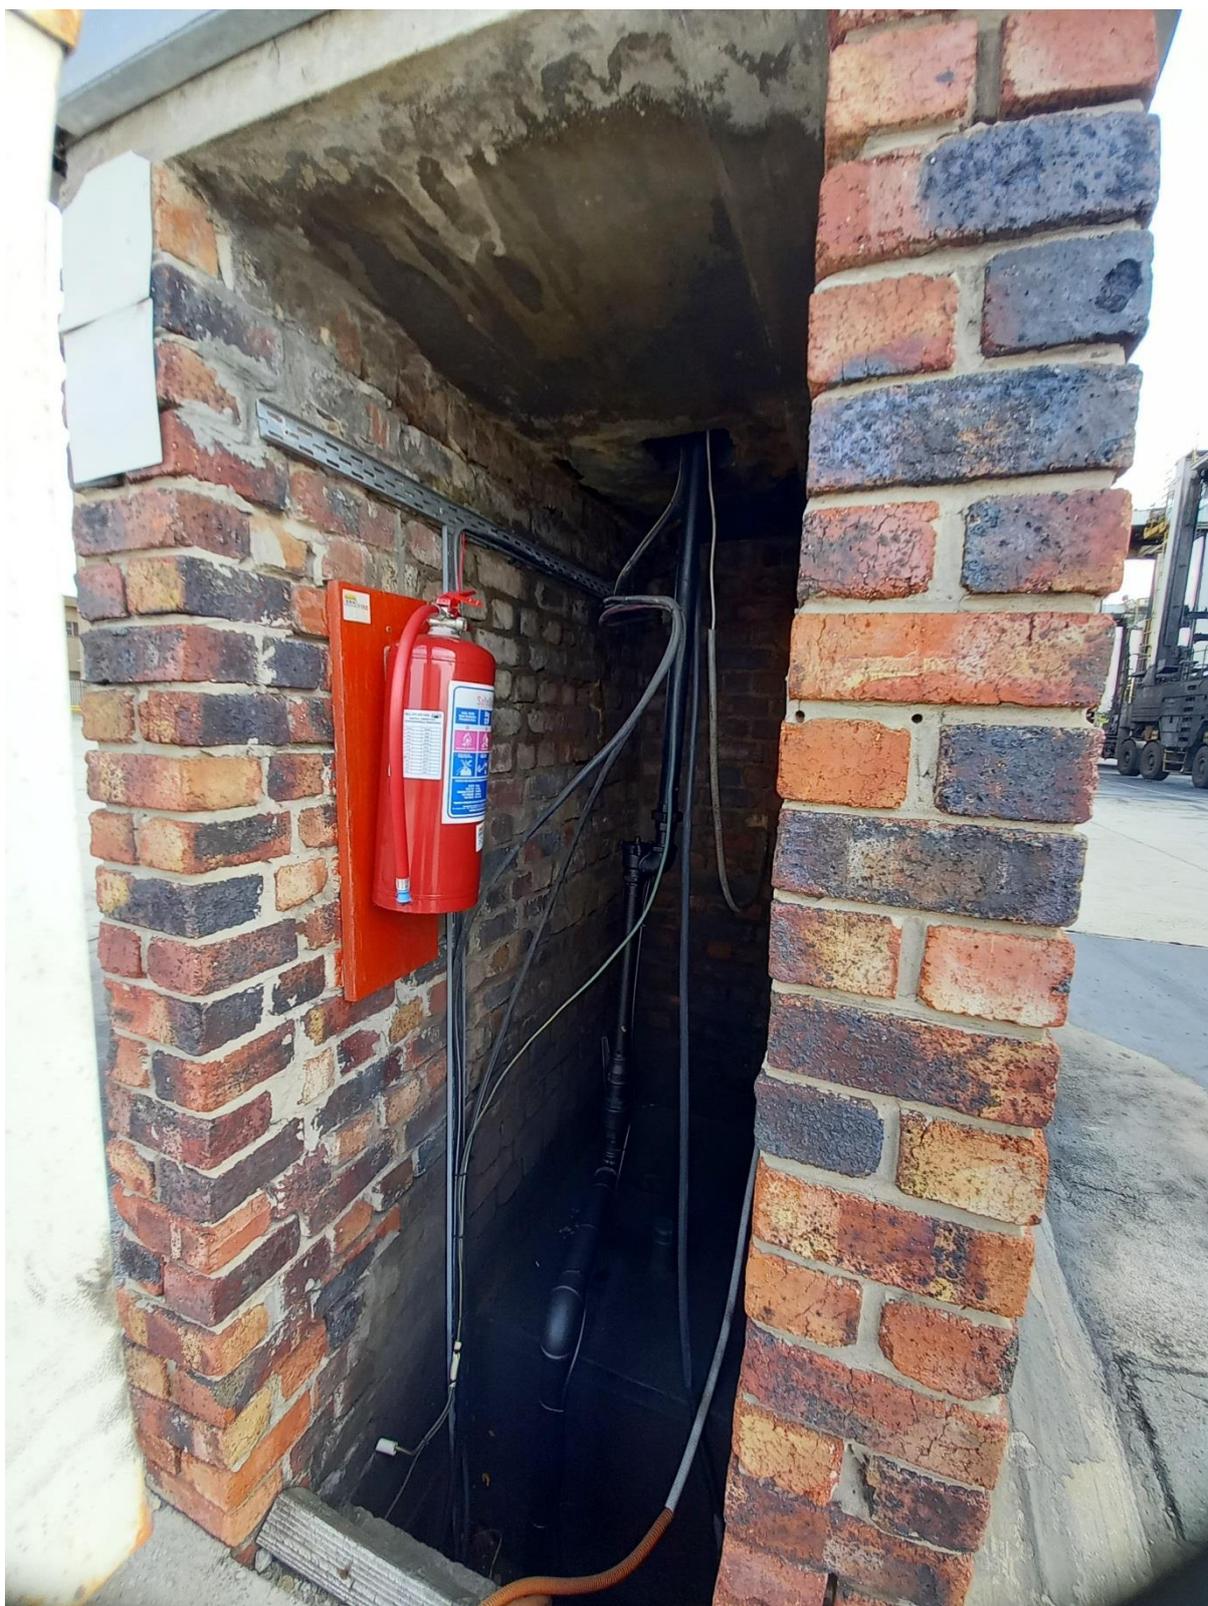
- Wiring and DP was below the dispenser and needs urgent attention to rectify.
- Earthing cables needs to be organized.

Electrical cables: urgent attention is required

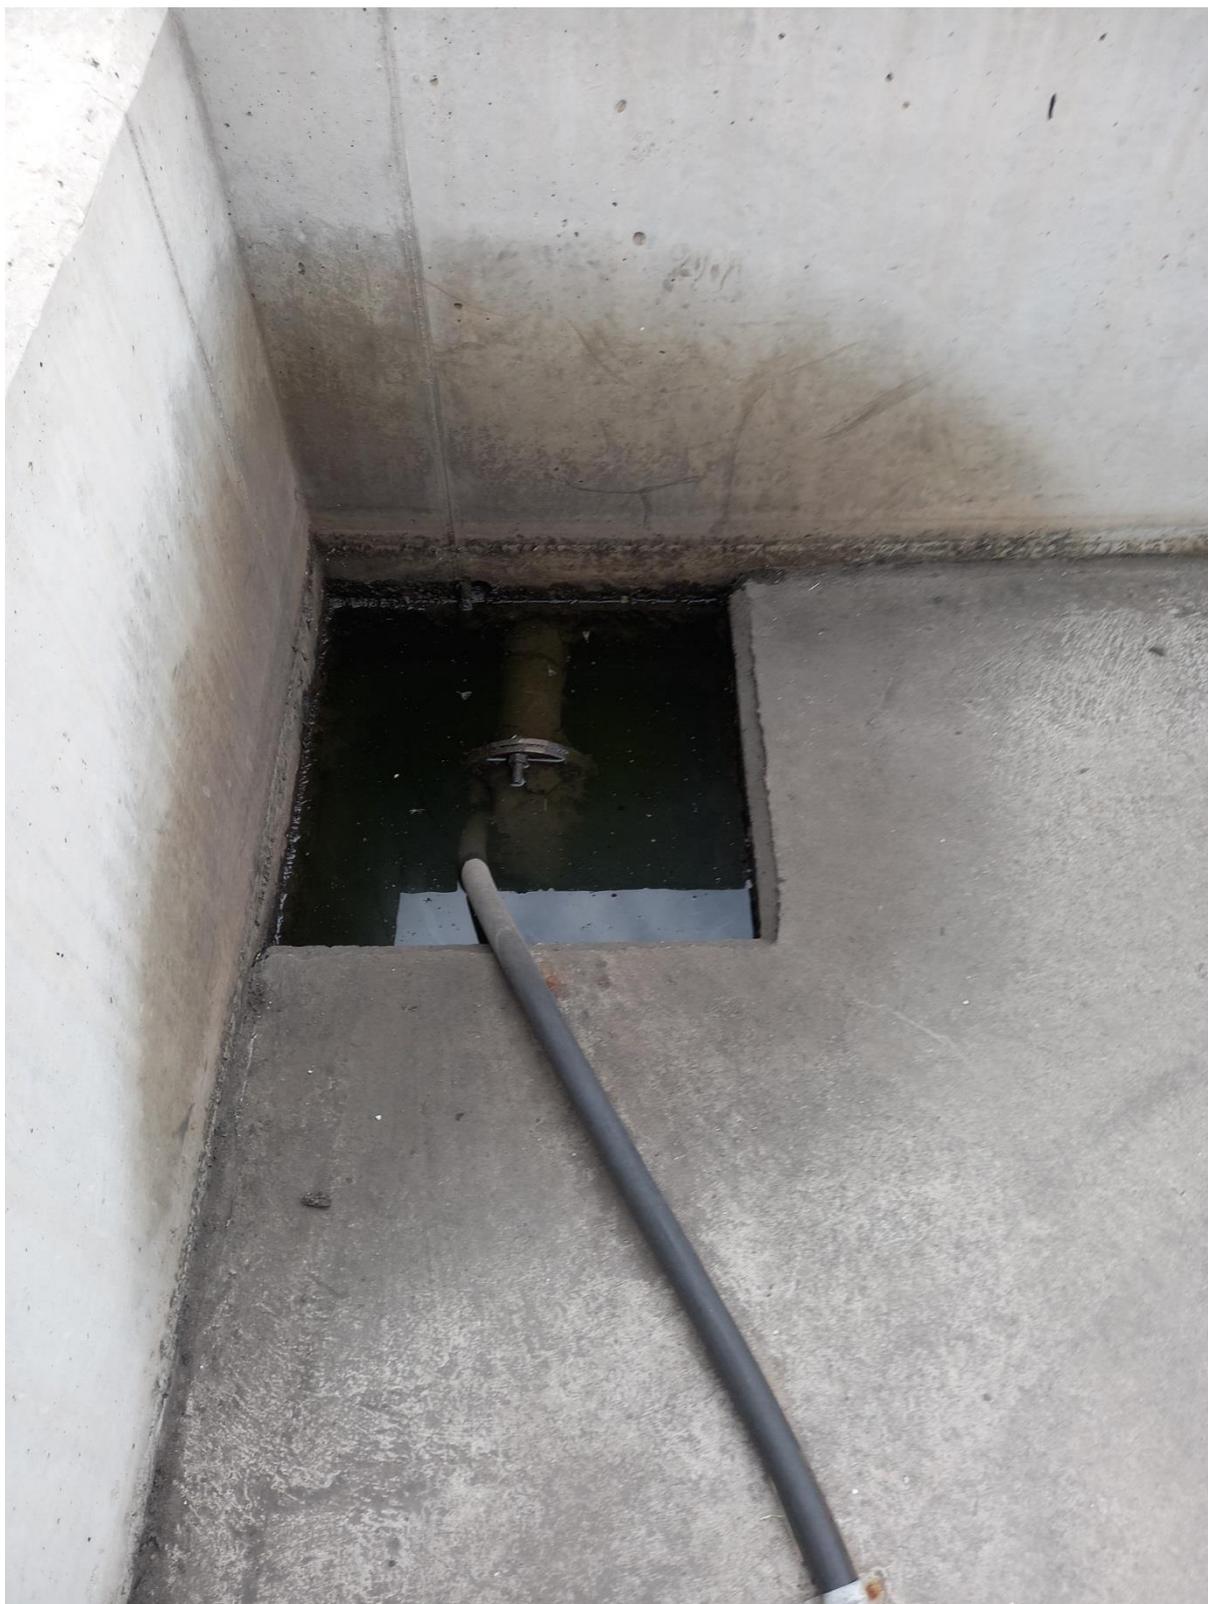
Strom water drain is choked

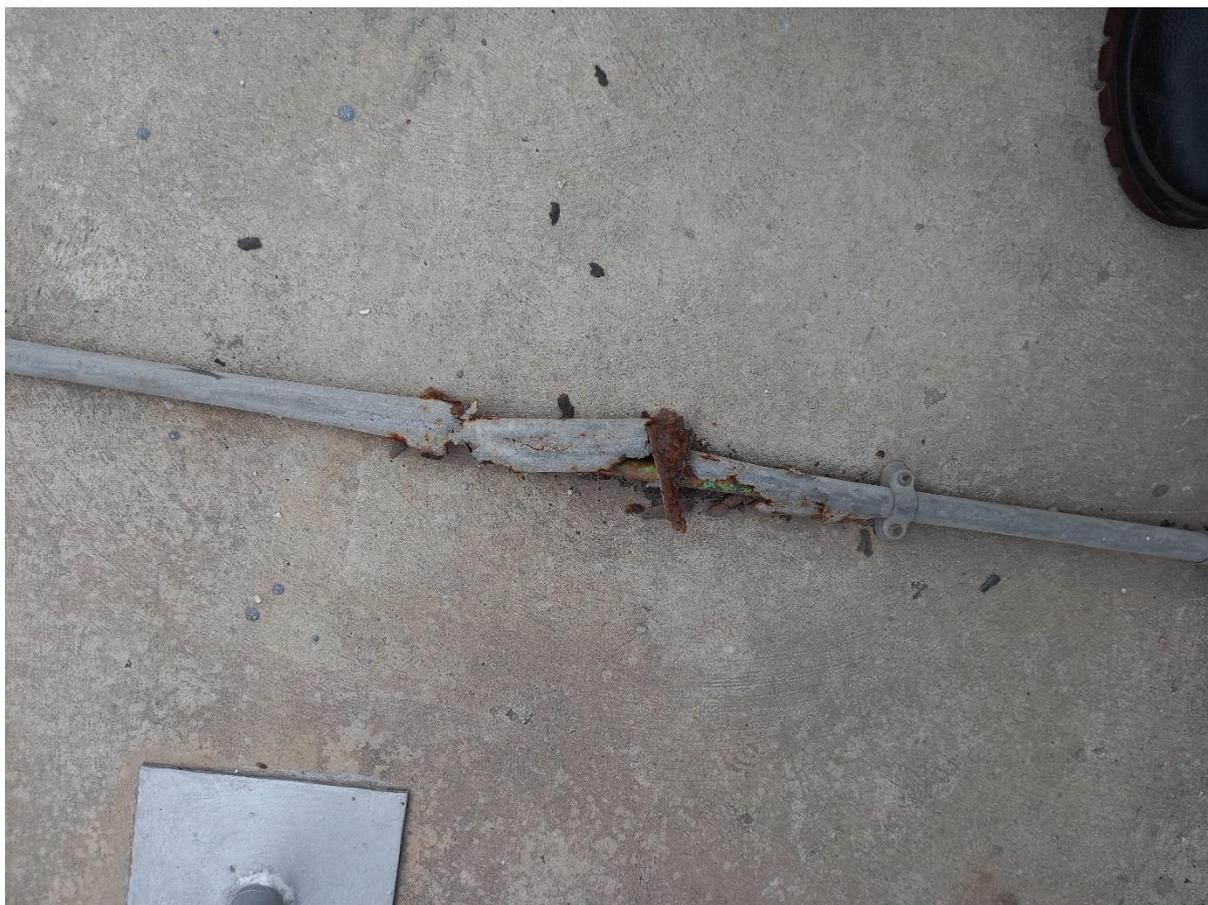
Earthing cable cover is broken and in a poor condition

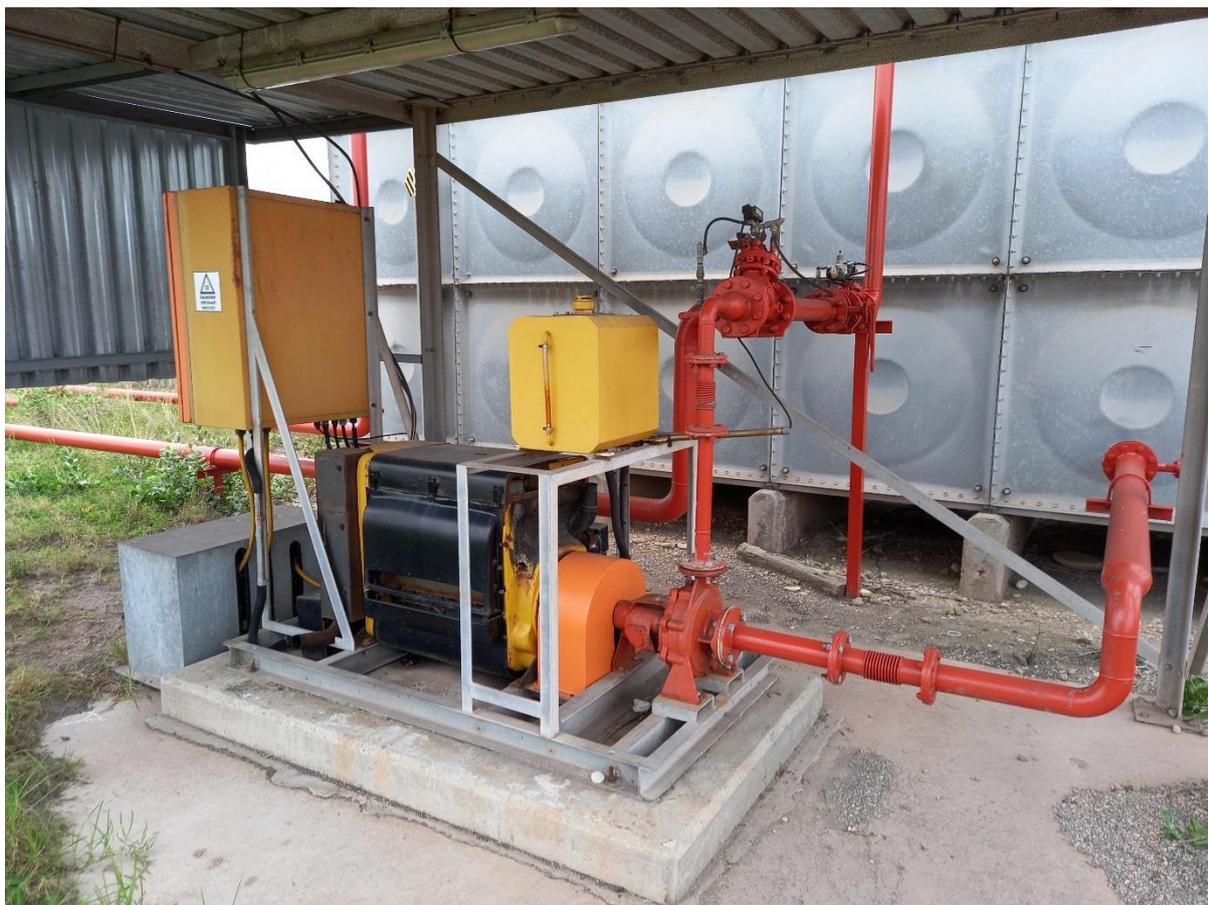
- Foam Water Tank Pumps DP is locked by TNPA; hence we were unable to check the condition.
- Foam water system is getting heavily rusted and urgent attention is required.

Foam Water supply system

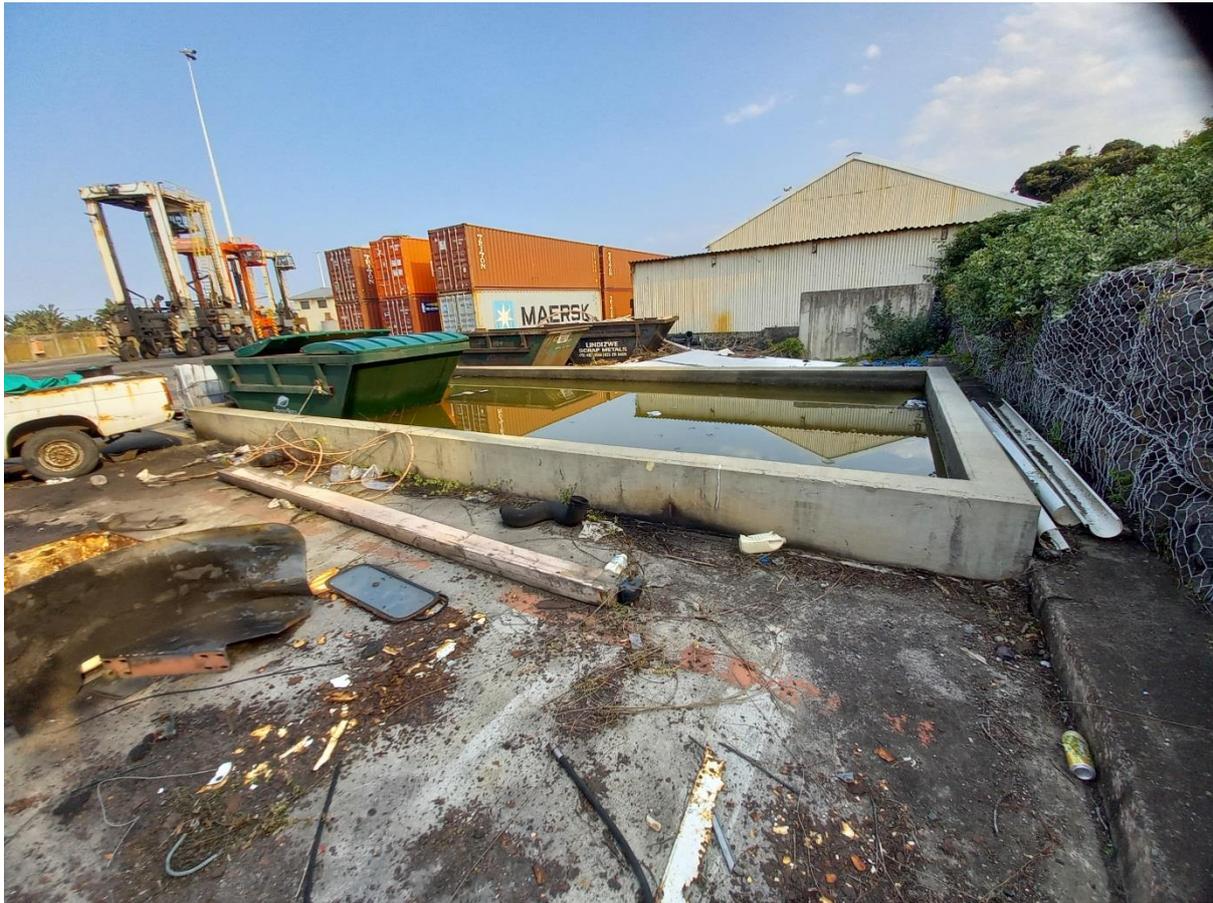
New area proposed to build the Tanks: severe cleaning is required.
