# **Report Name** : Inland Terminal Fuel Facilities - Site Visit Report

Project Number : Z9000113

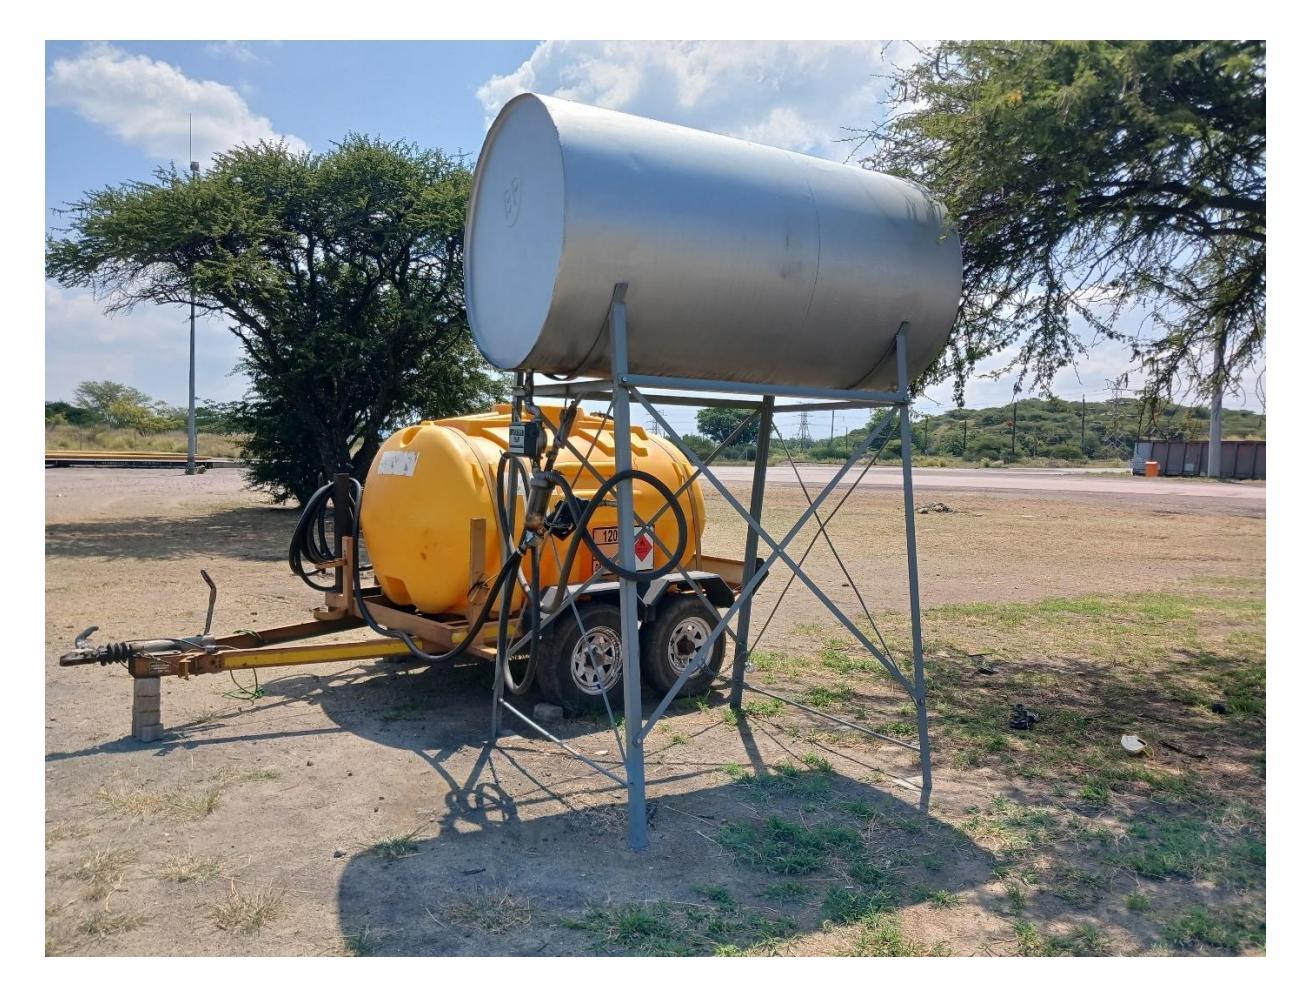
Figure 1: Pendoring Terminal – Temporary External Service Provider Fuel Facility.

- The terminal does not have a permanent fuel facility.
- The site is using a temporary mobile diesel bowser from external service provider.
- The fuel facility is managed and maintained by an external service provider.
- There is a soil contamination adjacent to the bowser caused by diesel spillage.
- No fire extinguisher on the diesel bowser or nearby vicinity.
- An elevated diesel steel tank shown below (Figure 1: Pendoring Terminal Temporary External Service Provider Fuel Facility) is not in use. The tank belongs to an external service provider that previously managed the facility, the tank to be taken off site.

- Conduct environmental assessment to ensure compliance
- Conduct risk assessment
- A permanent fuel facility that can be easily decommissioned (i.e., self-bunded tank with a concrete slab).

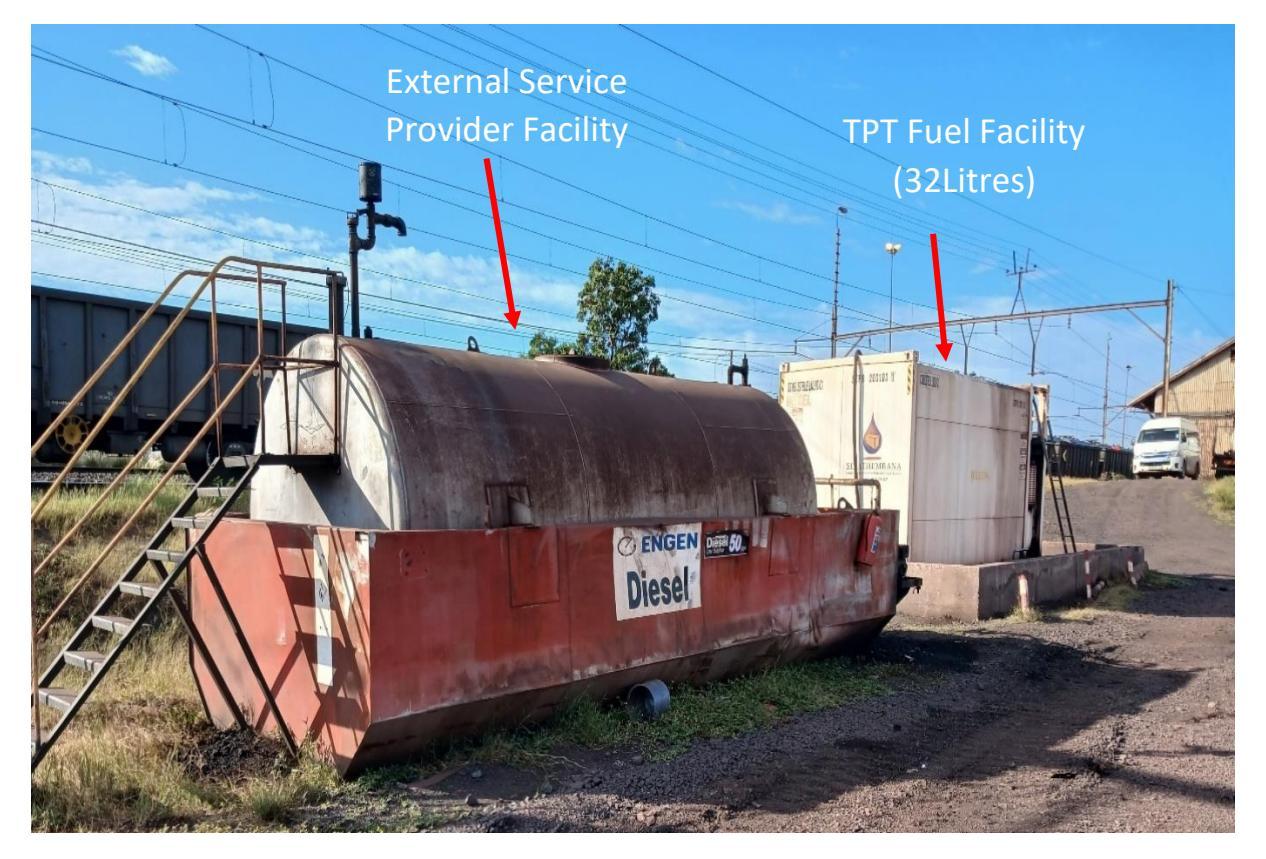
Figure 2: Lohatla Fuel Facility

- There are two fuel facilities onsite with two diesel tanks.
- The containerised self-bund tank belongs to TPT and the skid-mounted tank belongs to an external service provider that previously managed the facility (*see below Figure 2 : Lohatla Fuel Facility*).
- The TPT containerised self-bund tank diesel pump is not working.
- Currently the operations are using external service provider fuel facility.
- There is no oil separator or drainage system at the facility to handle spillages.

- The containerised self-bund fuel storage tank and fuel pump requires urgent maintenance and repairs to bring it up to standard.
- Improve general housekeeping to minimise diesel spillages around and within the facility.
- It is recommended that new drainage infrastructure be installed to ensure environmental compliance.

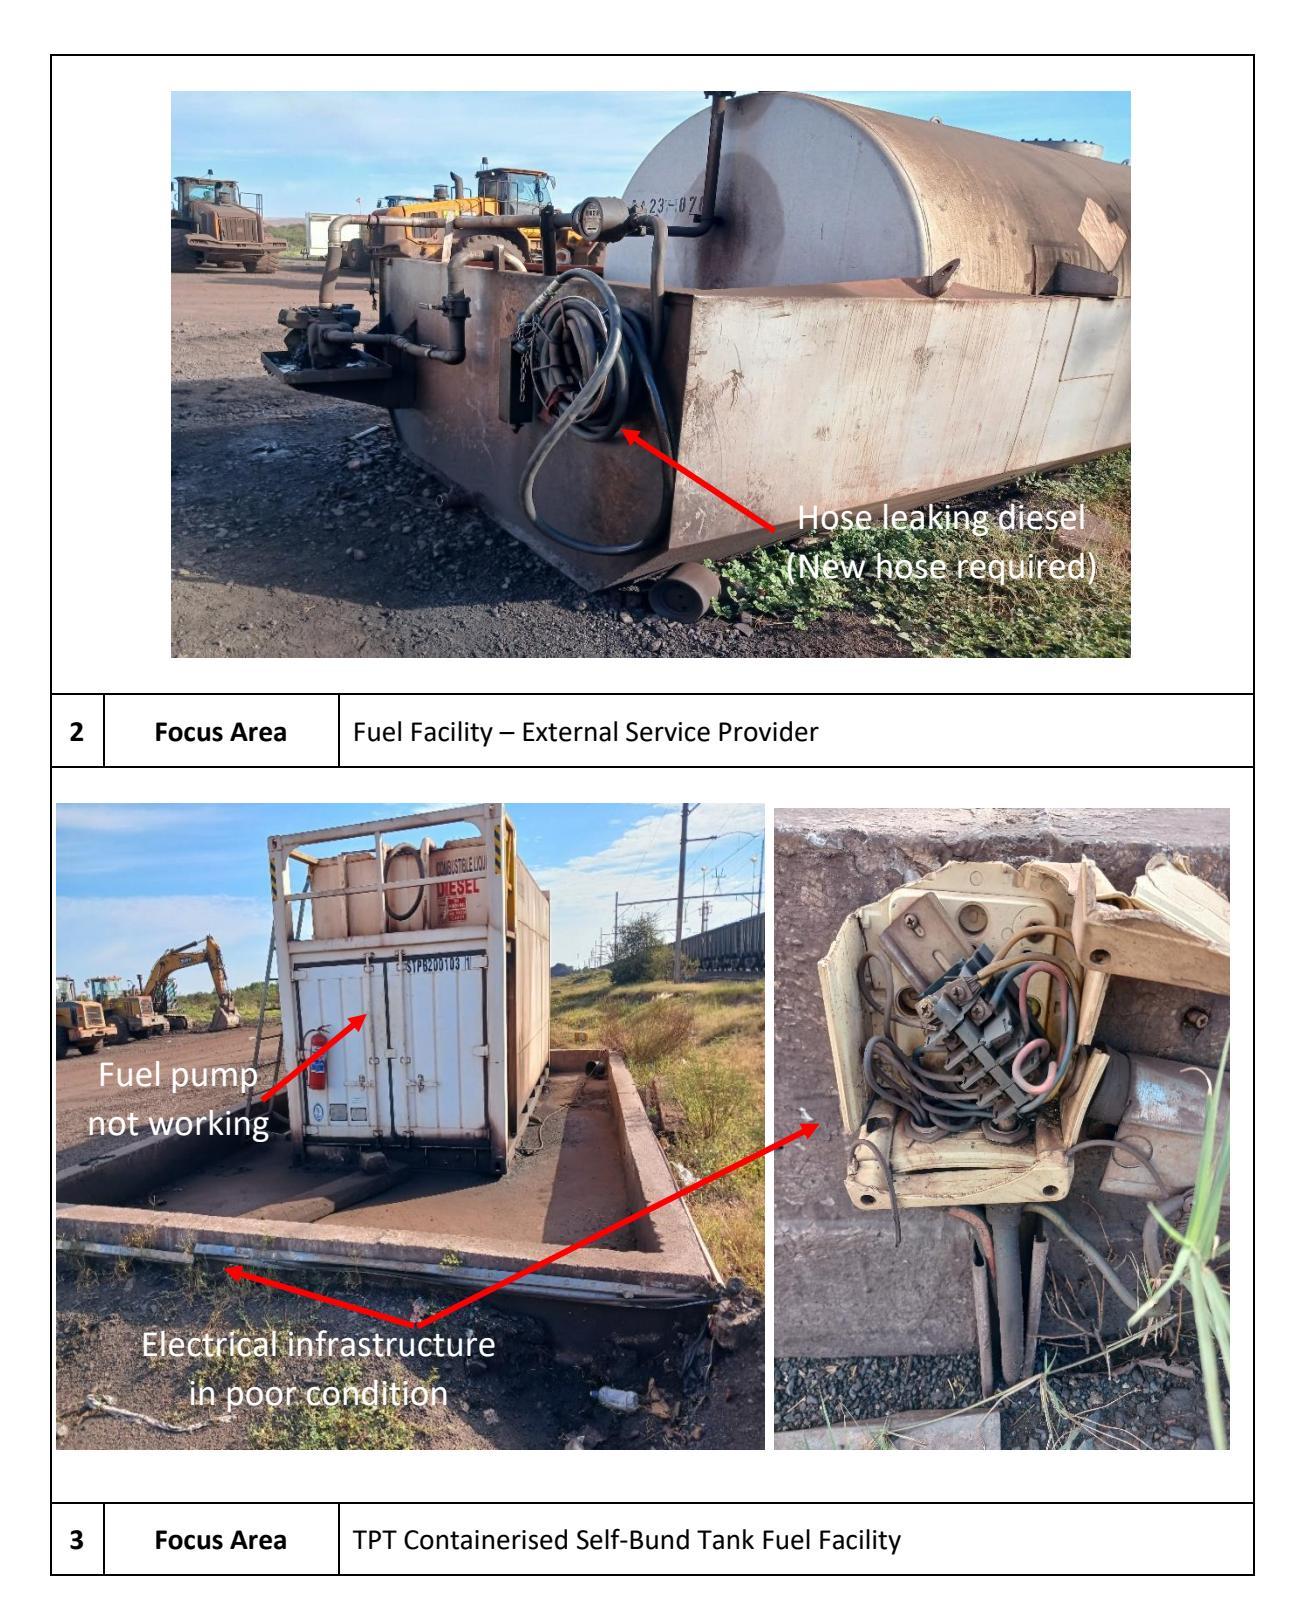
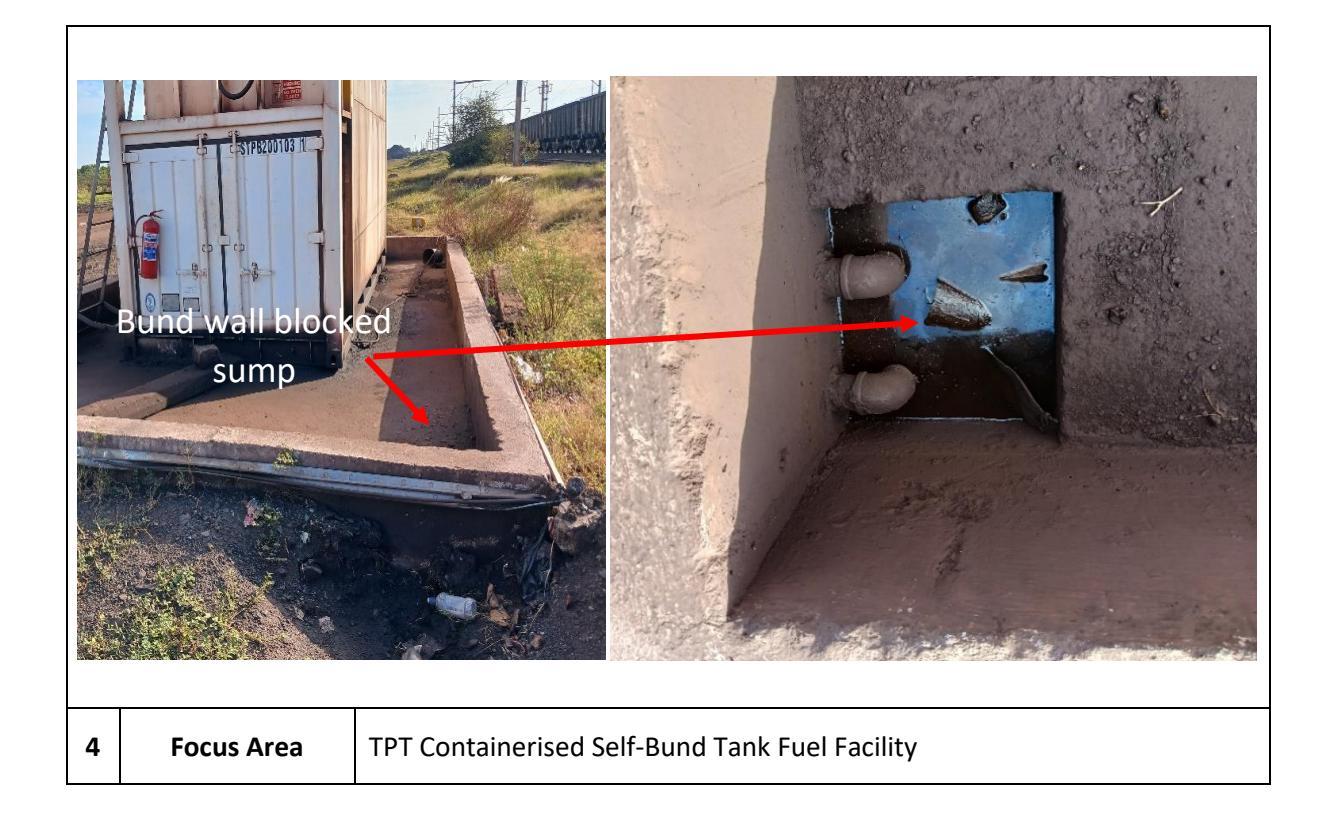
Summary of condition of the fuel facility during the site inspection on 29 February 2024, as illustrated by the following sample photographs below;

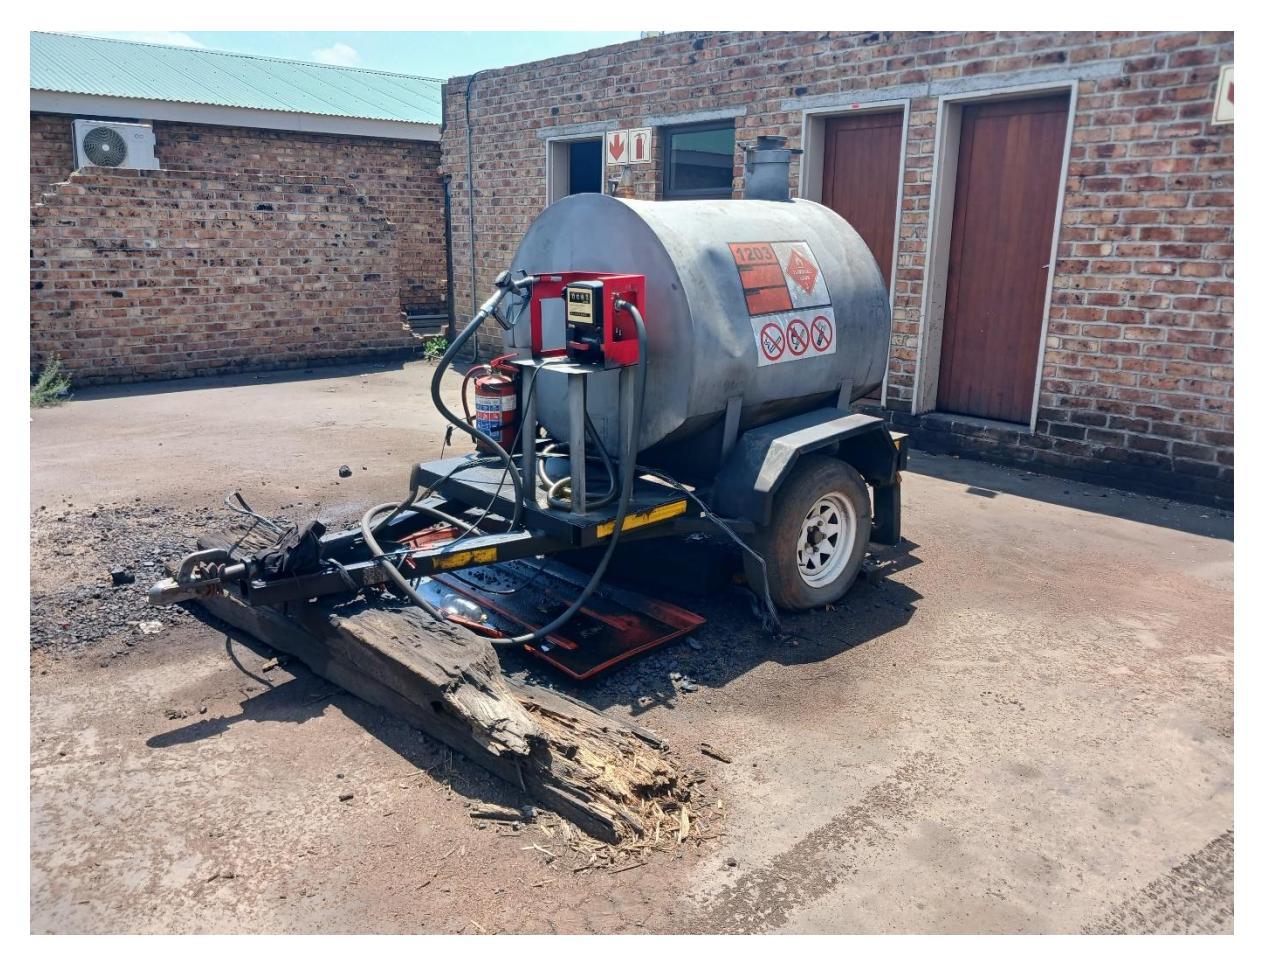
Figure 3: Kendal Terminal – Rented mobile diesel bowser.

- The terminal does not have a permanent fuel facility.
- The site is using a rental mobile diesel bowser (2000 litre capacity).
- The terminal has a high diesel run out risk exposure that is caused by limited tank capacity of 2000 litres that require regular diesel top-ups.
- The terminal is experiencing high fuel delivery frequency throughout the month, which is affecting the operations negatively because at times the supplier can't keep up with small volume deliveries.

• Install a permanent fuel facility (i.e., containerised self-bunded tank).

- For the interim solution, increase the size of the rented mobile bowser to at least 5000 litre capacity.
- Consider reusing the existing bund wall to place a suitable sized containerised self-bund tank.

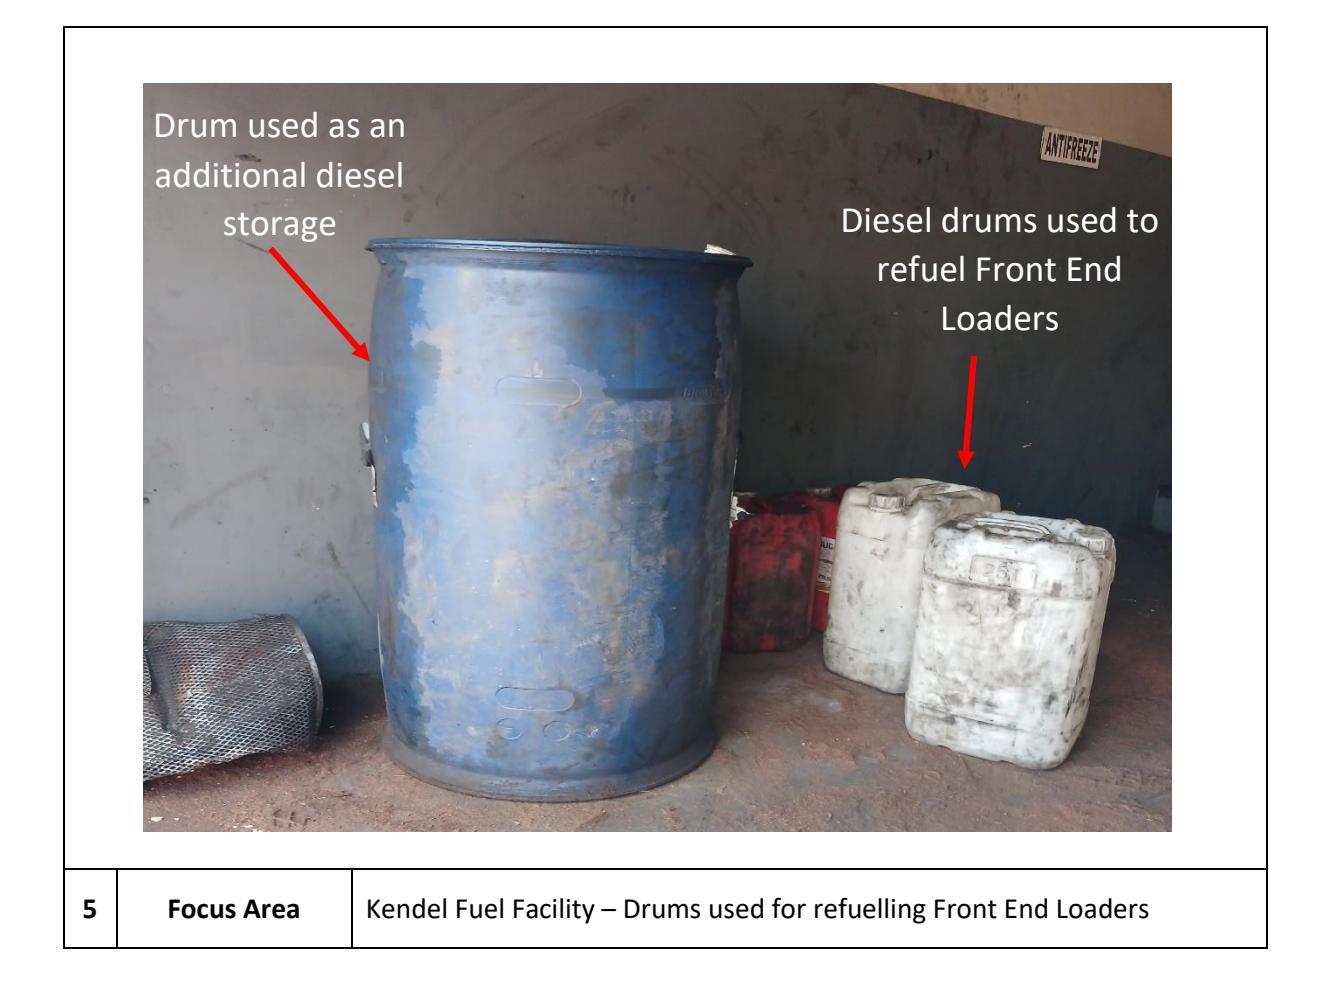
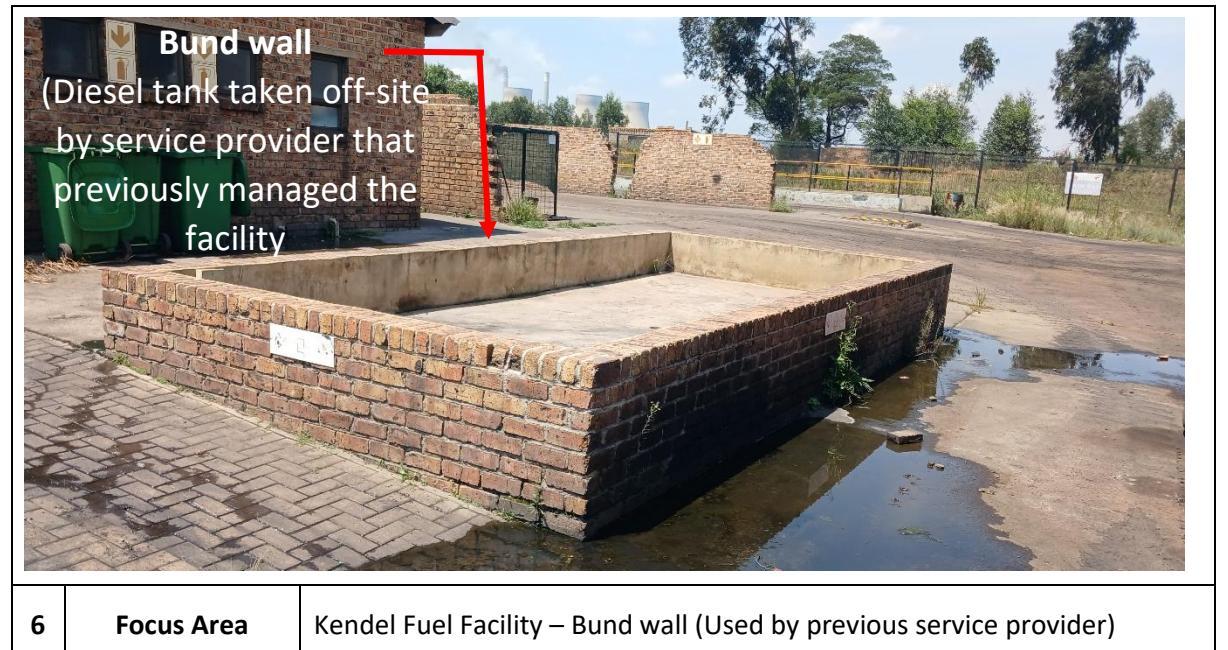
Summary of condition of the fuel facility during the site inspection on 01 March 2024, as illustrated by the following sample photographs below;
