Annexure G:  
Hydrographic And  
Geophysical Survey  
at Latimer's Landing  
– Preliminary  
Report

**HYDROGRAPHIC AND GEOPHYSICAL SURVEY AT  
LATIMER'S LANDING, PORT OF EAST LONDON**

East London Quay Wall  
East London Quay Wall: Final  
Geotechnical Report

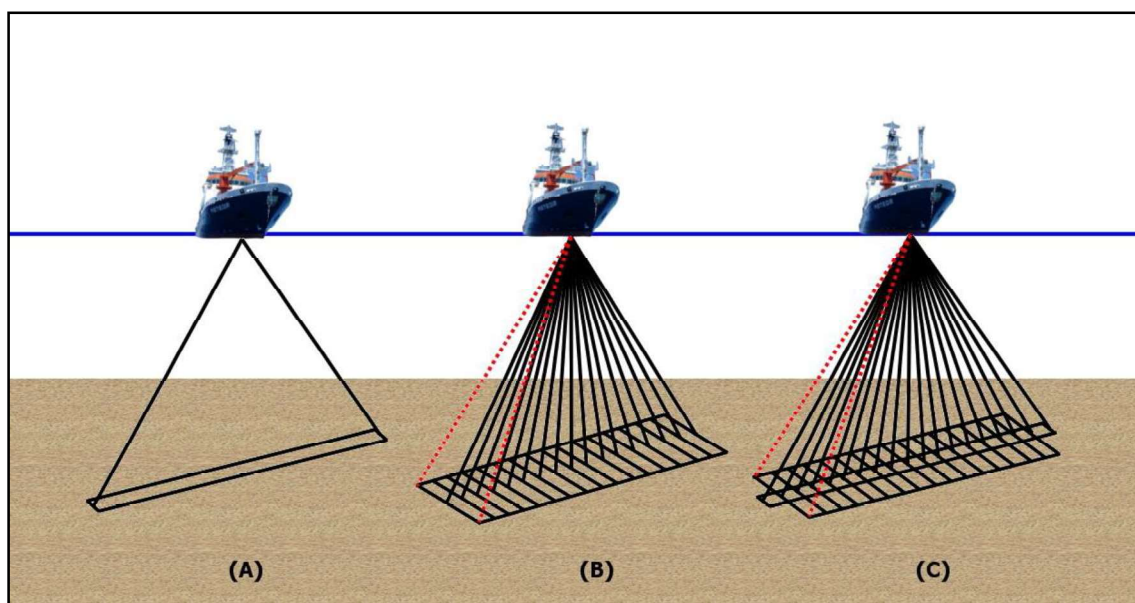
**Figure 2. Relationship of the transmit and receive beams for MBES. (A) Area of seafloor insonified by transmission pulse, (B) Area of seafloor covered by receiving hydrophones, (C) Received acoustic energy. Modified from Renard and Allenou (1979).**

Conventionally echosounders determine the travel time of the acoustic pulse by detecting the sharp leading edge of the return echo (Mayer and Hughes-Clark, 1995). This method of bottom detection is referred to as amplitude detection. As the angle of incidence increases, the return echo loses this sharp leading edge and the accurate determination of depth via amplitude detection becomes more difficult (Galway, 2000). MBES systems overcome this problem by determining the phase difference between two beams pointing in the same direction over the duration of the return echo envelope (Galway, 2000). The point at which there is no phase difference, corresponds to the maximum response axis of the beam, providing a measure of two-way travel time for a known angle from which a depth to the seafloor can be determined (Mayer and Hughes-Clark, 1995). Most MBES systems will compute both amplitude and phase bottom detection for each beam and then the software will select the better of the two for that specific beam (Galway, 2000).

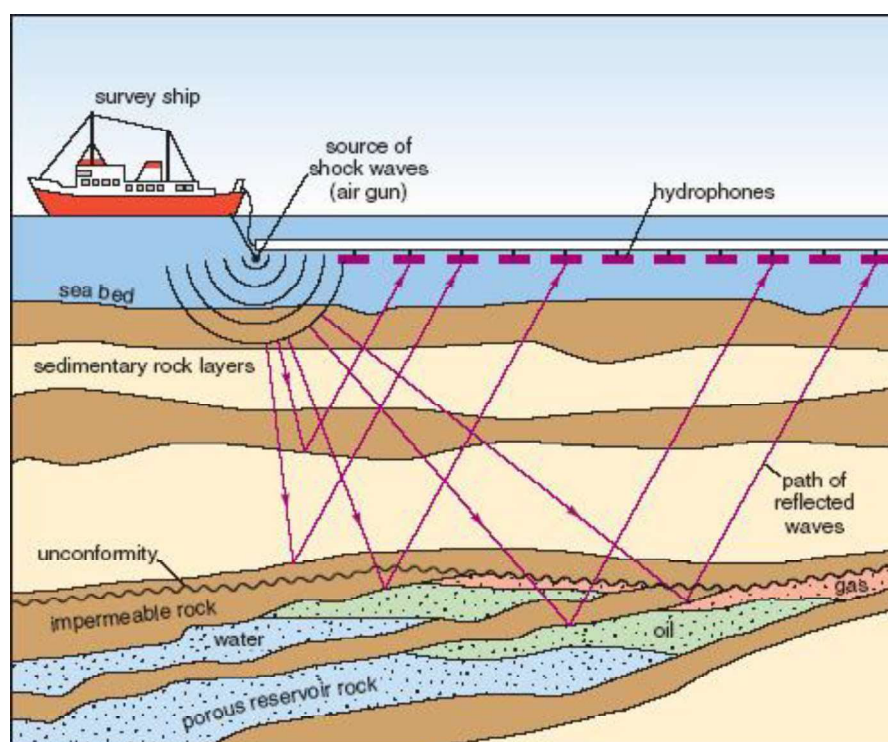
Figure 3. The principles of reflection seismics, as utilised by both seismic systems.

The principles of seismics are the following: A transducer “fires” sending a low frequency sound wave into the water column. Due to the low frequency, the sound wave is able to penetrate the sub-surface sediment. Wherever there is a marked difference in sediment density (the contact between different sediment types) part of the sound wave is reflected back towards the surface. This reflected wave is received by the transducers and digitized in the correct spatial frame. A simplified schematic of the process for oil and gas exploration is shown in Figure 3. The principles are the same for the CGS pinger and boomer system, in that there is a seismic source, which reflects off the internal layers of sediment and is recorded by a receiver.

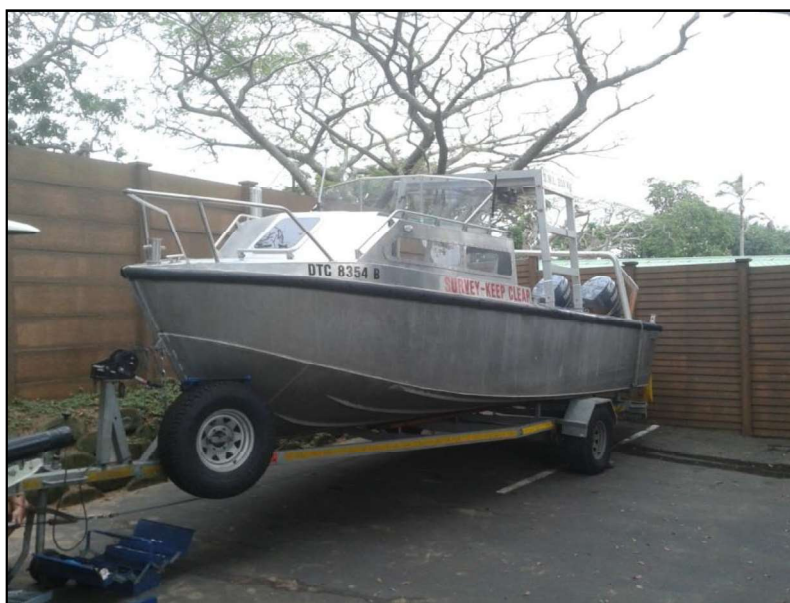
Figure 5. The nearshore survey vessel *R/V CSIR Surveyor*.

The nearshore vessel *R/V CSIR Surveyor* (Figure 5) was used for the collection of all geophysical data. She is an 8 m, custom-built, aluminium monohull. She is powered by two 100 Hp Yamaha four-stroke outboard motors. Due to her shallow draft of approximately 0.6 m she is able to safely navigate into extremely shallow water (surf permitting), to maximise data acquisition and area coverage.

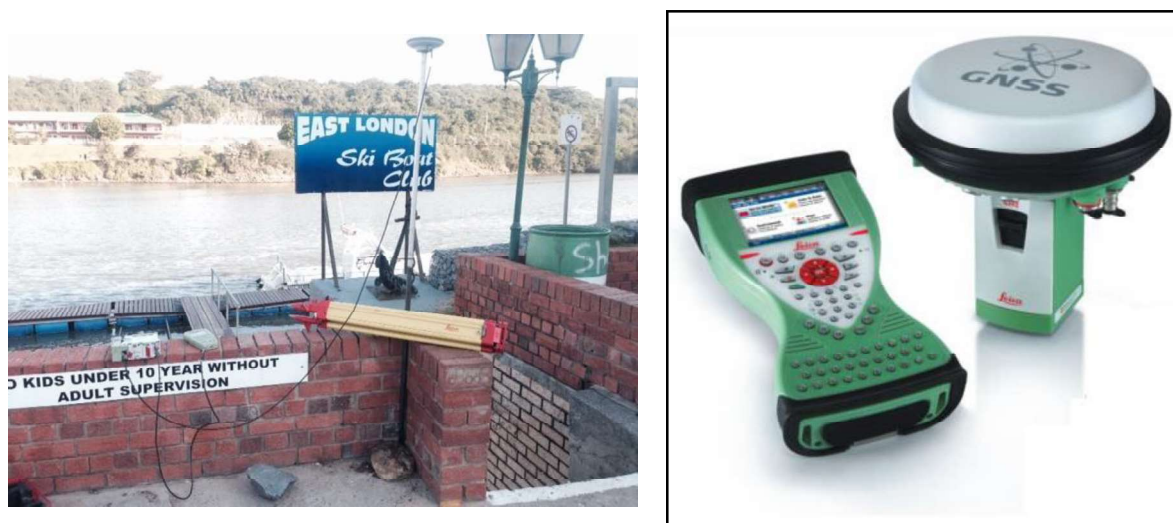
**Figure 6: Leica base station (left) and GS15 controller and GNSS GS15 receiver (right).**

The precision of the horisontal and vertical positioning data was within 3 cm during the survey.

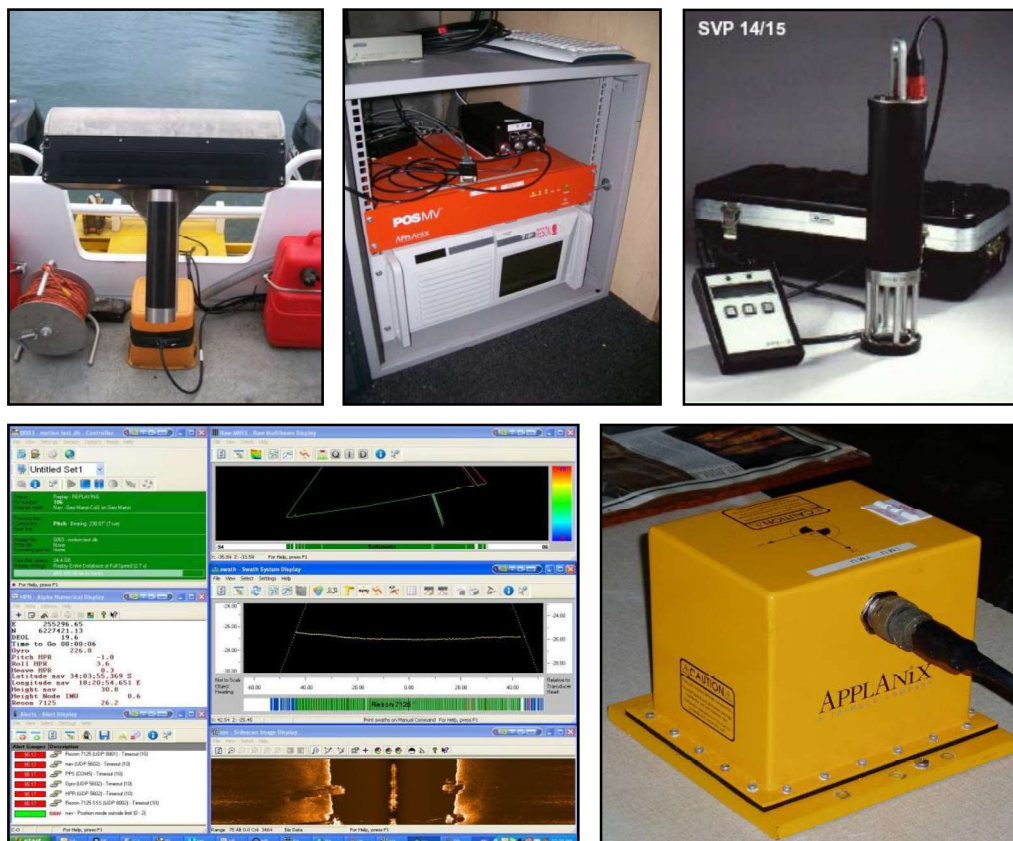
**Figure 7. Multibeam acquisition system: Reson SeaBat 8125 sonar (top left), processing unit (top middle), Applanix POS MV motion reference unit (bottom right) and processor (top middle), Navitronic SVP-15 sound velocity probe (top right) and *Qinsy* acquisition and processing software (bottom left).**

The SeaBat was interfaced to an Applanix POS MV 320 motion reference unit (MRU) with L1/L2 RTK capability. As an integrated GPS/inertial reference system, the POS MV outputs all motion variables at high rates of up to 200 Hz even in the presence of GPS dropouts or degraded differential GPS corrections. The data output variables include RTK positioning and elevation, velocity, 3D attitude (roll, pitch and true heading), heave (and true heave),

acceleration vectors and angular rate vectors. This high-specification system is the highest precision motion reference unit for use with multibeam sonar systems. The multibeam system was calibrated with a Navitronic SVP-15 sound velocity probe (SVP), which can accurately measure the velocity of sound in the water column in 0.5 m increments down to a depth of 200 m. All data from these devices were acquired and processed using *Qinsy* software.

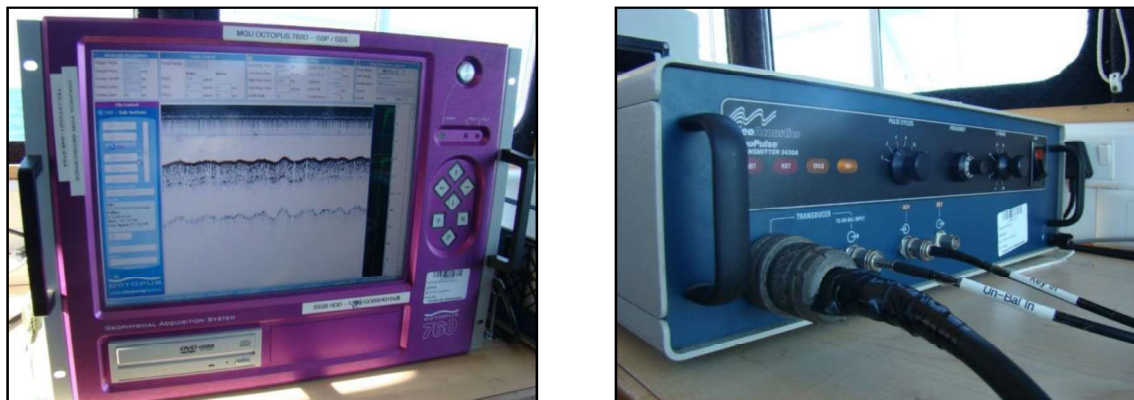
**Figure 7. Pinger seismic profiling equipment of Octopus 760D acquisition unit (left) and GeoAcoustics Geopulse transmitter (right).**

Octopus 760D seismic processor was used to acquire and store the seismic data in SEG-Y format. It is used for real-time processing, digital recording and as a post-processing workstation. Onboard processing facilities include swell filtering, stacking, water column blanking, time varied band pass filtering, time varied gain, and automatic bottom tracking.

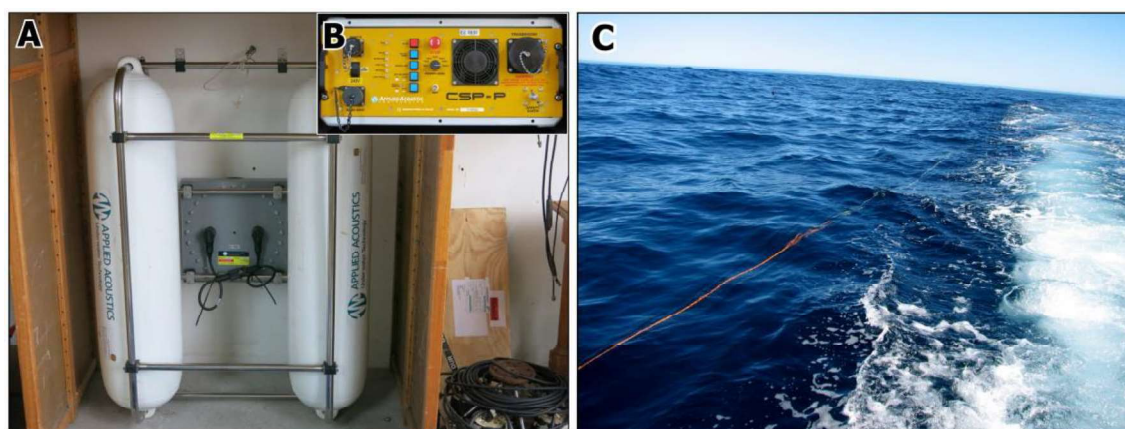
**Figure 8. Boomer seismic profiling system comprising plate and catamaran (A), power supply (B) and towed hydrophone array (C).**

An Applied Acoustic Engineering AA251 350J (1 kHz) boomer plate powered by a CSP-P 300 power supply (manufactured by the same company) was used for the acquisition of the boomer sub-bottom profiling data. The plate was used in conjunction with a Design Projects eight element hydrophone array which was interfaced with an Octopus 760D seismic processor to acquire and store the seismic data in SEG-Y format. The Octopus was used for real-time processing, digital recording and as a post-processing workstation. Onboard processing facilities include swell filtering, stacking, water column blanking, time varied band pass filtering, time varied gain, and automatic bottom tracking.

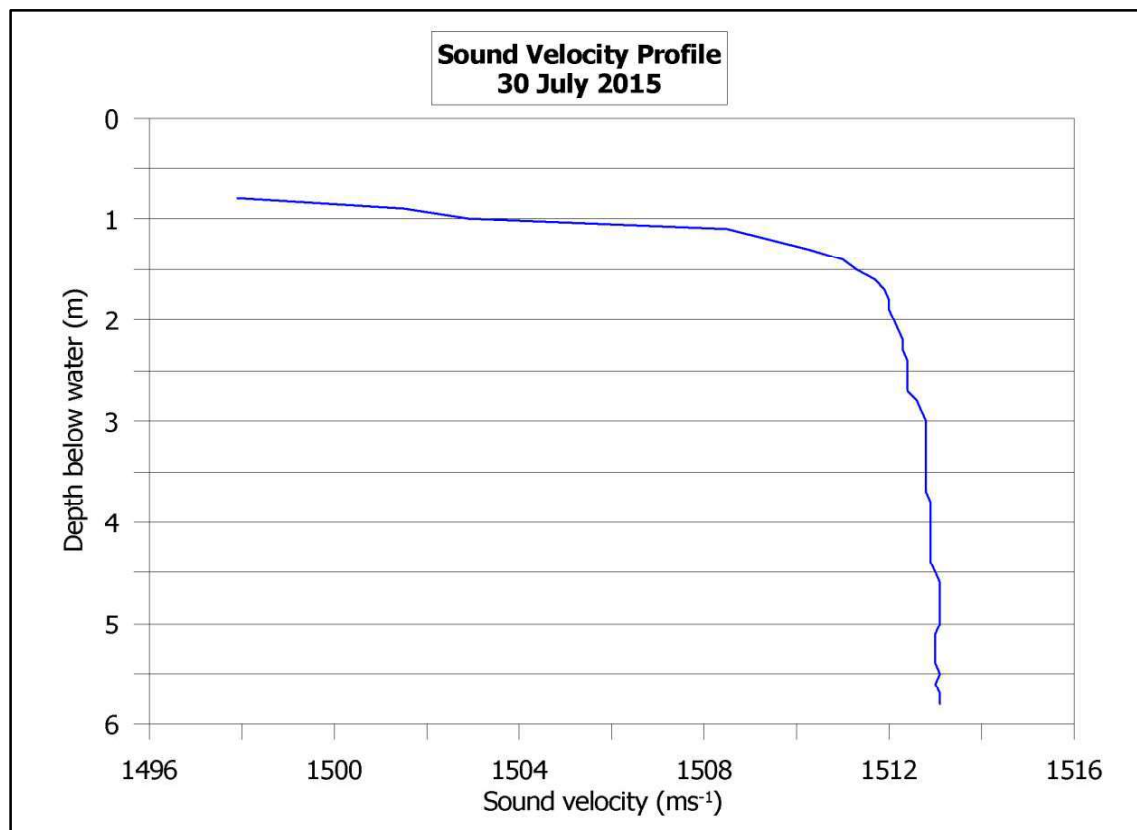
Figure 9. Sound velocity profile collected on site and used for the calibration of the geophysical equipment suites.

The calibration of the echosounder through the water column was done using a sound velocity probe at the survey area. The sound velocity profile was used by *Qinsy software* for calibration the echosounder data.

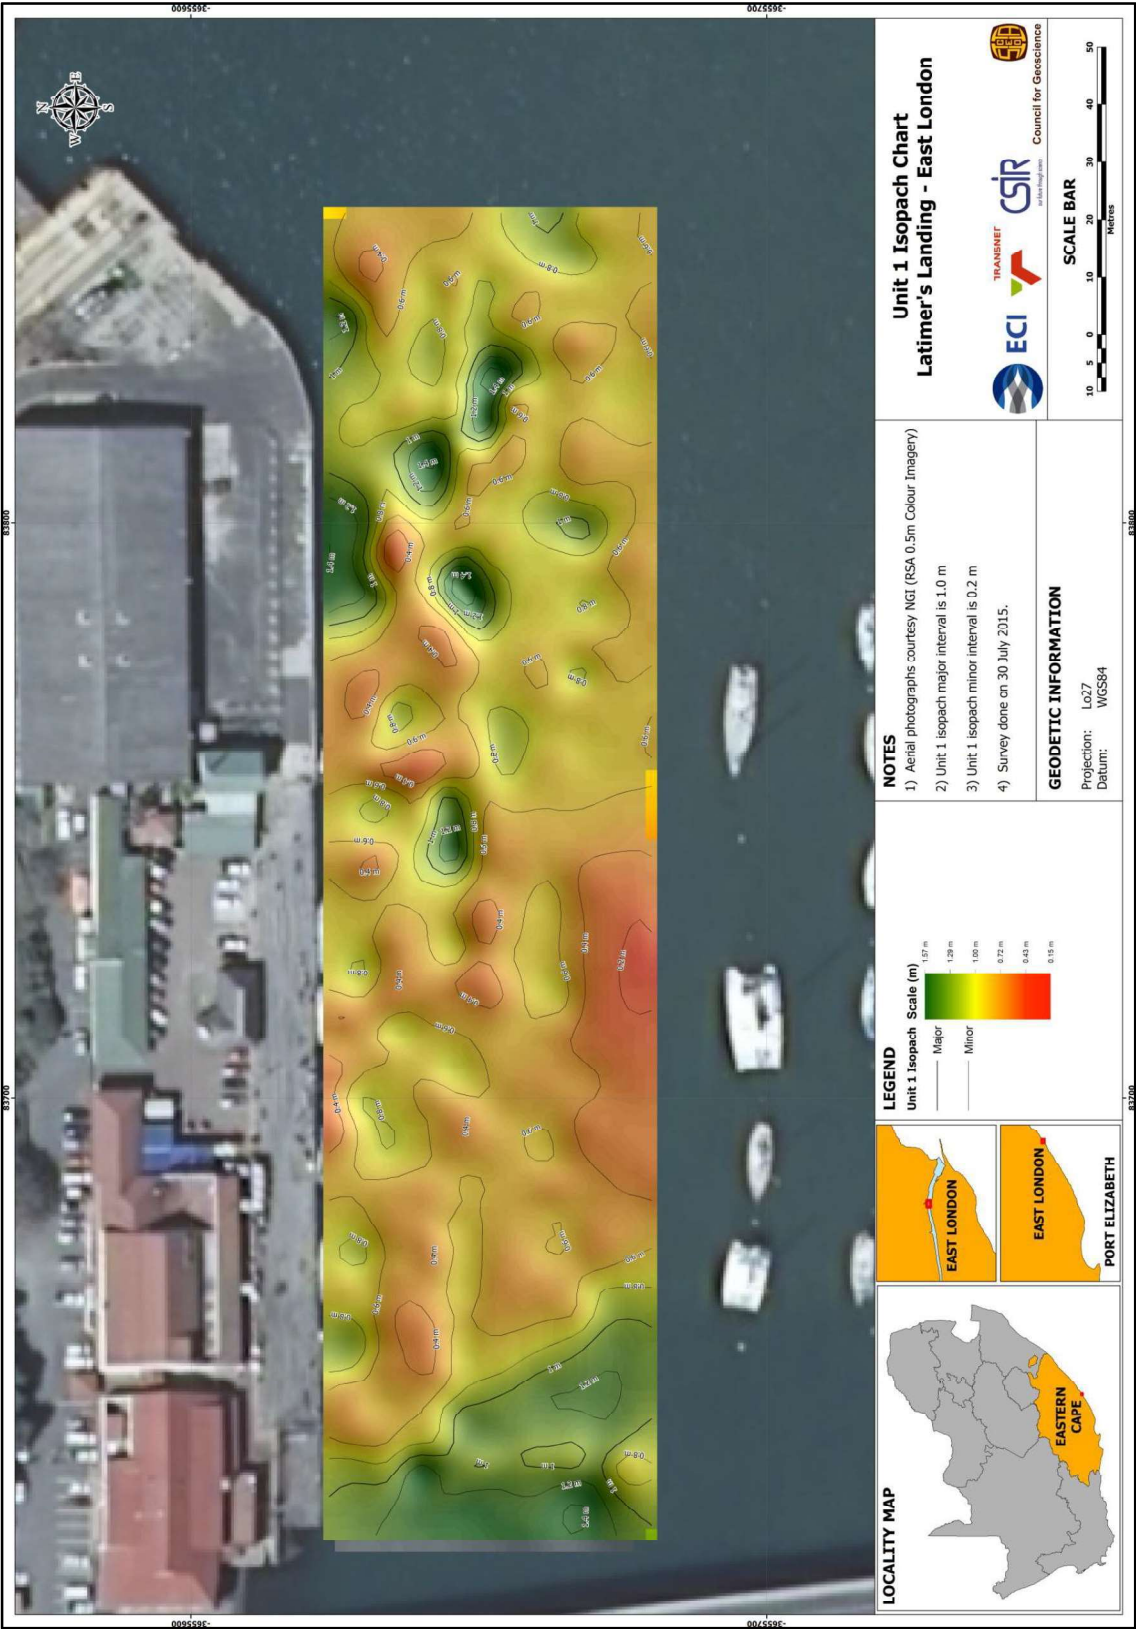
Figure 14. Unit 1 isopach for the area adjacent to Latimer's Landing.

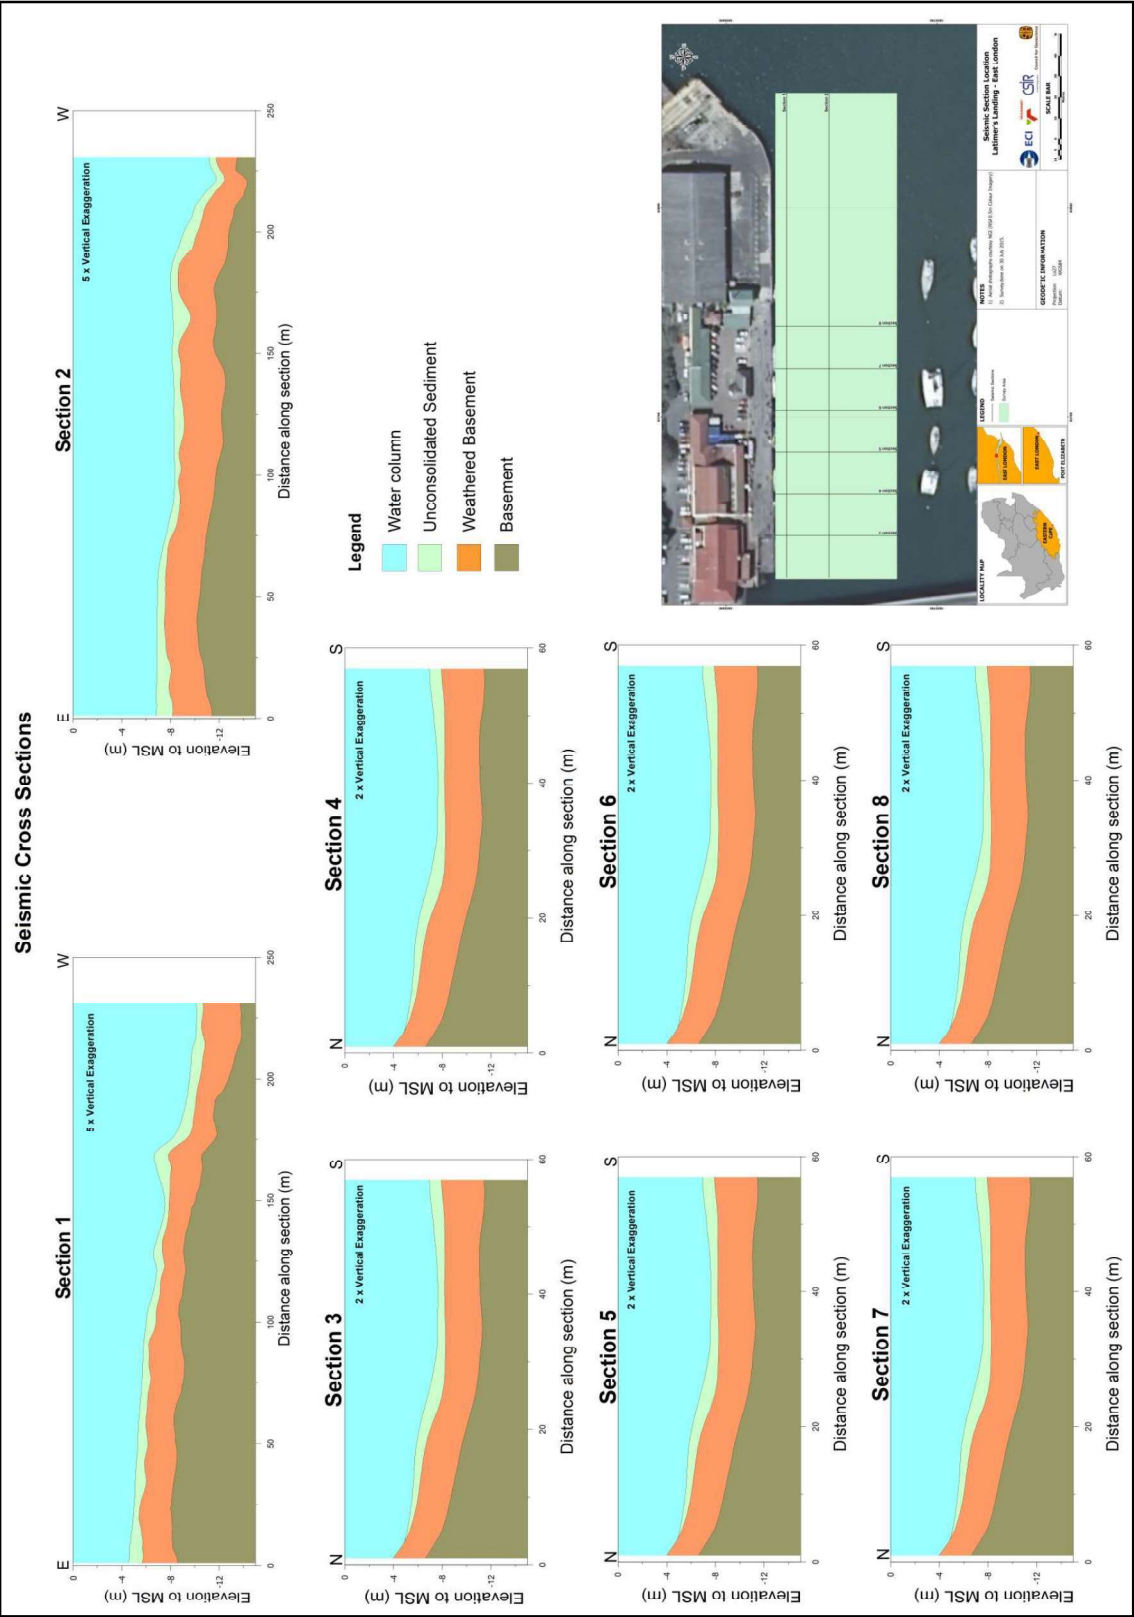
Figure 17. Cross sectional profiles of the sub-bottom geology.

The morphology of the basement has been formed and altered primarily by the erosive power of the Buffalo River with the palaeo-channel and thalweg of the river evident from the seismic surfaces. This basement morphology appears to be the controlling factor in the morphology of all of the layers above it with all exhibiting similar morphological trends. There are instances of isolated basement depressions which the authors would attribute to potholes which have developed in the basement.

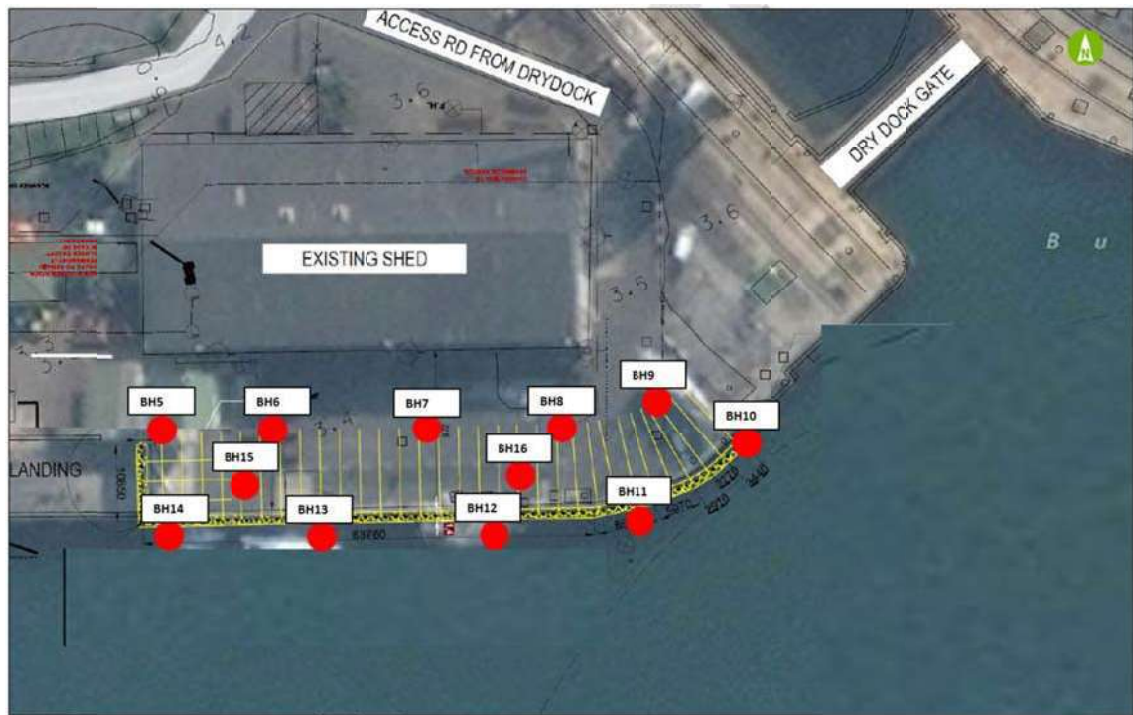
Figure 2: Borehole positions

A site layout plan and photographs were obtained from the Terreco geotechnical investigation report, which was dated November 2012. These were used to set preliminary positions of the initial 10 proposed boreholes. The final borehole positions were set out by Aurecon's representatives using a hand held GPS. Two additional boreholes were set out , following a request from TNPA. The off-shore boreholes were drilled off a drilling platform about 0.5m over the edge of the quay wall in the harbour basin. A total of 12 No boreholes were drilled and 8 No DPSH tests were conducted. The positions of the boreholes are shown in **Figure 2** below. Please note that the positions of boreholes BH1 to BH4, which were drilled for the Terreco investigation, are not shown on the figure below and these logs and have not been included in this report.

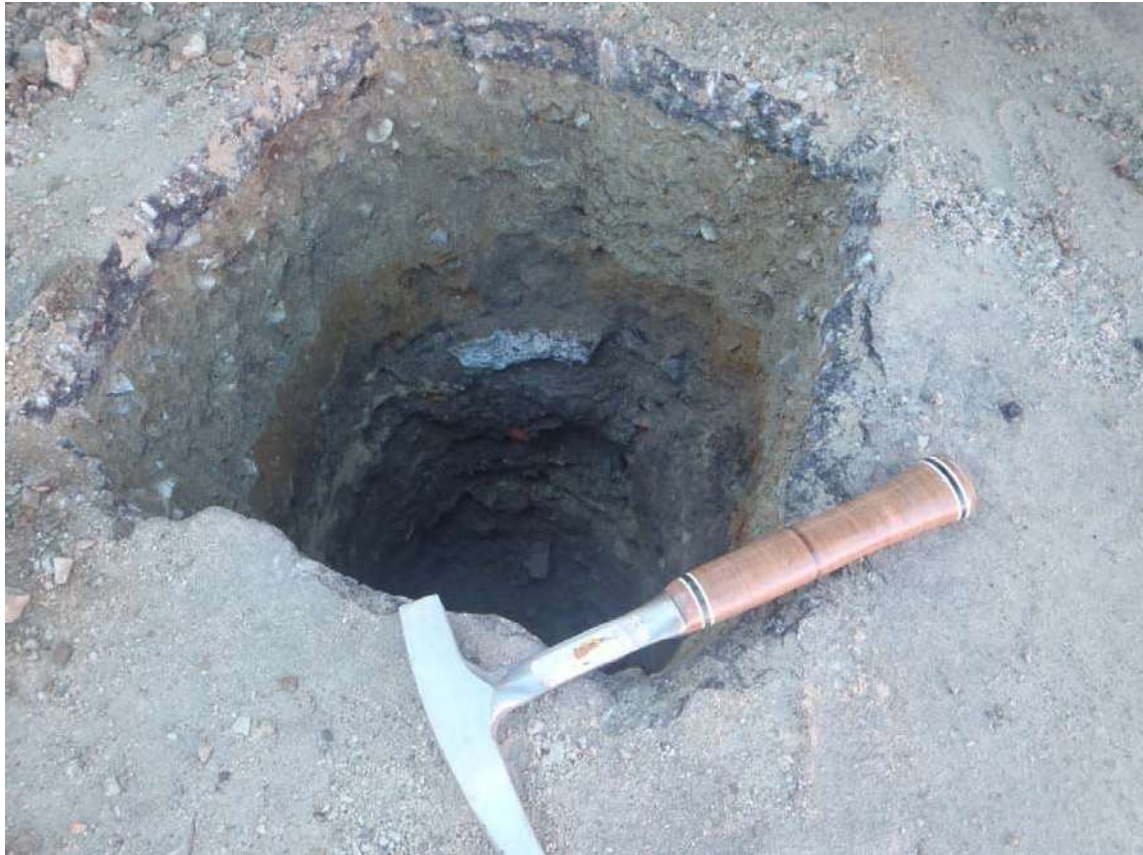
**Figure 3** below shows a picture of a trial hole excavated on the BH5 location. The compacted fill material of the quay platform is illustrated.

**Figure 3: BH5 Trial hole**

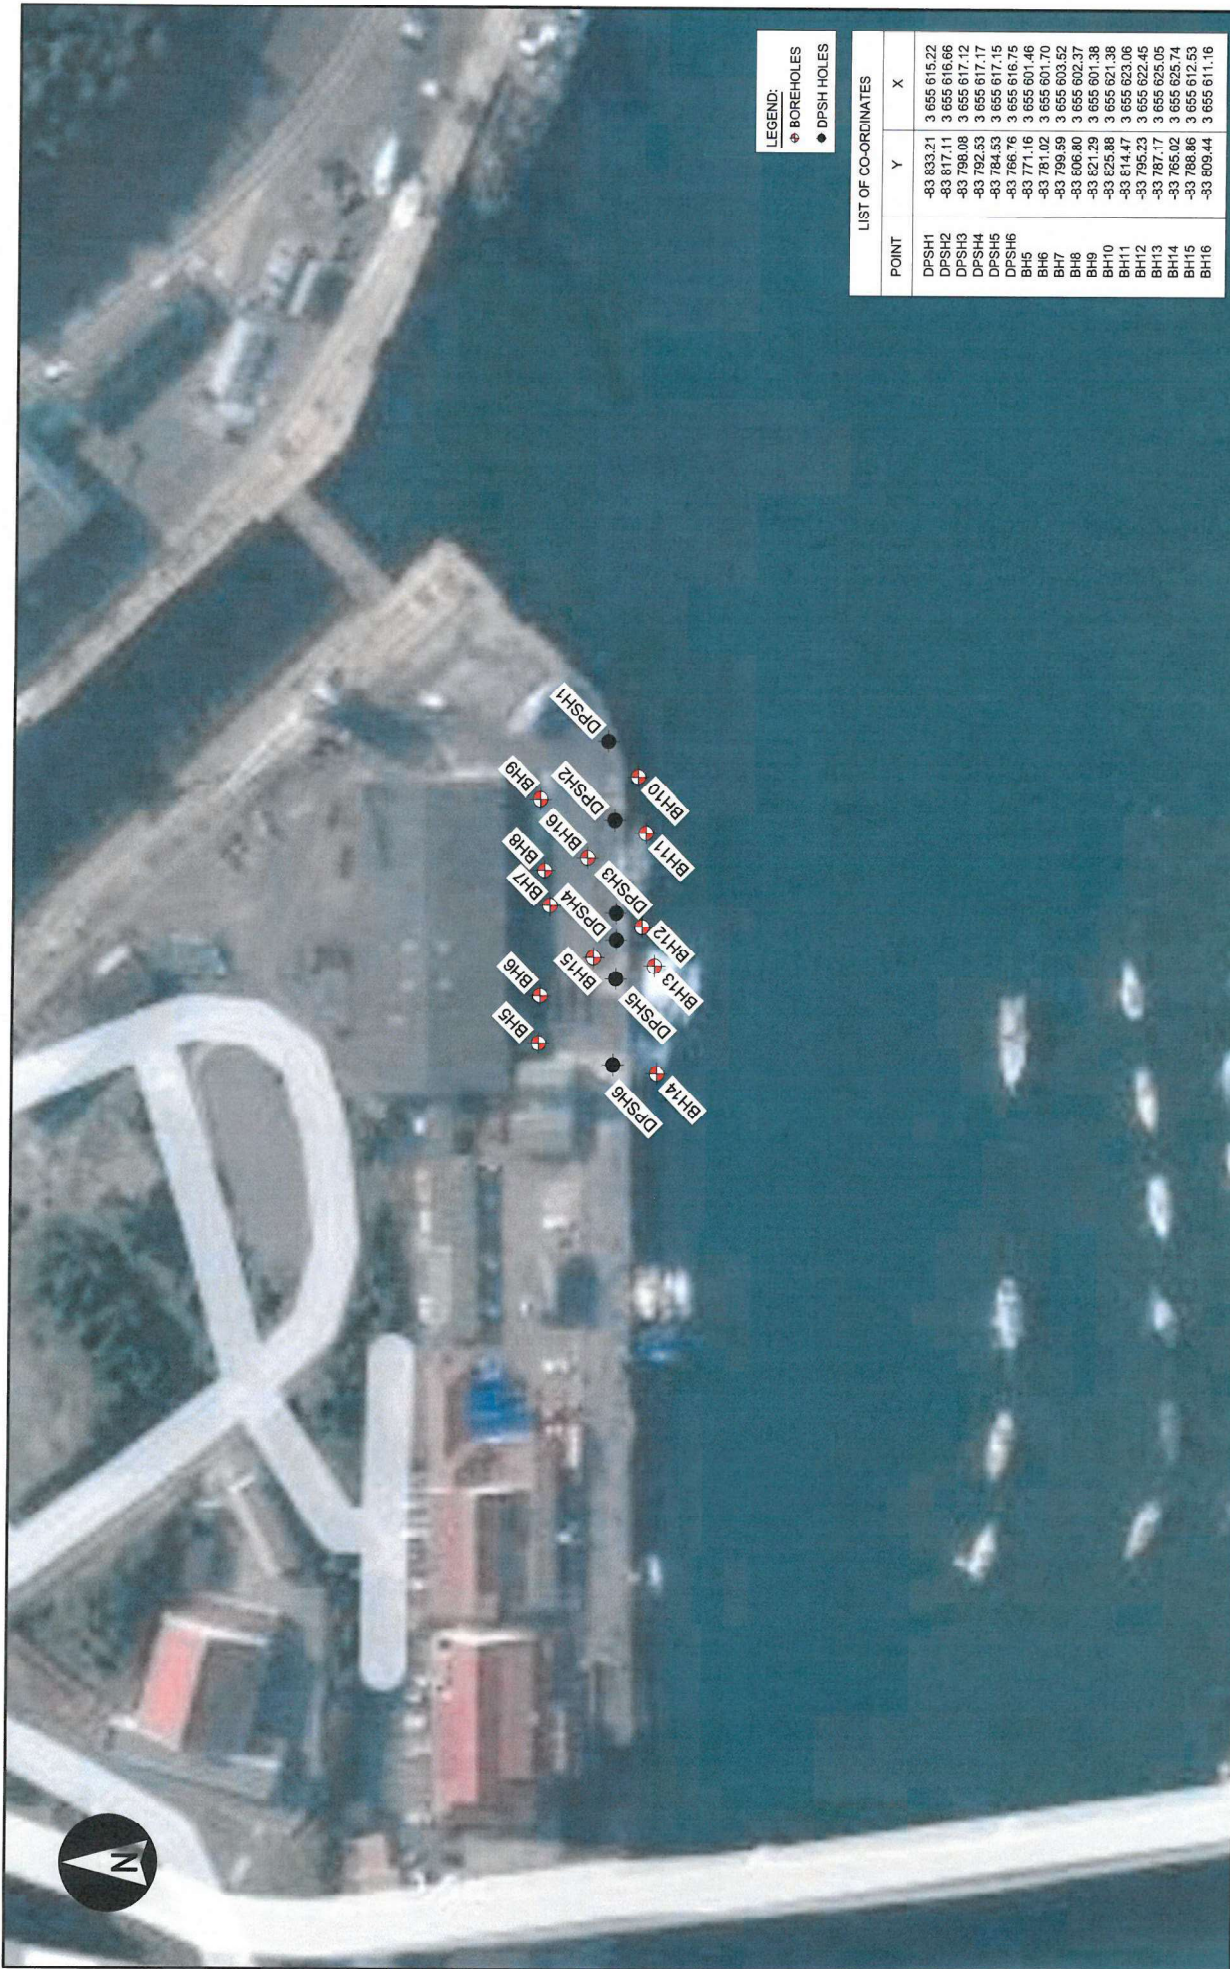
CLIENT		REVISION DETAILS		APPROVED		DRAWN		DESIGNED		PROJECT	
		REV	DATE							EAST LONDON QUAY WALL: GEOTECHNICAL INVESTIGATION	
										TITLE	
										BOREHOLE AND DPSH POSITIONS	
										PRELIMINARY NOT FOR CONSTRUCTION	
										PROJECT NO.	
										109552	
										SCALE	
										1:1000	
										REV	
										43	
										DRAWING No.	
										109552-G1-001	
										REV	
										0

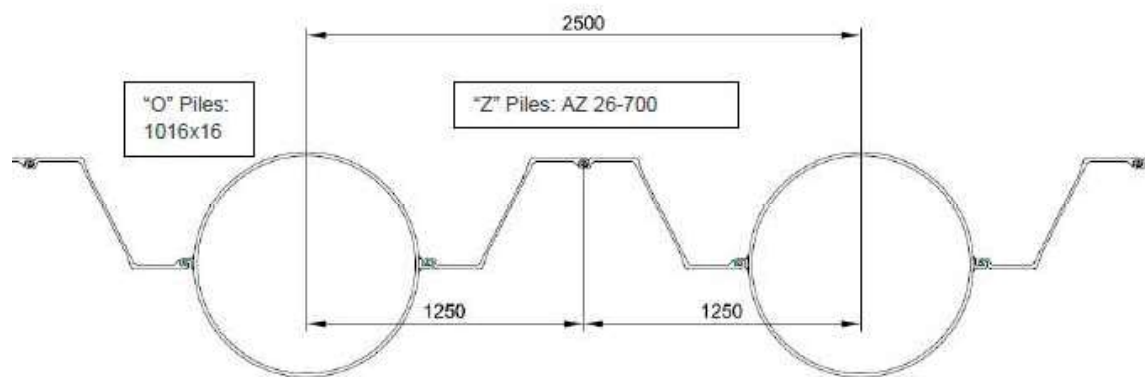
The wall parameters were obtained from the structural engineer for the chosen sheet piles detailed in the structural design report (109552-SDR-002 Rev 0). Figure 1 below shows a section through the sheet pile wall

Figure 1: Plan view section of proposed wall solution

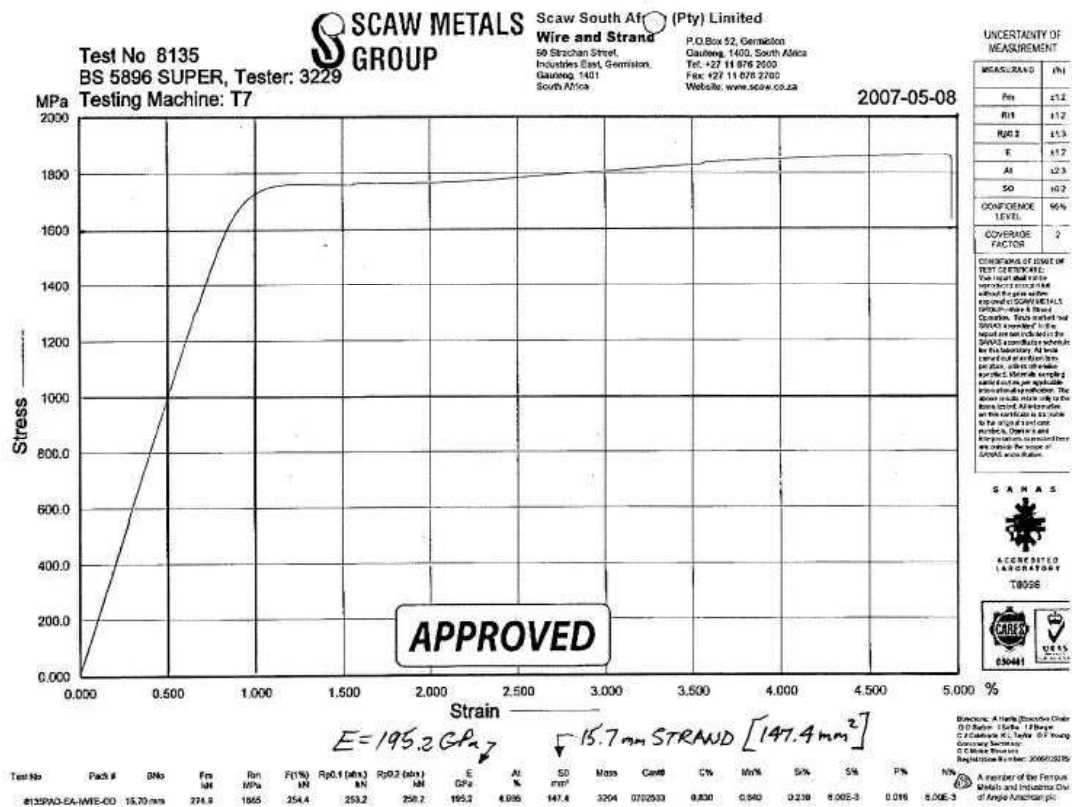
Figure 2: Approved Stress/Strain test for 15.7mm strand

<b>Anchor type (nominal diameter)</b>	<b>Strand area (mm<sup>2</sup>)</b>	<b>Ultimate Tensile Load (kN)</b>	<b>Yield Load (kN)</b>	<b>Elastic Modulus (GPa)</b>
15.7mm	150	265	233	190

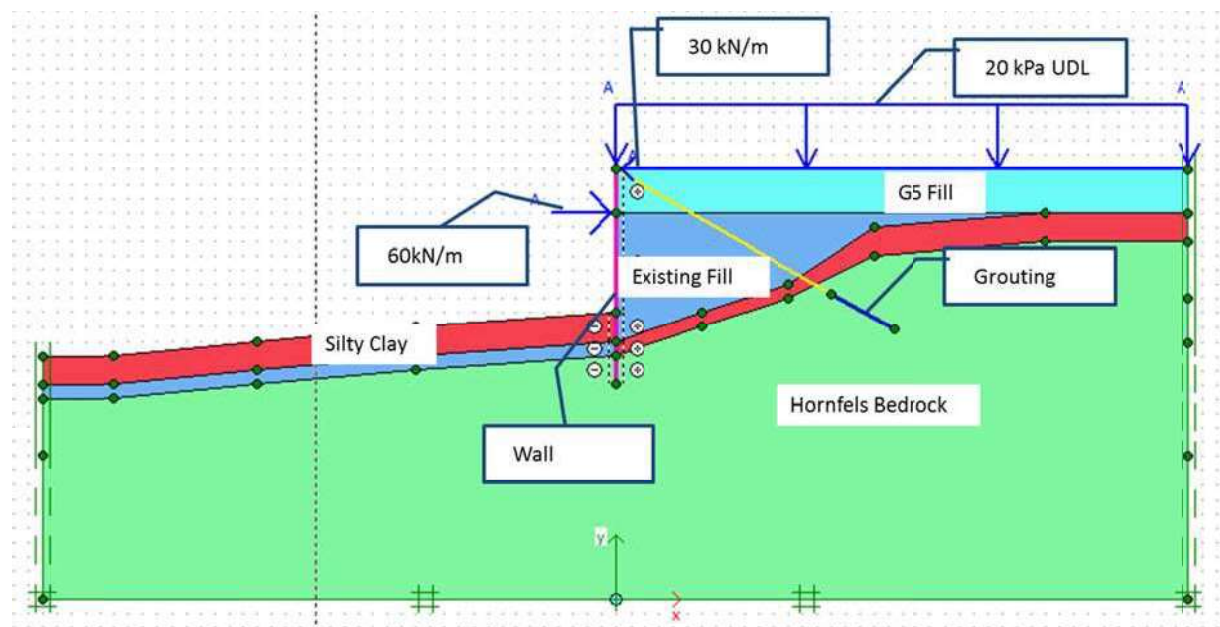
Figure 3: Plaxis 2D model of wall with anchors

Figure 3 and Figure 4 below shows the Plaxis 2D model of the wall with anchors installed and the “cantilever” wall before anchors are installed. The results of each load case are shown in the subsections that follow.

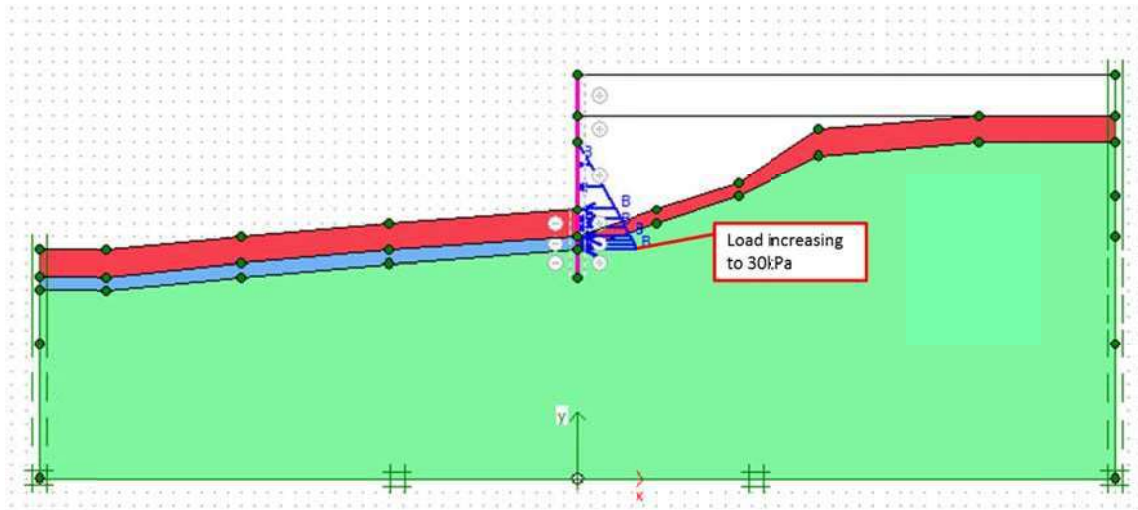
Figure 4: Plaxis 2D model of wall without anchors

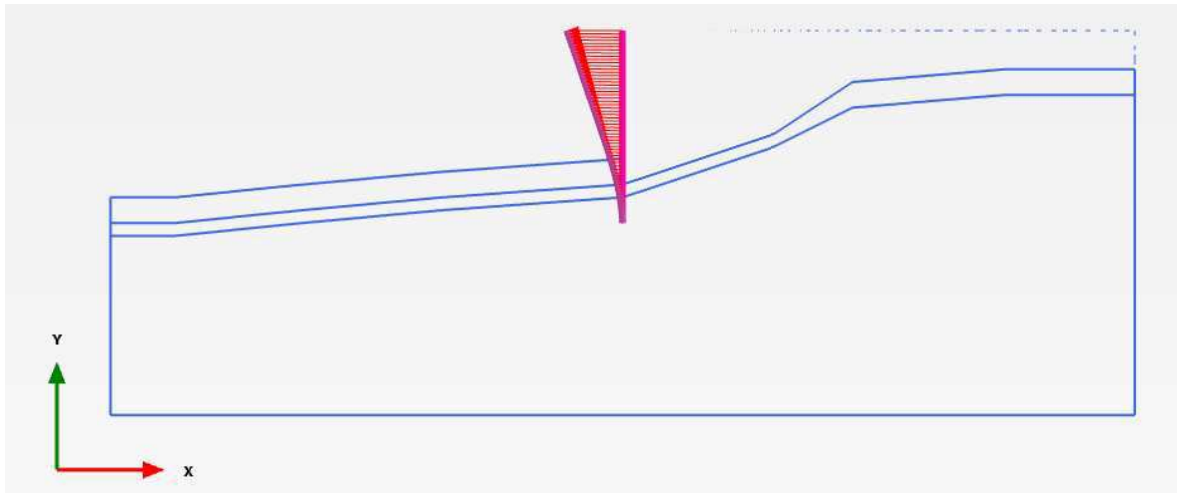
Distributed load: increasing from 0kPa to 30kPa from 8m above the base of the wall to the base of the wall. Embedded 2m into the founding rock (without anchors).

Figure 5: LC1- Horizontal wall displacements

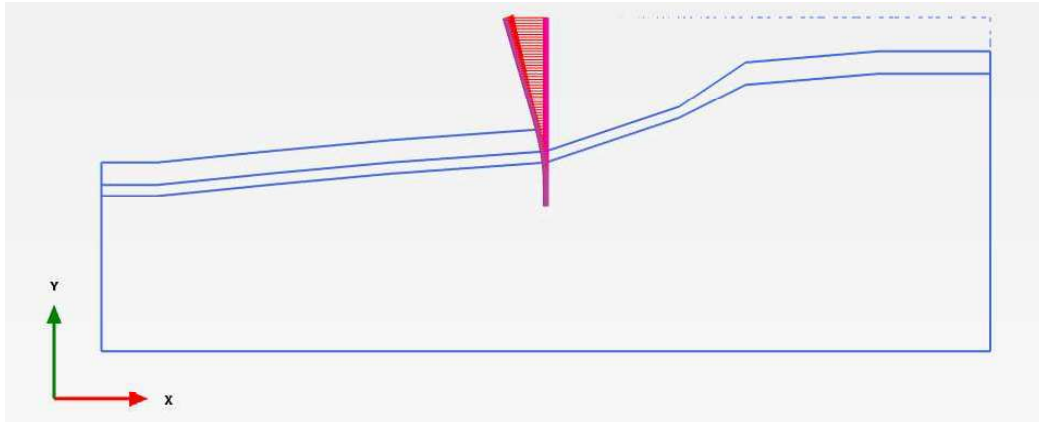
Distributed load: increasing from 0kPa to 30kPa from 8m above the base of the wall to the base of the wall. Embedded 4m into the founding rock (without anchors).

Figure 6: LC2- horizontal wall displacements

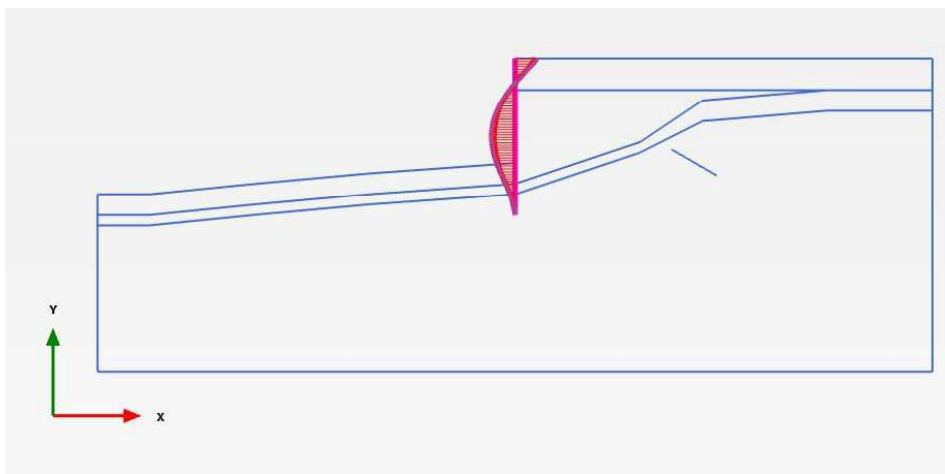
20kPa UDL load on top of the fill material.

Figure 7: LC3- Horizontal wall displacements

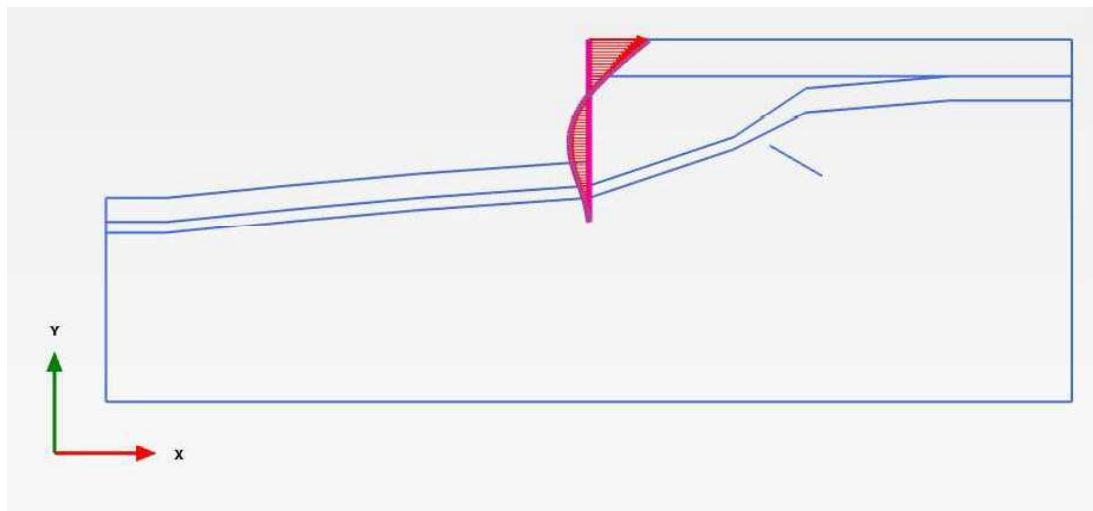
20kPa UDL + 60kN/m berthing force on the wall

Figure 9: LC4- Horizontal wall displacements

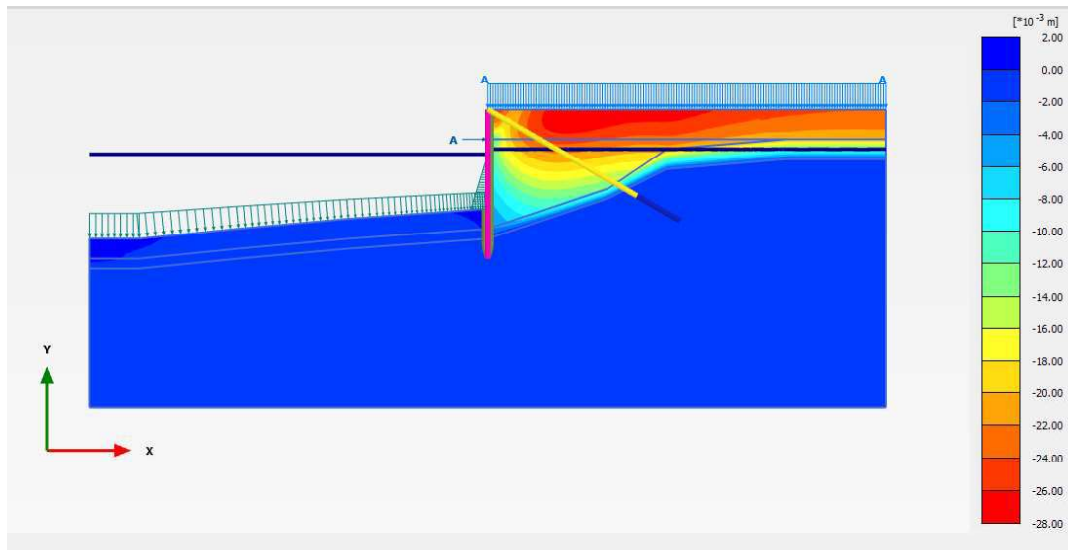
Figure 10: LC4- vertical pavement settlements

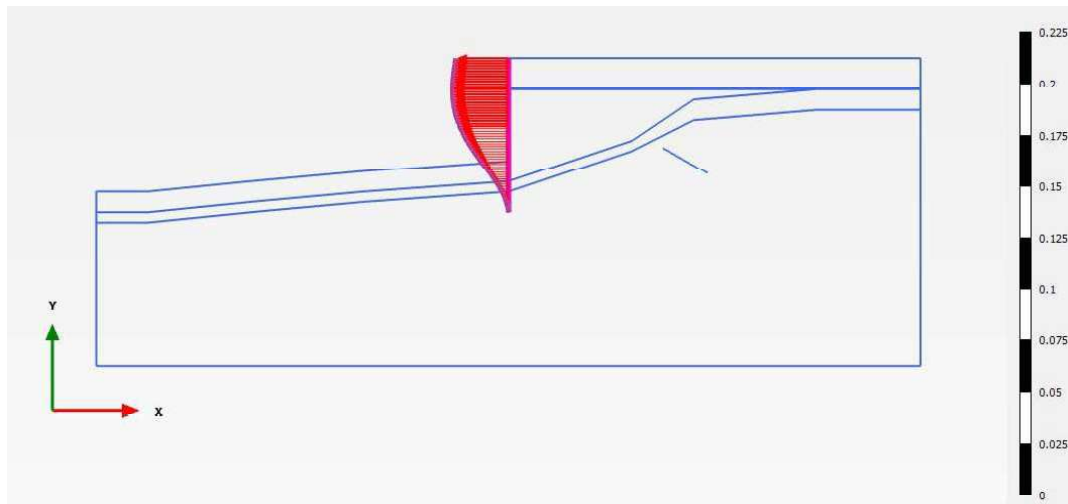
20kPa UDL + 30kN/m mooring force on the wall

Figure 11: LC5- Horizontal wall displacements

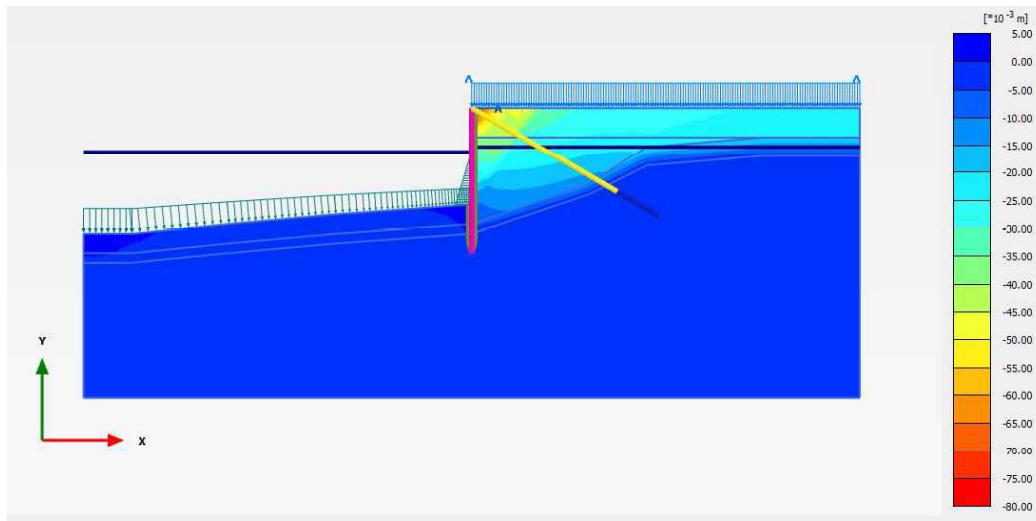
Figure 12: LC5- vertical pavement settlements

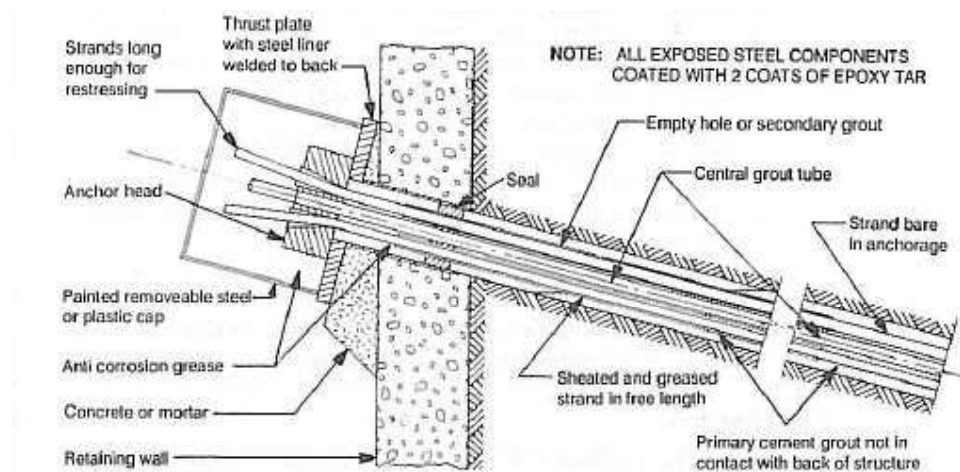
Figure 13: Typical detail for restressable permanent strand anchors (SAICE code of practice, ref 8)

- Each anchor should be prestressed to 400kN. This is 34% of the anchor yield strength. The factor of safety is 2.9.
- The anchor strands should be locked off using an anchor head with a bearing plate capable of sustaining twice the working load (2650kN). The strands must be re-stressable and should be protected with a painted removable steel cap filled with anti-corrosion grease. See Figure 10 below for typical detail for re-stressable permanent strand anchors.
