East London Quay Wall

East London Quay Wall: Final Geotechnical Report

Reference: 109552-G1-01

19 January 2014

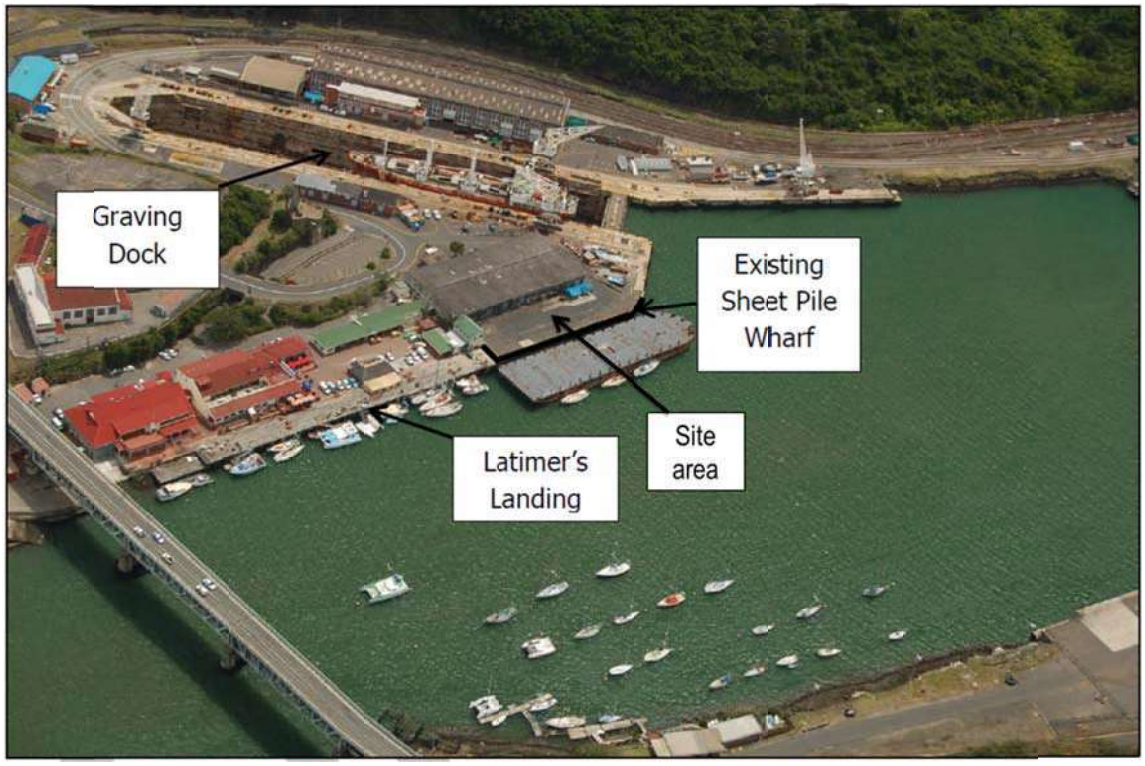
Figure 1: Aerial view of the site

The site is completely paved with no visible vegetation in and around the site. **Figure 1** below illustrates the aerial view of the site.

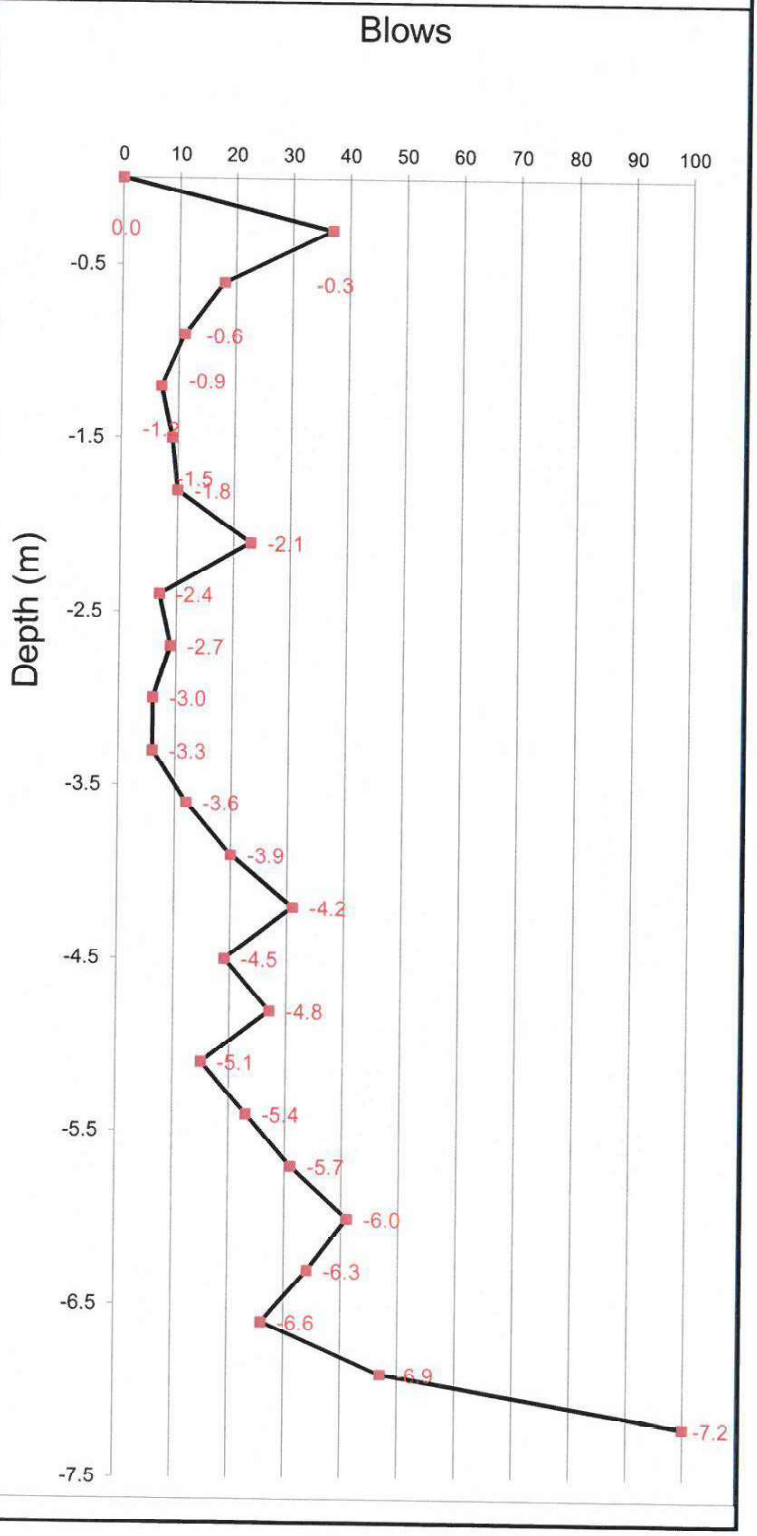
Client:	Aurecon	Test poition:	DPSH 3
Project:	East London Quay Wall	Date:	6/18/2013
Cont. No:	109552 Operator: E. Mbhele	REFUSAL DEPTH	7.2m

The DPSH depths attained varied from 5.4m (DPSH1A) to 7.5m (DPSH2) where refusal is taken as 100+ blows per 300mm. DPSH 3 in particular show loose material from about 600mm to 3.9m depth. This may be consistent with the loss of fines through the corroded sheet pile.

Compaction grouting behind the original sheet piled wall Is recommended in order to fill cavities behind the sheet pile wall and for a distance of 15m back from the quay wall.
