### CONDITION ASSESSMENT REPORT FOR THE KZN ~~ROWING~~ ASSOCIATION

Project Name : Condition Assessment (Ex-Hydro jetting &  
Industrial Services (PTY)LTD

Owner : Transnet National Ports Authority

Release Date: 02/06/2025

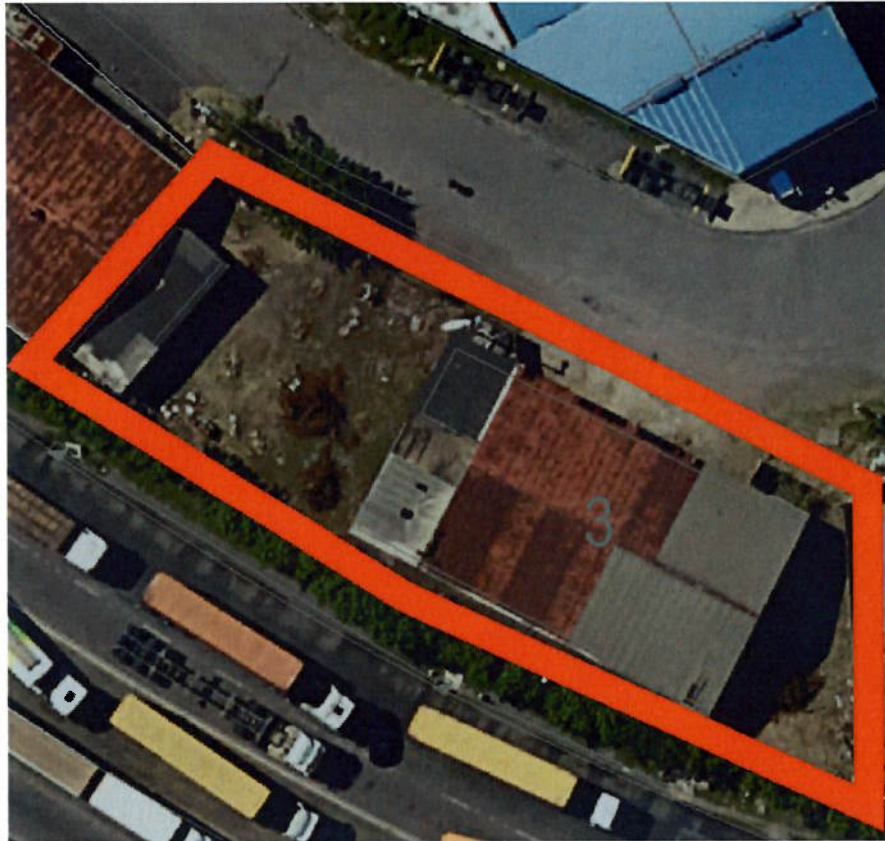
Figure 2: Site Layout

The property comprises two building structures. The property is in Grunter Gully which is predominantly a fishing wharf in Bayhead Precinct.

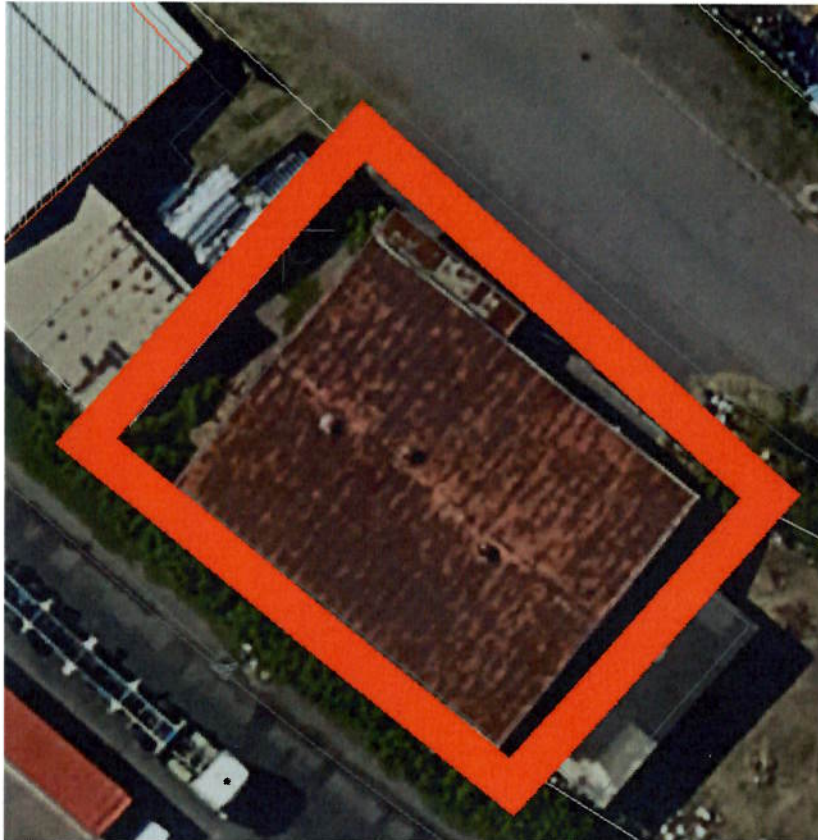
*Figure 2: Site Layout*

The property comprises one building. The property is in Grunter Gully which is predominantly a fishing wharf in Bayhead Precinct.

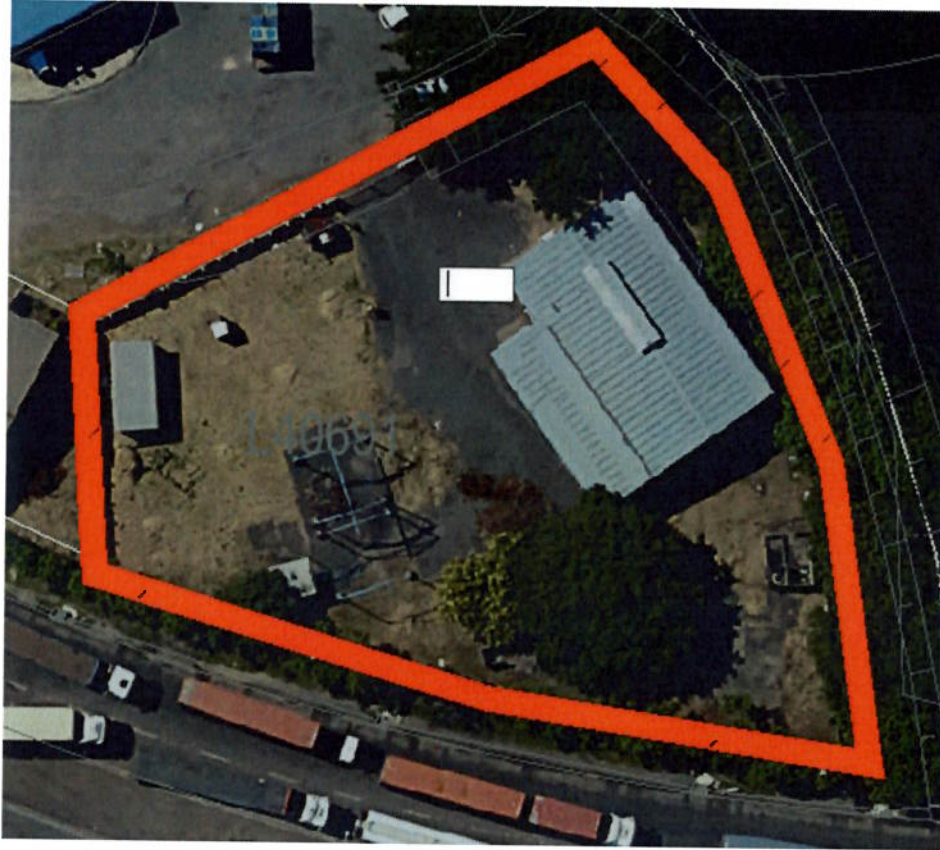
*Figure 2: Site Layout*

The property consists of two buildings. It is in Grunter Gully, a predominantly fishing wharf area within the Bayhead Precinct
