MILLSITE DEPOT TANK 2 INFORMATION

Tank diameter : 10.02 m
Height : 11.825 m
Tank capacity : 930 m³
Product : Diesel
Roof type : Fixed

Visual inspection photos

Description of the service: The modification and alteration of diesel storage tank, at Transnet Freight Rail Millsite depot, for a service period of 6 months.

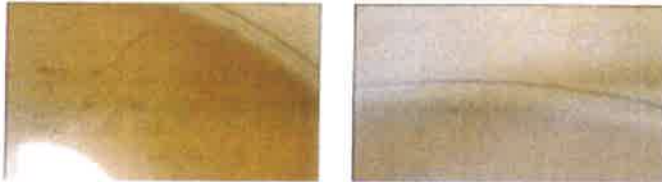
Supports welded directly to tank floor

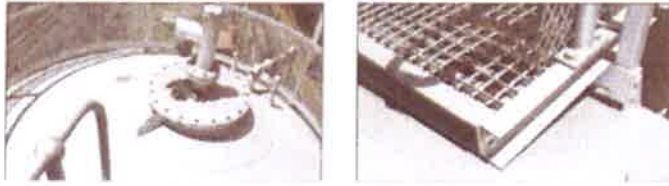
Roof External

Roof plates coated with non-slip

- i. supply and install anti-slip strip on the roof, to cover all service points,
- ii. supply and install atmospheric normal vent that is equipped with a screen mesh that complies with API 650 section 5.8.5,
- iii. supply and install an emergency venting system, and
- iv. prepare and wire brush and paint tank roof including all nozzles. Using an approved primer and Transnet aluminium zinc metal paint (apply 2 coats).
