CONDITION ASSESSMENT REPORT FOR THE KZN ROWING ASSOCIATION

Project Name : Condition Assessment (KZN Rowing Association)

Owner : Transnet National Ports Authority

Print Date: 24/11/2023

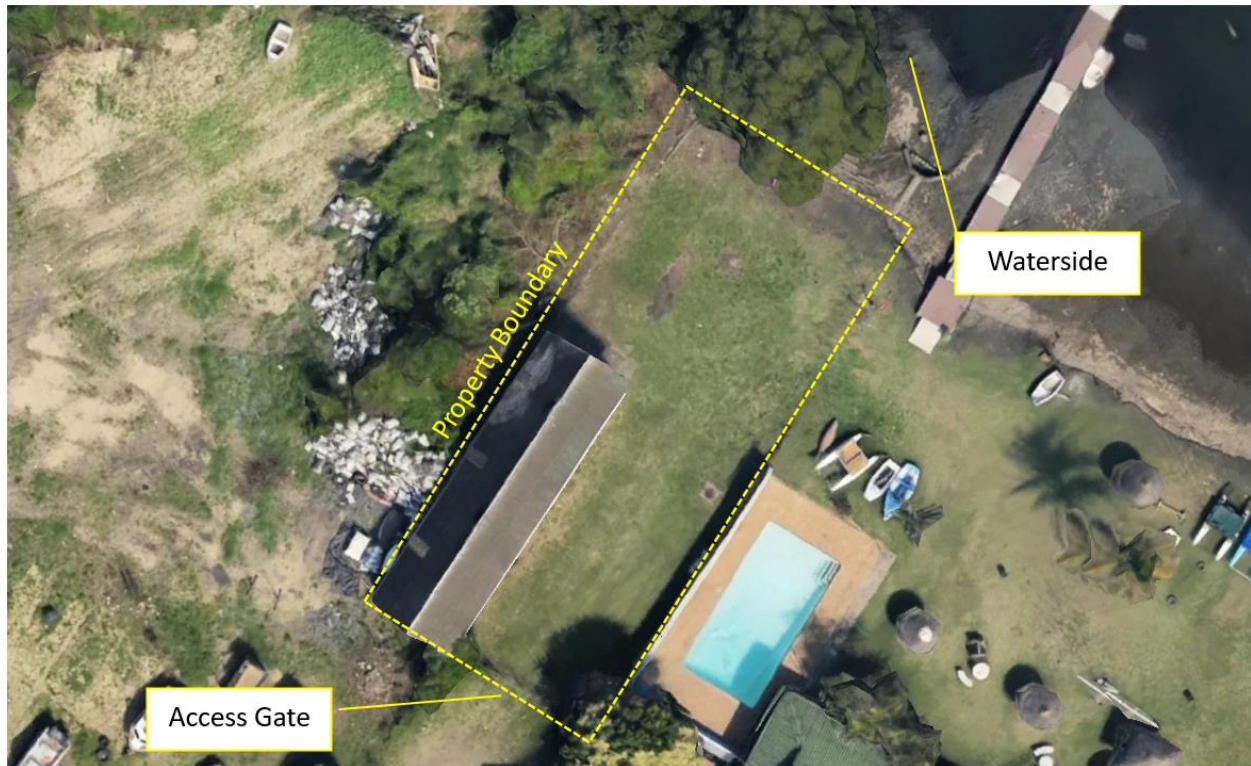
Figure 2: Site Layout

The property comprises of a single building structure, which consists of a main open plan area and ablution facilities. The property is located at an area which where there's mainly fishing and recreational activities. The property is 30m away from the Bayhead's silt canal which is utilized by private small craft users.
