Technical Report
2015/05/02/GENV

Port of East London:
HFO Tank Site Geo-Environmental Assessment

May 2015

Prepared for: **Transnet National Ports Authority**

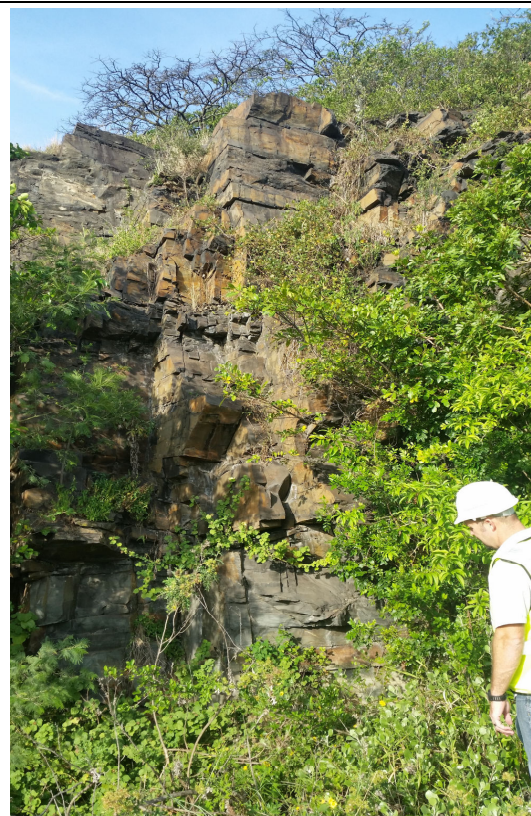
Photo 4: Structural geological assessment

The AGES team followed an integrated geo-environmental approach during the assessment and specialists conducted studies and field visits together to ensure that all aspects that need to be covered in the investigation are included and integrated. (Photos 3 & 4).

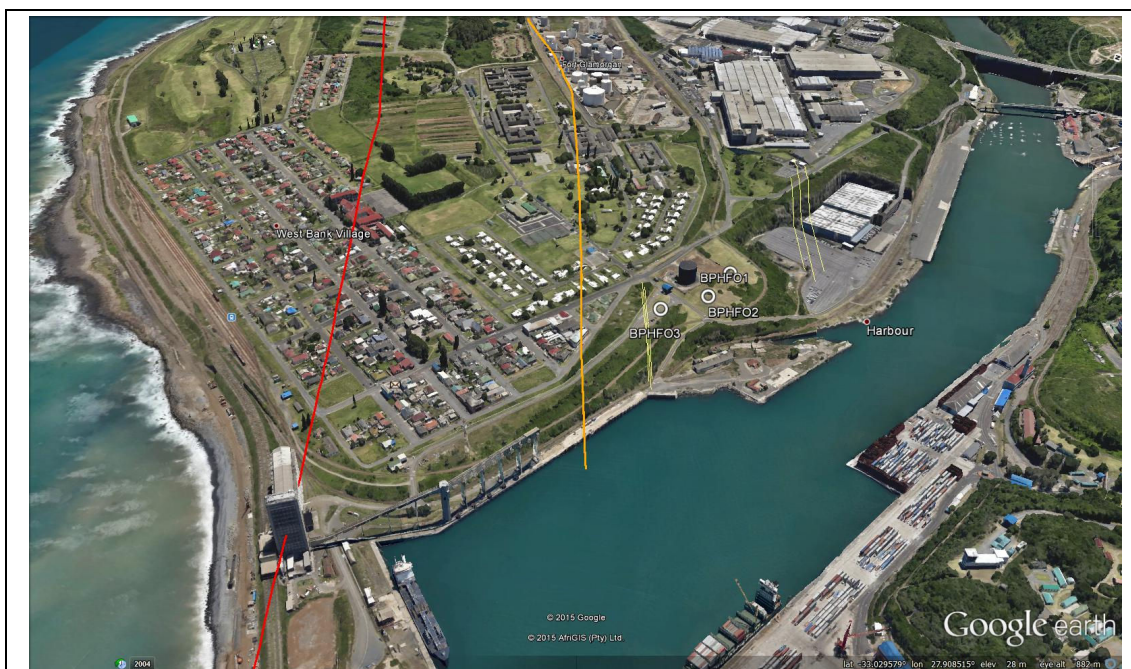
Figure 3: Predicted vs actual Dolerite sheet contact and joint directions

According to the published geological map, the dolerite sill contact (depicted by the orange line in Figure 12) should occur approximately 170m south-east of the HFO site. Site surveys have shown that this contact is not present where the map indicates and is more probably located 570m away as indicated by the red line in Figure 12. Taking an expected northerly dip angle of 15° into account, it is unlikely for the dolerite sill to occur at shallow depths below the HFO site as was reported in earlier studies.

Observations and measurements of strike and dip directions in rock exposures around the site have indicated that the general strike direction of the main joint set that occurs is parallel to the ENE line on which the dolerite outcrop is found. This suggests that there is possible faulting present closer to the dolerite sill contact as well as within the sandstone host rock. Such structures could be preferential flow paths for groundwater. The main ENE strike direction of joints and possible secondary faults is indicated in Figure 3 as yellow lines.

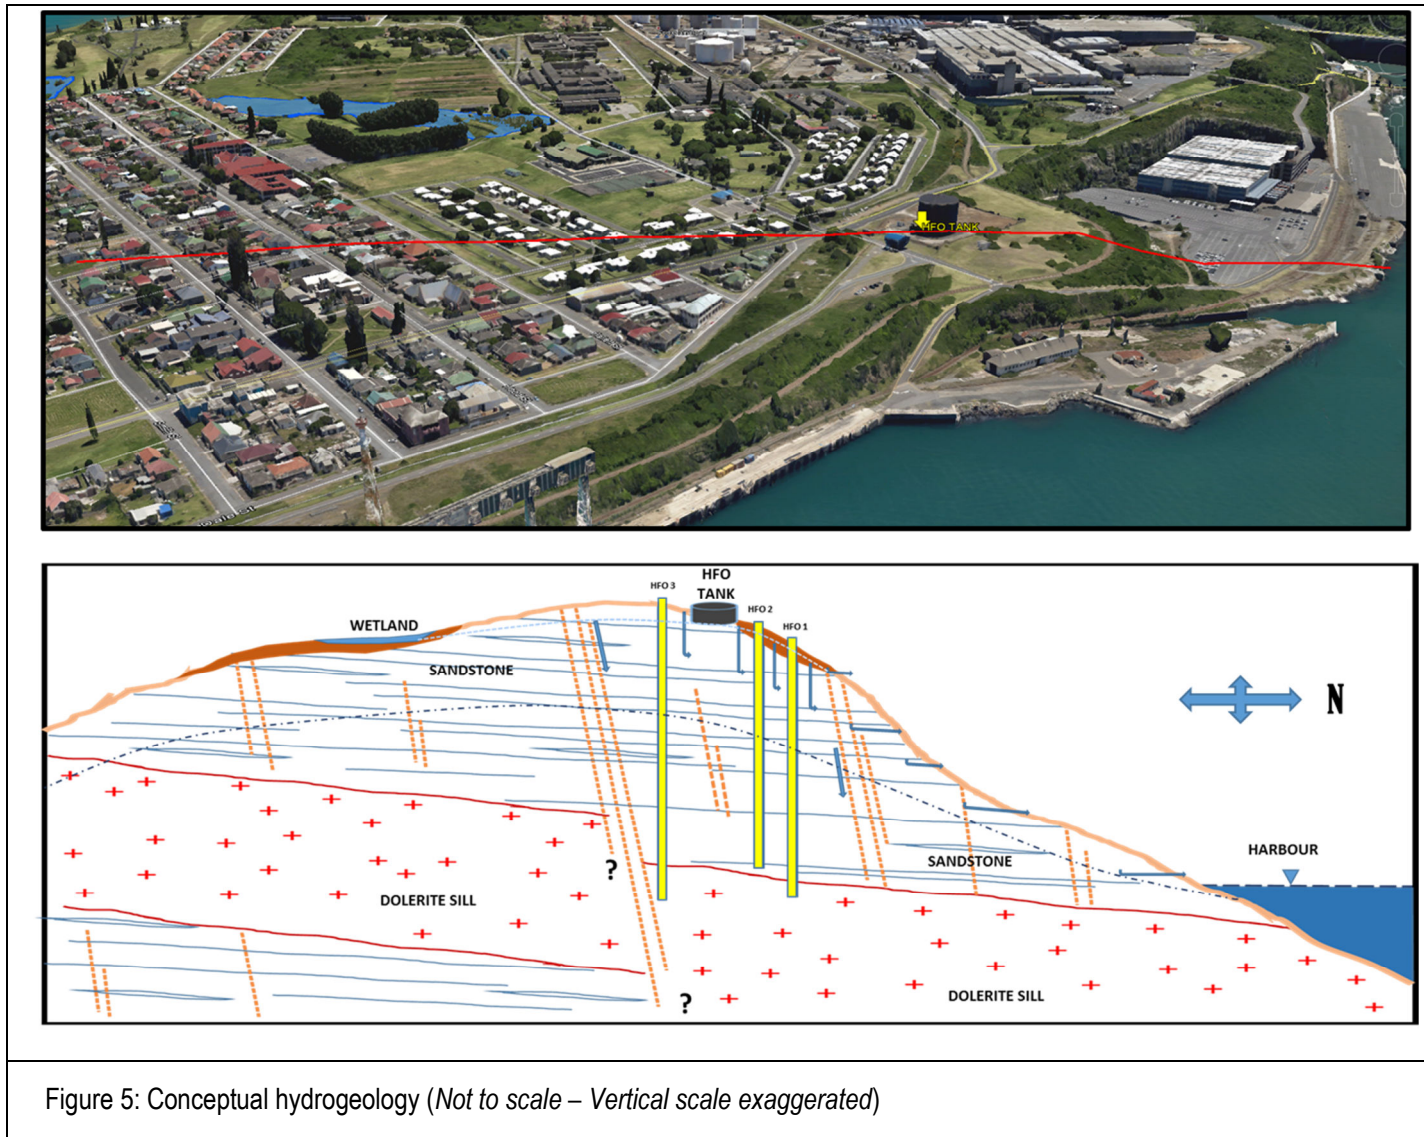
In the conceptual model it is indicated that although it was reported in previous studies that some boreholes penetrated dolerite as shallow as 3m, it is impossible for dolerite to be present within the first 30 m. Baked and altered dark grey quartzitic sandstone was most probably difficult to distinguish from dolerite during the drilling process. It is however likely that dolerite was intersected in depth and it is indicated as such in the conceptual model. (Figure 5).

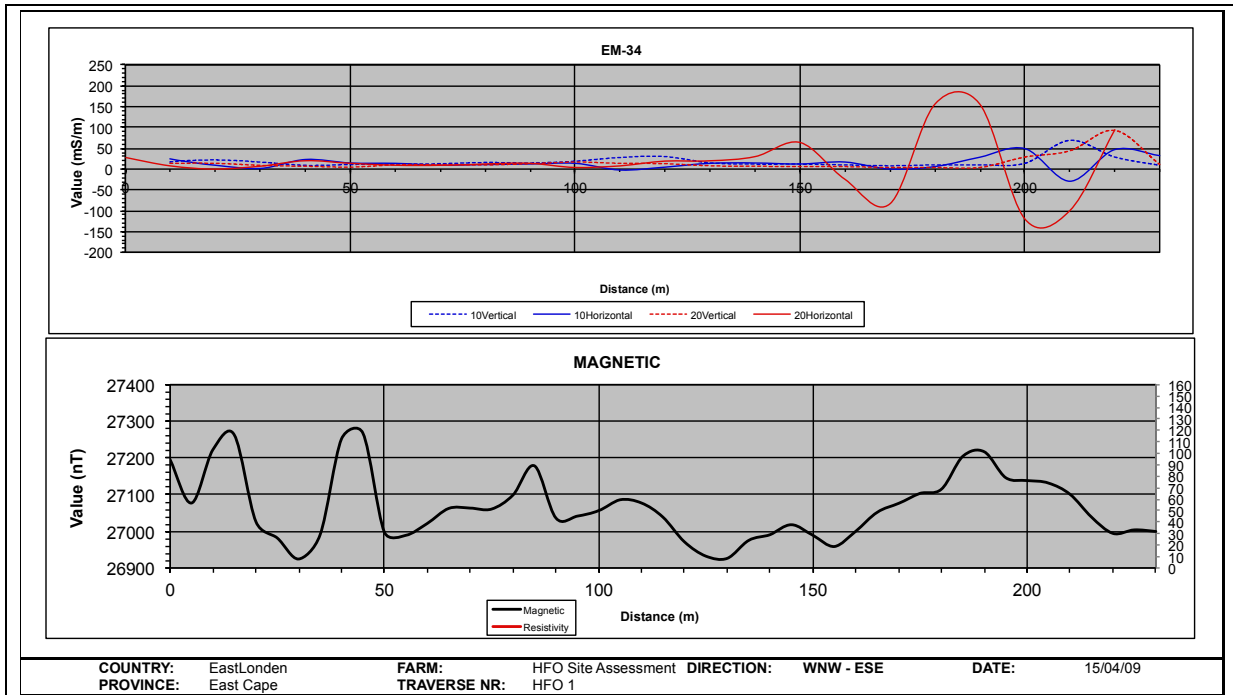
Figure 7: Geophysical profile HFO 1 – EM 34 & Magnetometer

Geophysical profile HFO1 starts at HFO 1a and ends at HFO 1b. The EM 34 profile indicates shallow weathering associated with fractures at 167m and 205m from the start of the profile. (Figure 7) The weathering is in association with a less weathered geological structure at 185m from the start of the profile. There is a strong correlation between the magnetometer and EM 34 geophysical data at 185m from the start of the profile, indicative of fractured rocks on either side of a geological structure. Borehole BP HFO 03 that could not be found on site, was probably drilled in close proximity to the fracturing in profile 1 but will need to be verified if its location can be confirmed. The fracturing is expected to be further east of this unidentified borehole.

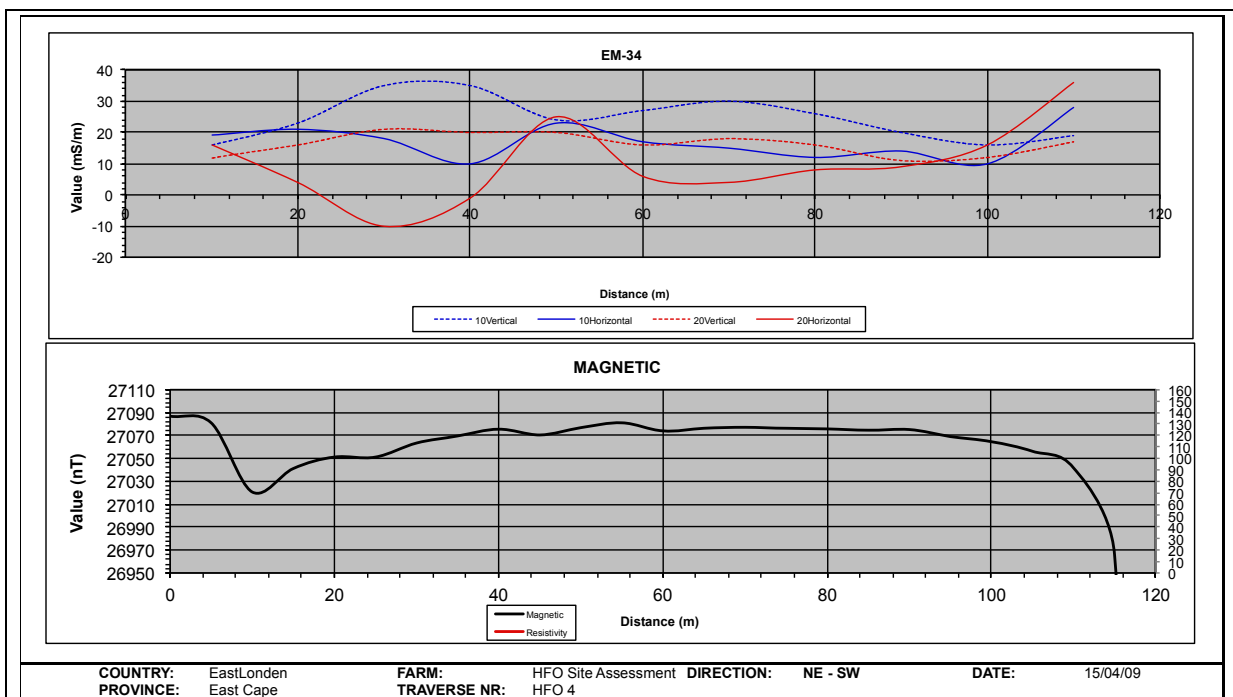
Figure 10: Geophysical profile HFO 4 - EM34 & Magnetometer

Shallow weathering was noted in profile HFO 4 at approximately 32m from the start of the profile. (Figure 10). The weathering does not correlate to a magnetic anomaly and is expected to be in the unconsolidated sandy material above the bedrock.

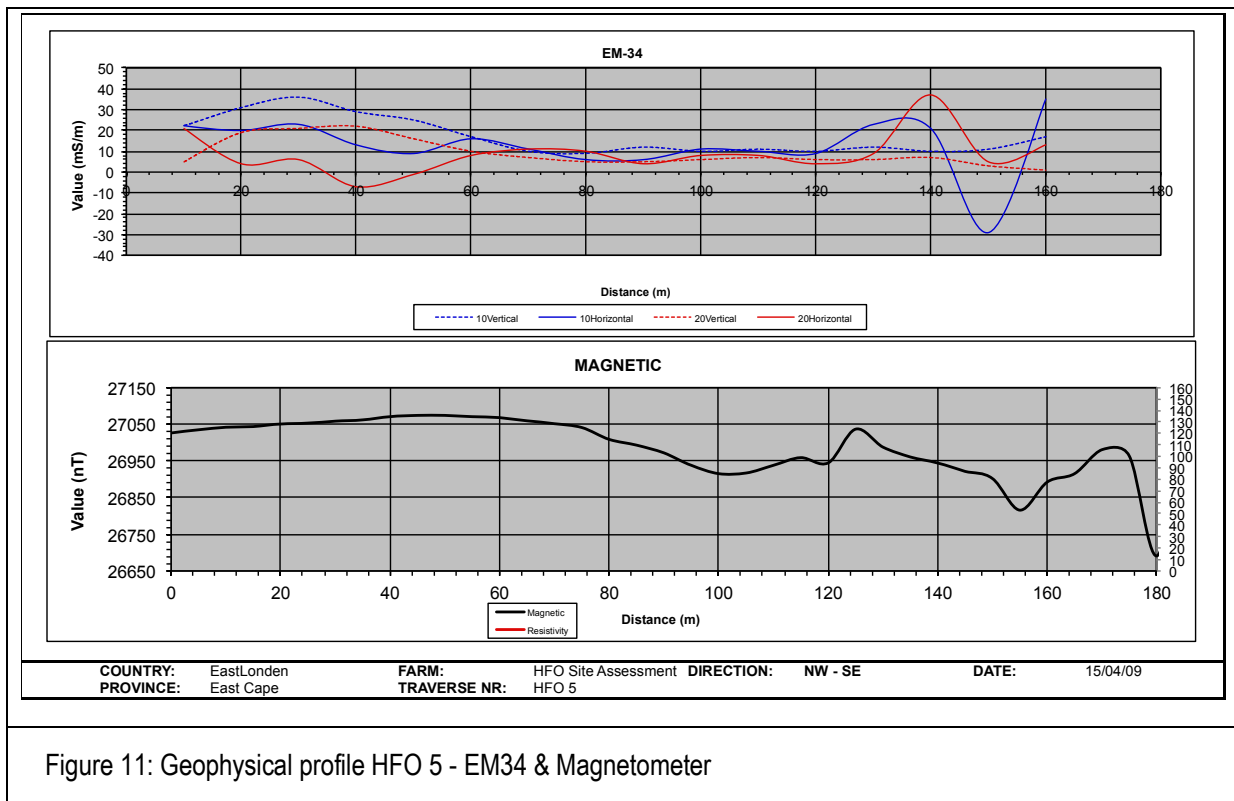
Figure 11: Geophysical profile HFO 5 - EM34 & Magnetometer

Profile HFO 5 indicates the presence of sand as encountered and described in the geotechnical section of the report as well as deeper fracturing noted in the sedimentary outcrops north of the tank. (Figure 11).

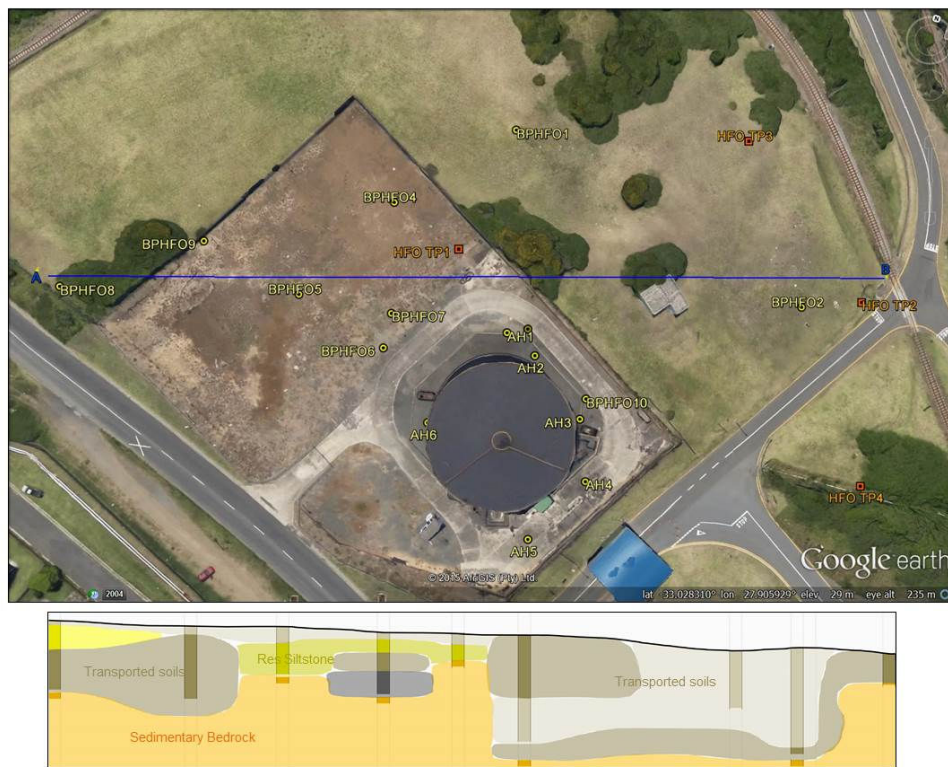
Figure 14: Preliminary conceptual model of soils (Google Earth Pro)

In the model it is shown that deeper sand occur in the zone directly north east of the HFO tank. This zone can act as a preferential pathway for shallow groundwater flow towards the Buffalo River and harbour.

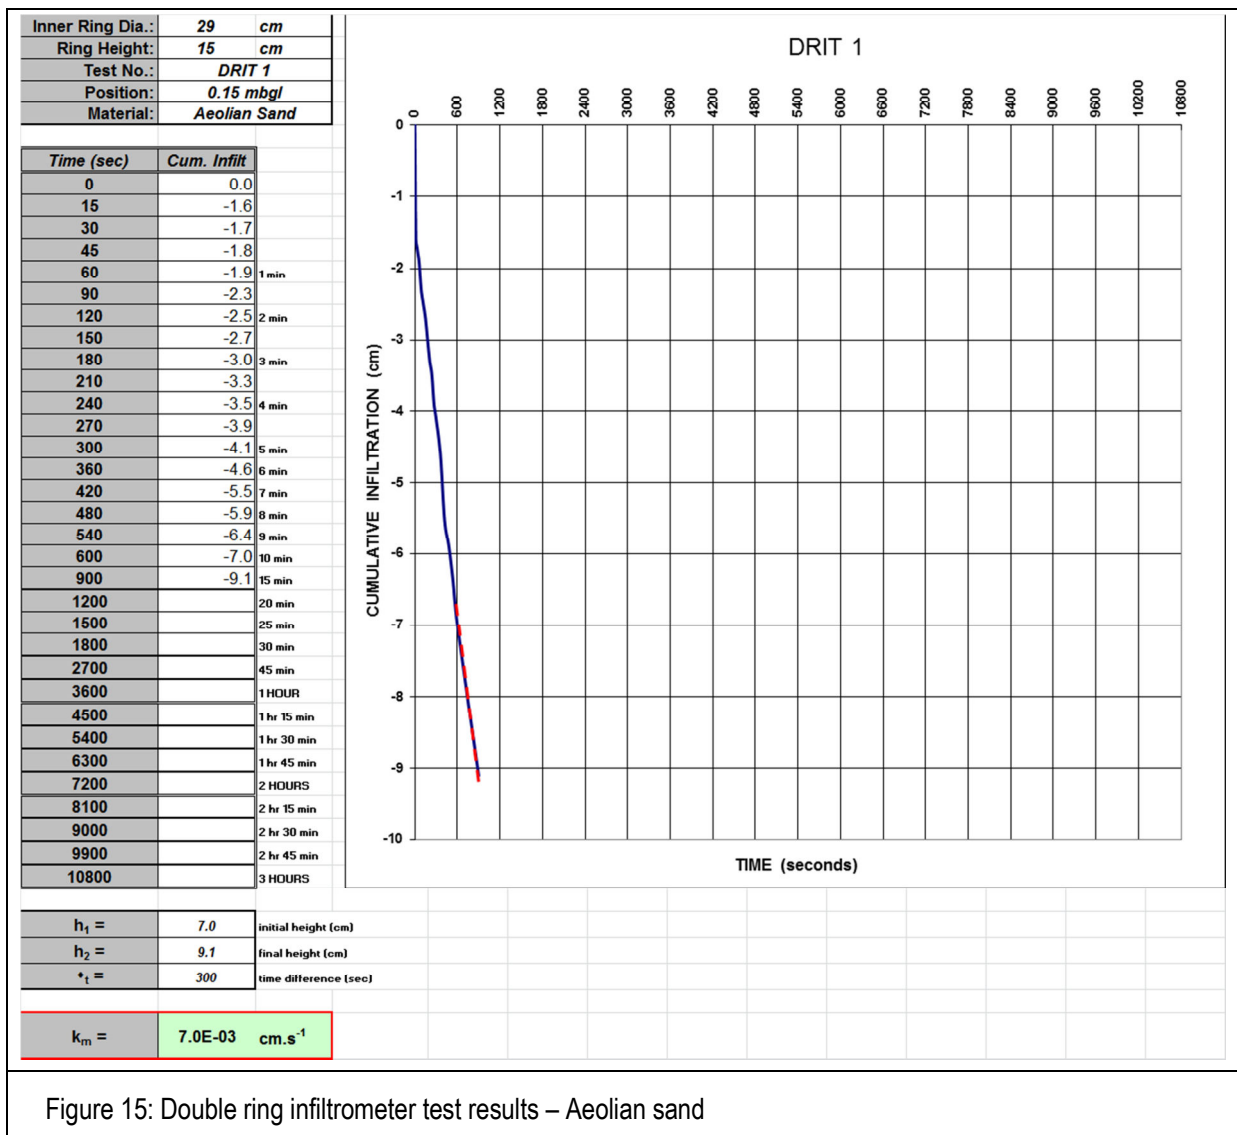
An in-situ permeability test was conducted on the material to measure the permeability. This was done utilising the double-ring infiltrometer method. Results from the in-situ field test are presented in the figure below and indicates that the material has a measured permeability of 7.0×10^{-3} cm/s which related well with laboratory analyses results.

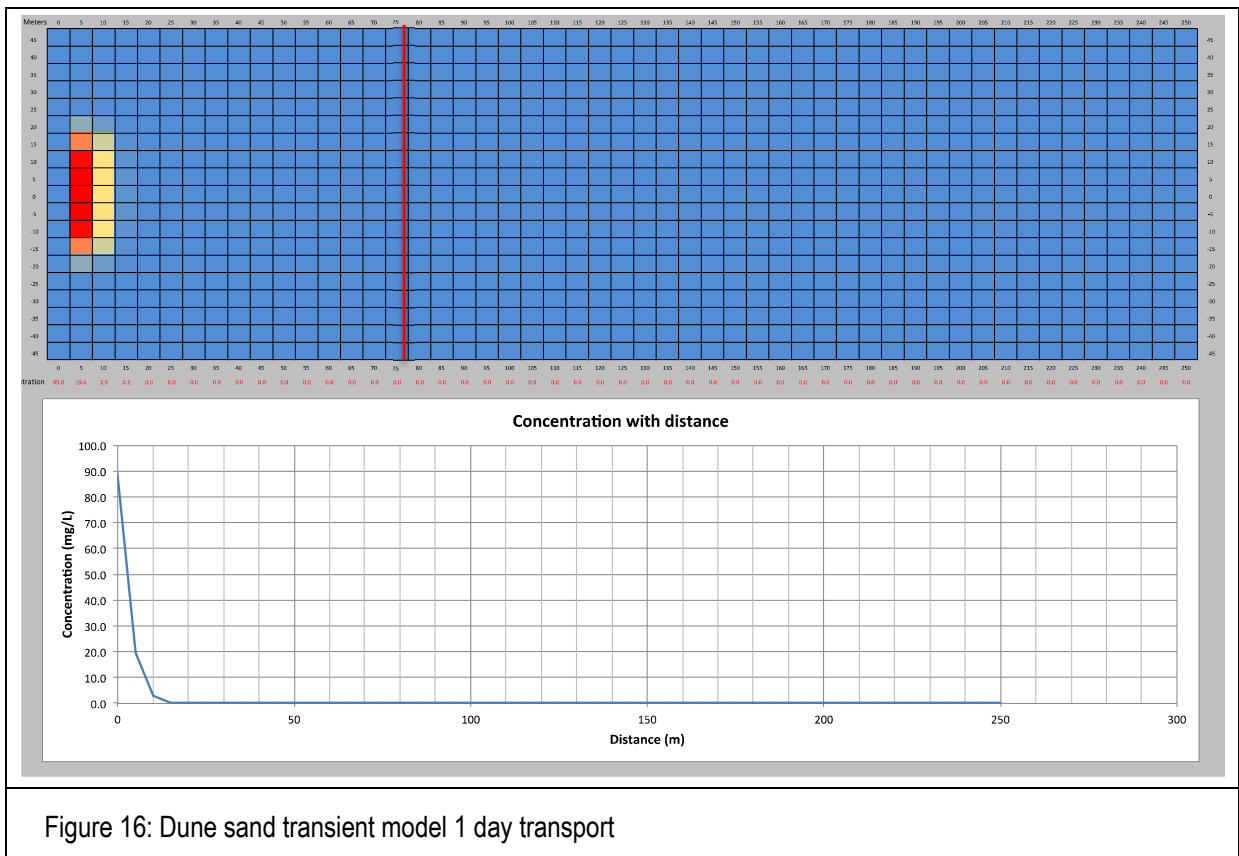
Figure 16: Dune sand transient model 1 day transport

Based on the geotechnical findings a hydraulic conductivity of 4.86 m/d was calculated for the sieve analyses conducted on the dune sand sample taken from trial pit HFO3. The sand was selected due to its high permeability and it is located downstream of the HFO tank in the vicinity of the monitoring borehole BP HFO 2 that had a strong diesel odour during sampling. The seepage velocity was calculated using Darcy's equation and was determined to be 1.43 m/d.

From the dune sand transient model we can conclude that the initial contaminant concentration of 89 mg/l will reduce to less than 0.2 mg/l over a distance of 15m. Rock exposures have indicated that water within the sands and shallow weathering enters vertical joints along which it infiltrates until it reaches resistive horizontal bedding planes on which it flows towards the outcrop after which it enters the harbour as surface water flow.

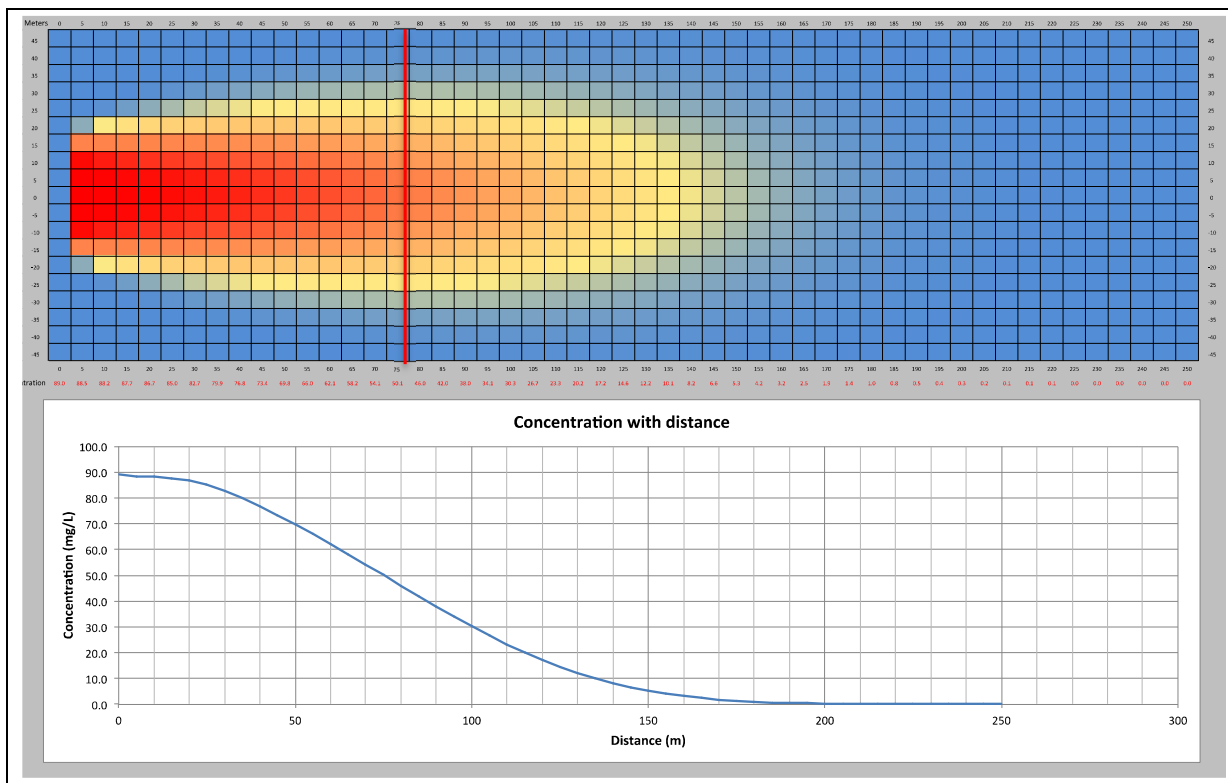
Figure 17: Fractured rock transient model 1 day transport

From the fractured rock Domenico model we can also conclude that the contamination plume would travel approximately 205m before reaching an end concentration of 0.2 mg/l. With the rock outcrop being only 75m downstream of the contaminated borehole it is indicated in Figure 17 that pollution can reach the Buffalo River Estuary before reaching acceptable concentrations.

It can be concluded that contamination transport through the fractured rock could be orders of magnitude faster and therefore further and wider than in the dune sand. Fractures in the underlying formation strike in a north east direction and are associated with horizontal bedding planes along which groundwater can flow towards the Buffalo River. It is further concluded that any contamination entering the overlying soil layers would most likely enter the fractured rock and flow along the bedding planes and would be discharged along the Buffalo River. Once contamination has entered the fractures it can be transported up to 104m in a single day under ideal conditions.

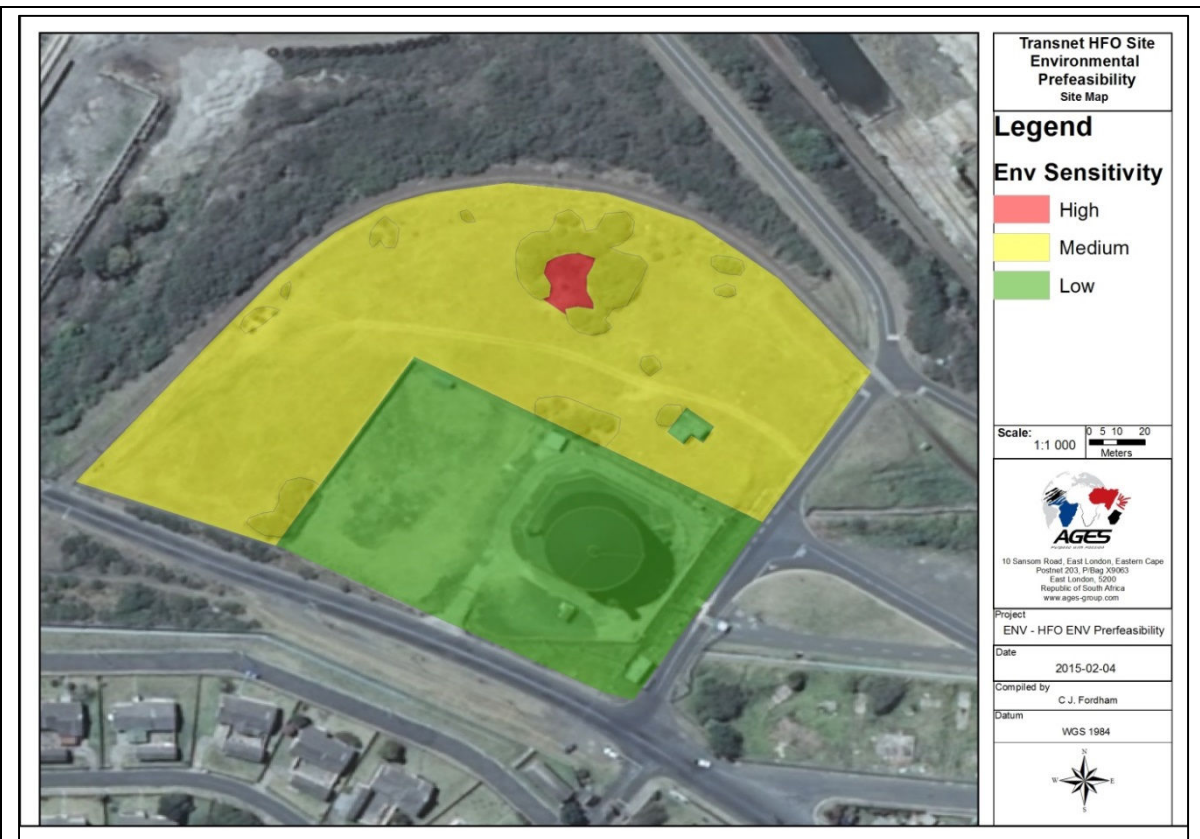
Figure 19: Map illustrating site environmental sensitivity

Outside of the HFO compound small portions of indigenous Buffels Thicket (Coastal Thicket) [Figure 22(a)] and coastal grassland vegetation [Figure 22 (b)] dominates the site (Figure 19). A small dam\artificial wetland also being noted (Figure 19). In general the entire site was rated with medium sensitivity due to the levels of anthropogenic influence and high levels of alien plant infestation. Although the dam/artificial wetland region was rated as highly sensitive due to the ecosystem services it provides for the fauna of the region.

The medium rated coastal thicket (Figures 19 and 20), is predominantly dominated by alien vegetation such as *Lantana camara* and *Cestrum laevigatum* [Figure 22 (c and d)]. There are however still sensitive natural coastal vegetation species present such the *Sideroxylon inerme* protected trees [Figure 22 (e)] which resulted in its medium sensitivity rating.

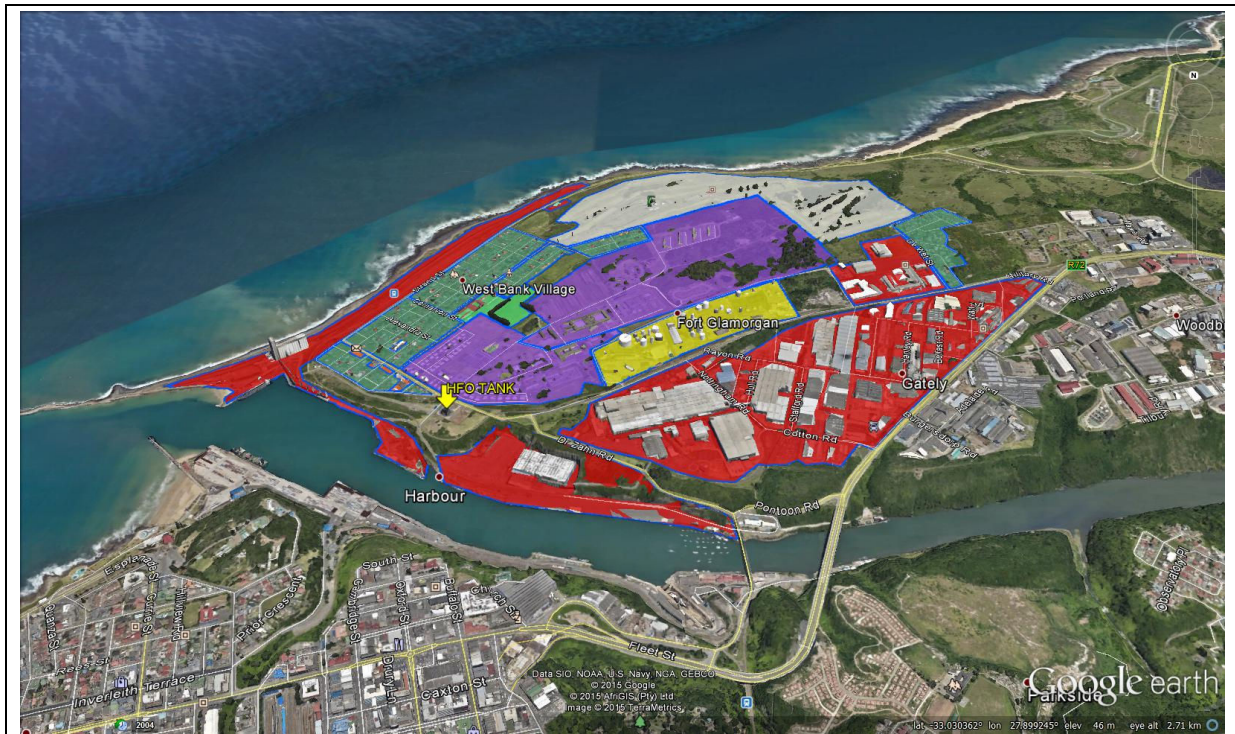
Figure 22: Aerial view of the HFO site and main different land use areas

The coastal grassland section of the site is regularly mowed and dominated by *Stenotaphrum secundatum* [Figure 22 (f)]. Following specialist consultation it was concluded that common mole-rats (*Cryptomys hottentotus*) or possibly the Hottentot golden moles (*Amblysomus hottentotus*) are living within this section of the property. These mole-rats are responsible for the large number of mole hills\holes. Both of these species are widespread and not protected under South African legislation. The coastal grassland portion of the site was rated as medium sensitivity due to these high levels of ecological activity.

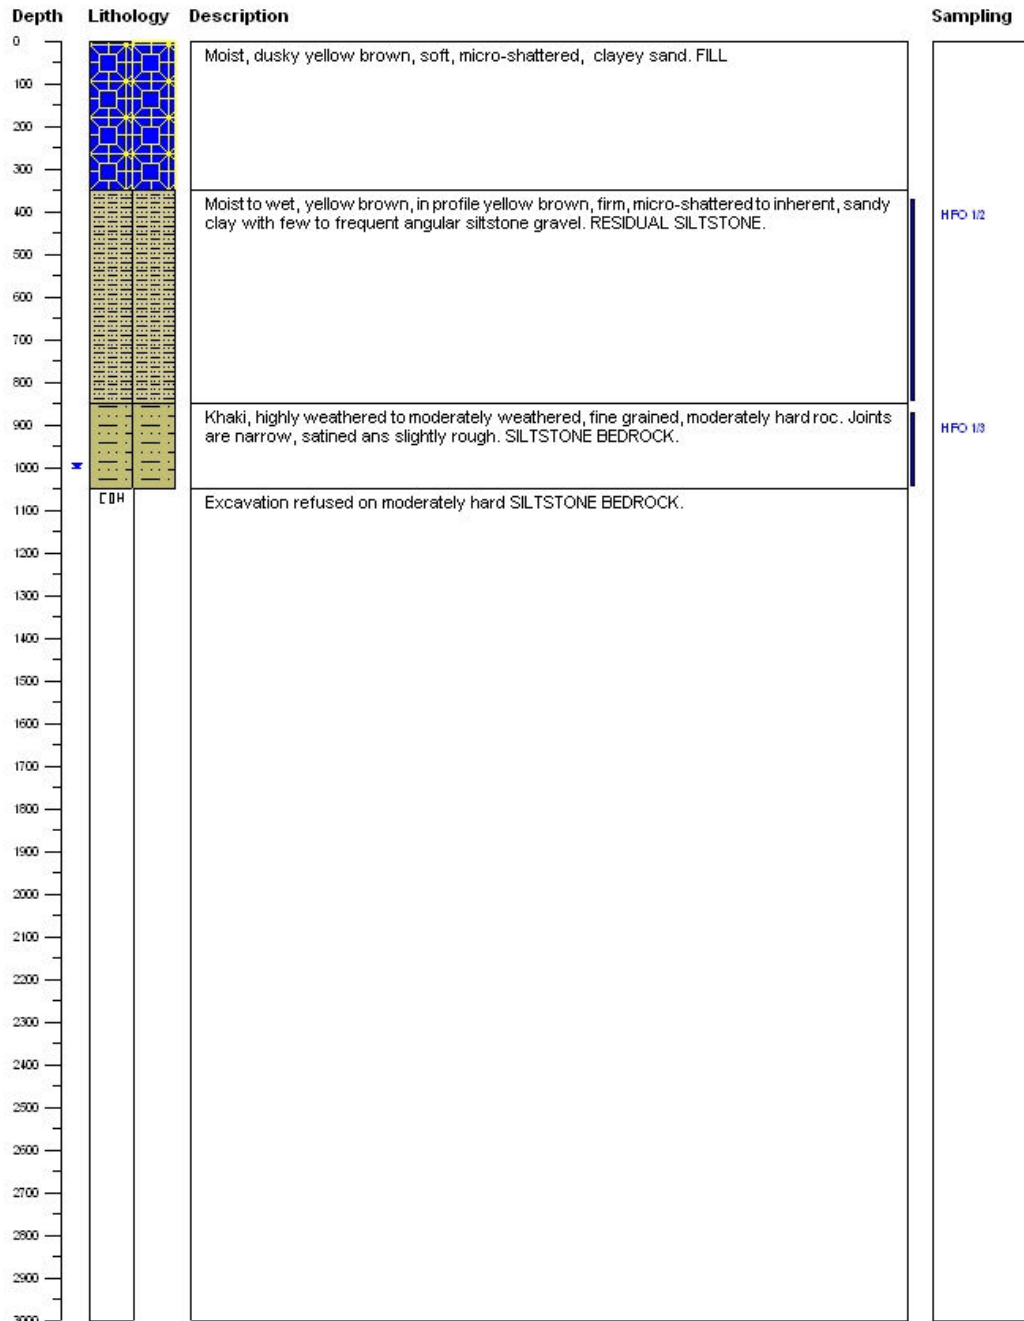
PROJECT: GTEC HFO Site Assessment		TRIAL PIT NO.: HFOTP1	
CLIENT:	TNPA	LATITUDE:	S33.02821
CONTRACTOR:	Community Labour	LONGITUDE:	E27.50583
MACHINE TYPE:	Hand Dug	ELEVATION:	32 m am sl
		DATE EXCAVATED:	08 April 2015
		DATE PROFILED:	08 April 2015

Notes: Strong seepage @ 1.00 m bgl
 Sidewall stability good
 2 Disturbed sample taken

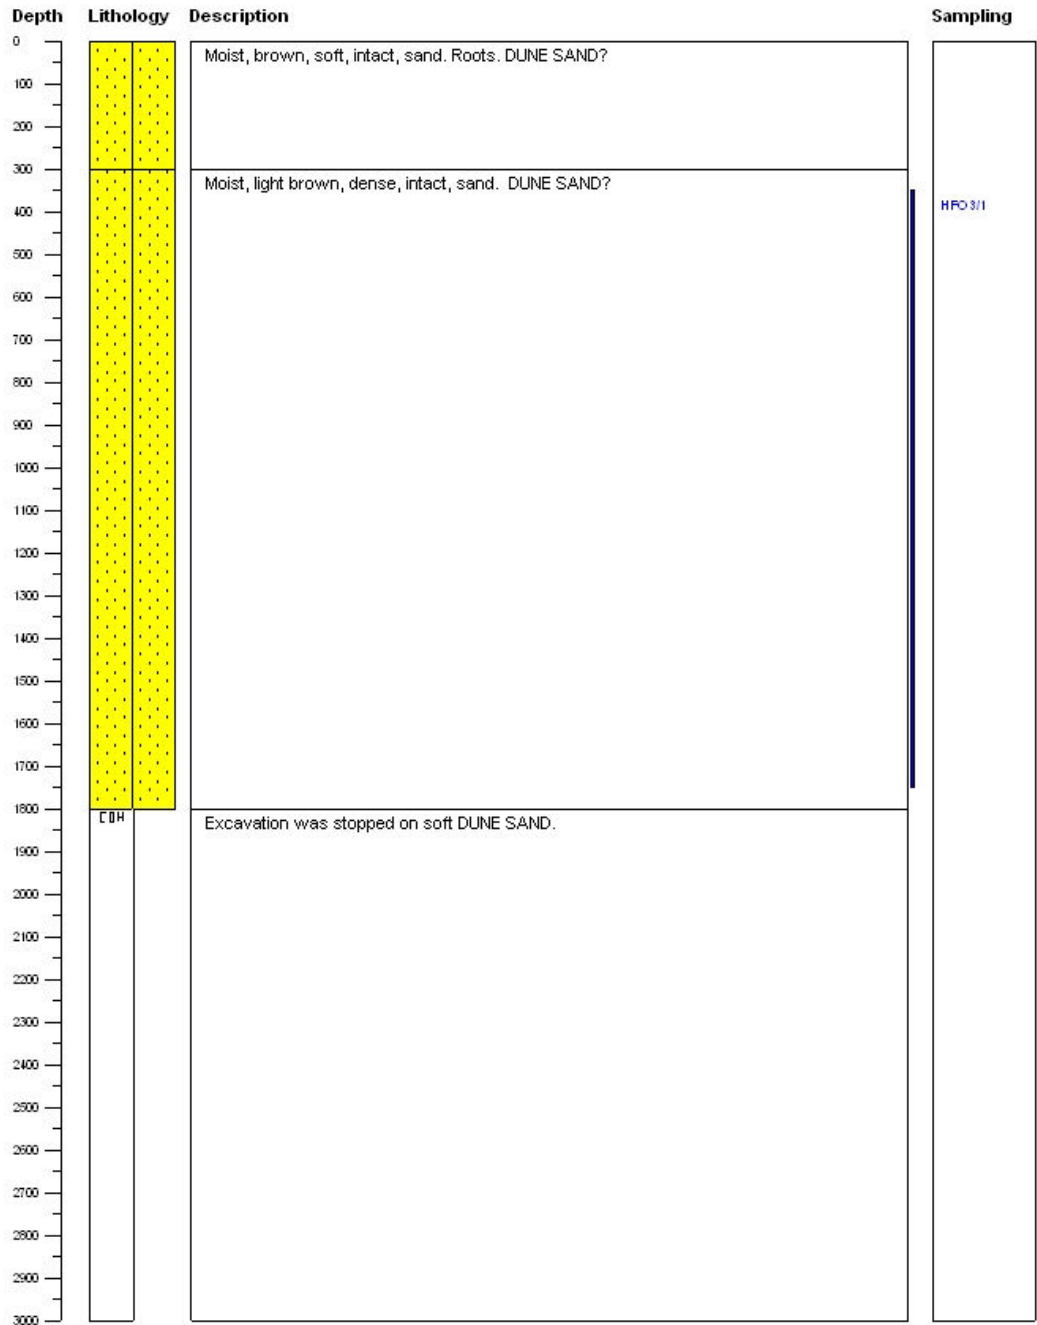
PROJECT: GTEC HFO Site Assessment		TRIAL PIT NO.: HFO TP3	
CLIENT: TNPA	LATITUDE: 333.02780	DATE EXCAVATED: 08 April 2015	
CONTRACTOR: Community Labour	LONGITUDE: E27.96654	DATE PROFILED: 08 April 2015	
MACHINE TYPE: Hand Dug	ELEVATION: 20 mm sl

Notes: No seepage
 Sidewall stability good
 1 Disturbed sample taken

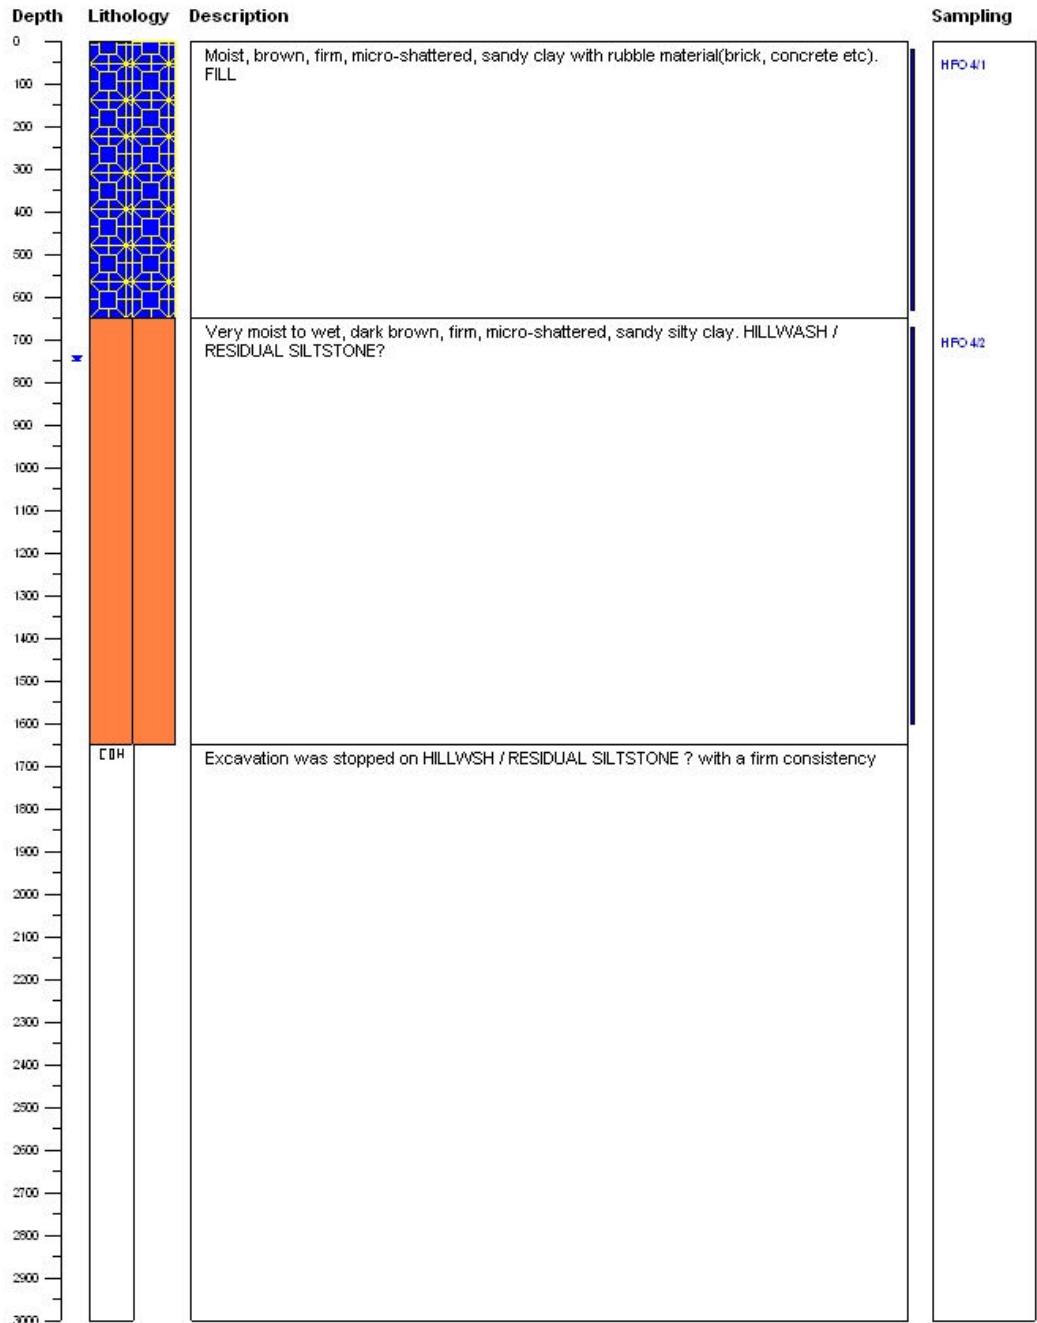
PROJECT: GTEC HFO Site Assessment		TRIAL PIT NO.: HFO TP4	
CLIENT: TNPA	LATITUDE: 333.02845	DATE EXCAVATED: 08 April 2015	
CONTRACTOR: Community Labour	LONGITUDE: E27.90701	DATE PROFILED: 08 April 2015	
MACHINE TYPE: Hand Dug	ELEVATION: 16 mm sl

Notes: Seepage @ 0.75 mbgl
Sidewall stability good
2 Disturbed sample taken
