## **CONDITION ASSESSMENT REPORT FOR THE (former) CORAL REEF CHARTERS AT BAYHEAD PARK**

Owner : Transnet National Ports Authority

The Bayhead area within the Port of Durban is a multifaceted region, encompassing storage container yards, ship repair facilities, and various supporting services. This technical report is dedicated to presenting the results of a condition assessment carried out on the Ex-Coral Reef Charters warehouse in Bayhead on October 26, 2023.

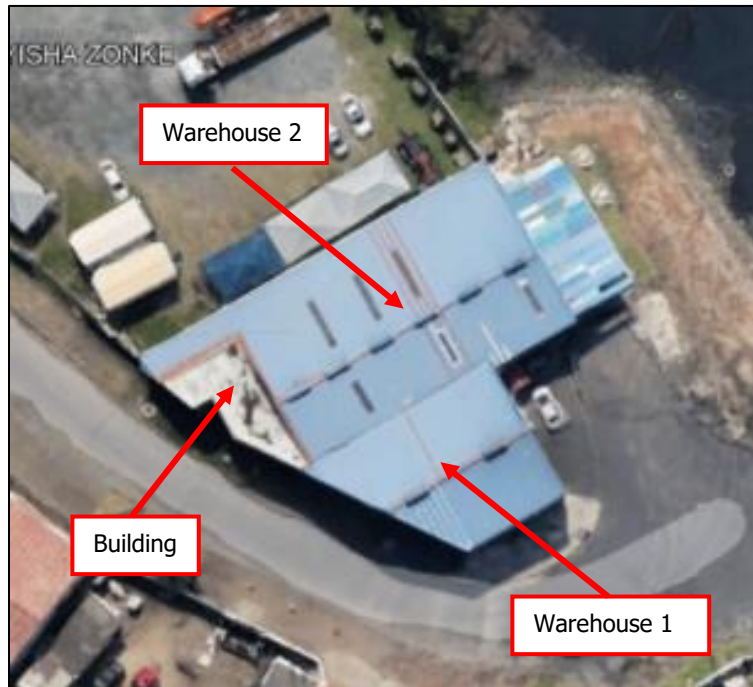
Figure 3-1: Site layout (2 Grunter Gully Street).

The property comprises of three structures, namely, two warehouses and a building as shown in Figure 3-1. An exterior inspection of the warehouses was conducted since the team had no access inside the warehouses and building.
