TRANSNET NATIONAL PORTS AUTHORITY
CONDITIONAL ASSESSMENT REPORT
STRUCTURAL REPORT

SITE: EXPRESS WAREHOUSE, MAYDON WHARF,
DURBAN
COMPILED: TNPA PORT ENGINEERING
DEPARTMENT
DATE: JUNE 2023

TRANSNET NATIONAL PORTS AUTHORITY CONDITIONAL ASSESSMENT REPORT

SITE: DG WAREHOUSE, MAYDON WHARF,
DURBAN

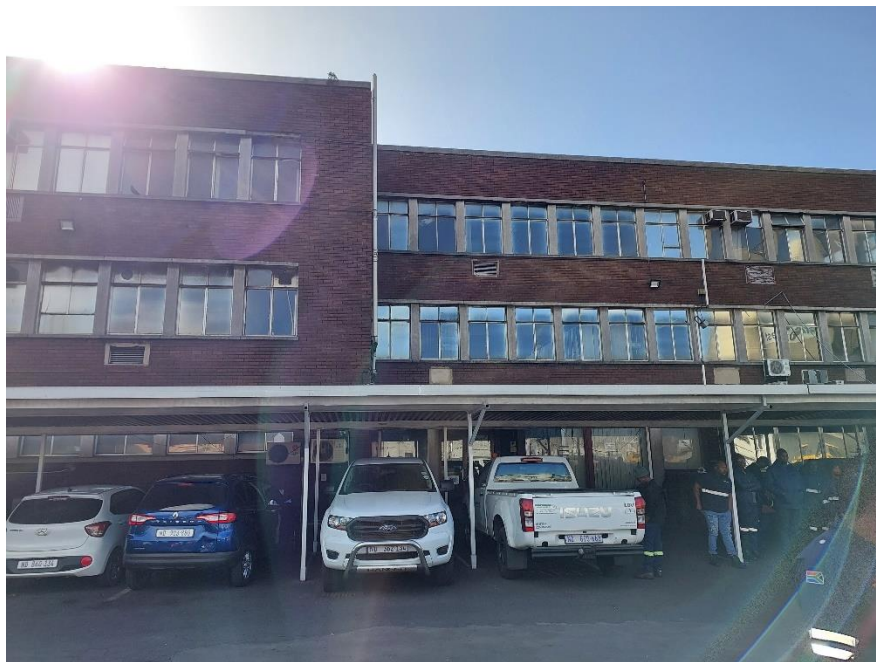
Figure 2: Main admin building exterior

The building overall is structurally sound with no major defects noted on the main structural elements. The façade brickwork doesn't show any signs of cracking nor does the columns or beams of the structure. The building does display significant water damage to the walls, ceilings and floor. The damage is indicative of unsealed windows and water ingress from openings in the wall via old aircon units. The water proofing and drainage on the roof will have to be investigated further to determine the extent of the damage however signs of waterproofing failure of the roof is evident from the water damage noted on the underside of the slab.

It is recommended that the following actions are taken to address the water ingress within the building:

- Strip and reapply roof waterproofing,
- Unblocking roof fullbores and gutters,
- Remove and seal old aircon unit cavities in walls,
- Replace or repair all existing windows.

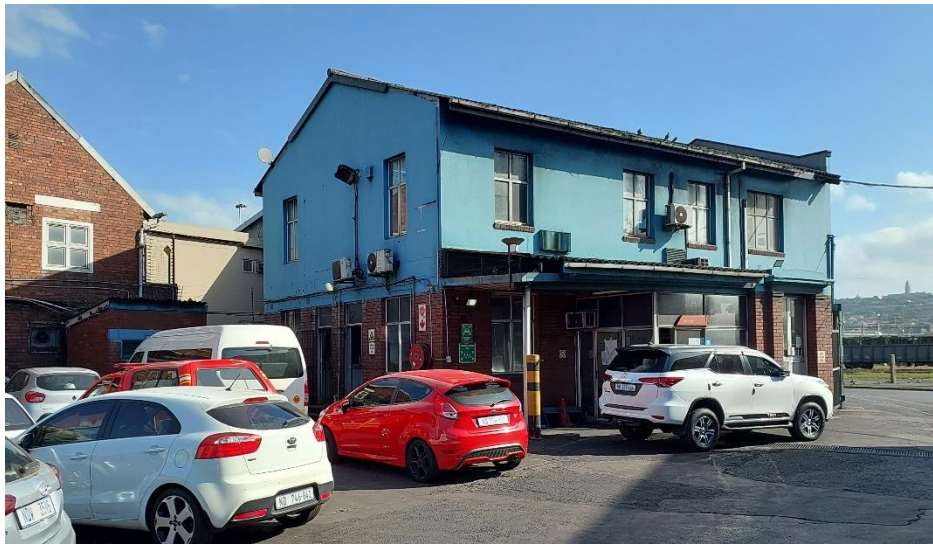
Figure 3: Office block exterior

The overall condition of the building is good with no major structural defects noted in the visual assessment. There were no leaks detected from the roof and office space on the second floor was well kept. The cracking noted on the walls on the second floor pose no structural risk and can be repaired. The ground floor displayed no indications of damage to the structure. The overall condition of the ground floor is good with only aesthetic issue noted.

It is recommended that the following interventions are taken:

- Cracking patched with suitable structural repair mortar,
- Partitioning brickwork be broken out and replace with new brickwork with stitching bars inserted to form a brickwork joint.

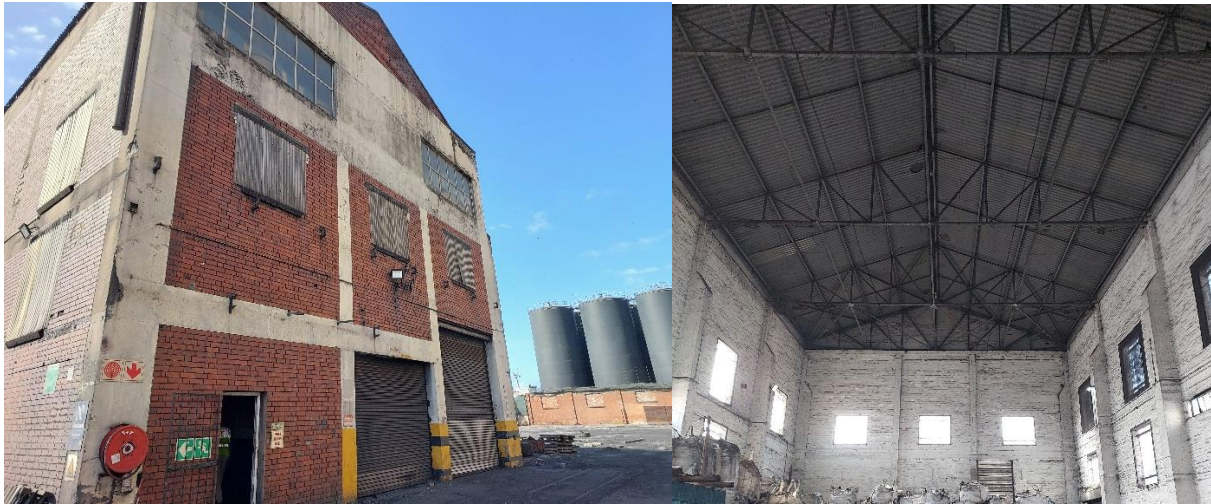
Figure 4: Exterior and interior of the workshop

The workshop structure is in good condition with the only serious damage noted on the brickwork on the eastern entrance of the structure. The remainder of the structure does not display any serious structural defects. The roof trusses are in good condition and does not display any notable corrosion. The roof sheeting has some holes visible from the inside of the building which may lead to leaks into the structure.

It is recommended that the following actions are taken:

- Roof sheeting to be tested for leaks,
- Outer sheeting to be fixed and loose sheeting removed,
- Interior surface to be repaired and leveled,
- Eastern brickwork to be removed and rebuilt with new supporting beam.
